# HIGHWAY ACCIDENT REPORT

SCHOOLBUS/AUTOMOBILE COLLISION AND FIRE,

NEAR RESTON, VIRGINIA

REPORT NUMBER: NTSB-HAR-72-2

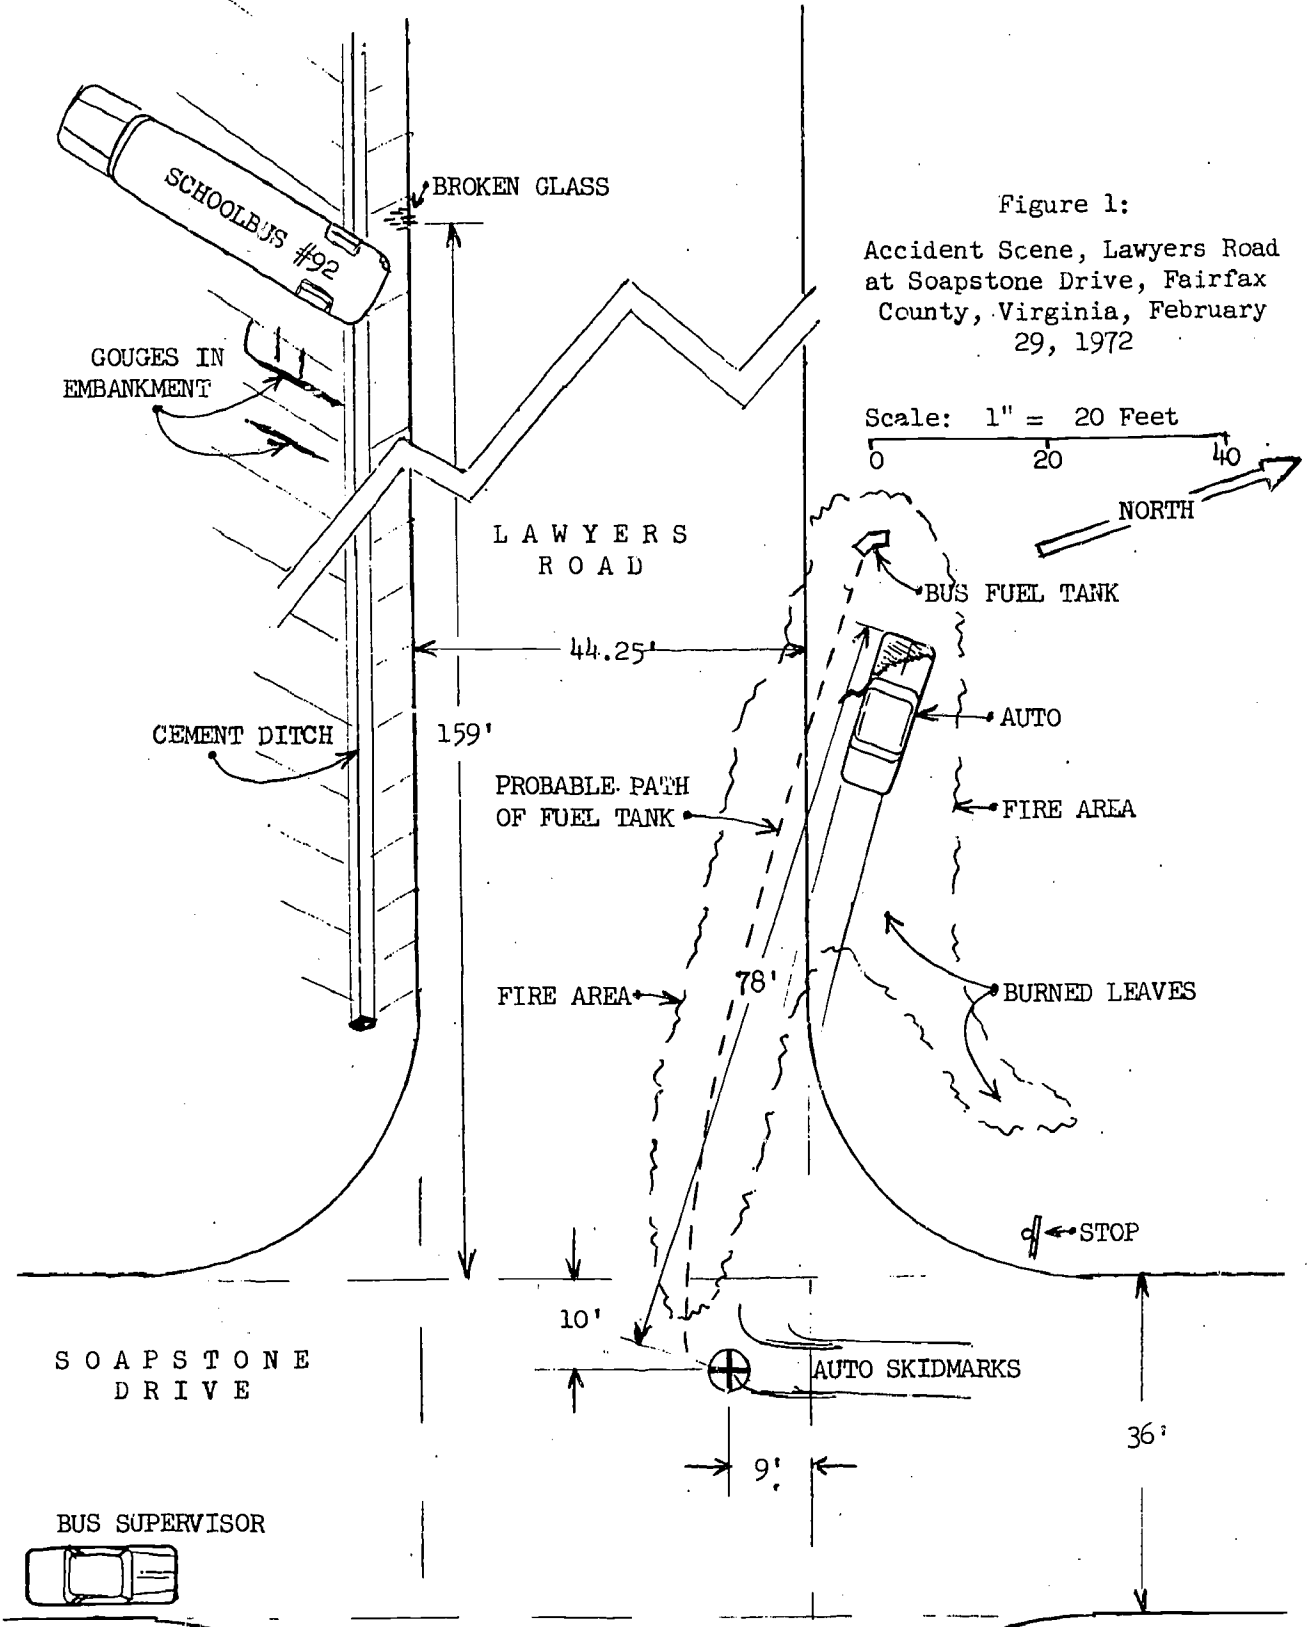
The schoolbus driver was thrown from her seat toward the right at impact and completely lost control of the bus, which traveled forward and to the left. It crossed a shallow cement-lined drainage ditch and struck a steep dirt embankment, about 140 feet west of the intersection, off the south side of Lawyers Road. With its front axle and springs broken away from the chassis, the bus bounced and slid westward another 25 to 30 feet, overturned onto its right side, returned upright, and came to rest some 175 feet from the point of impact. It did not catch fire. The driver was shaken and bruised; all four children (three students and pre-school son of the driver) were slightly injured--cuts and bruises--during the overturn kinematics. (See Figure 1.)

Figure 1:  
Accident Scene, Lawyers Road  
at Soapstone Drive, Fairfax  
County, Virginia, February  
29, 1972

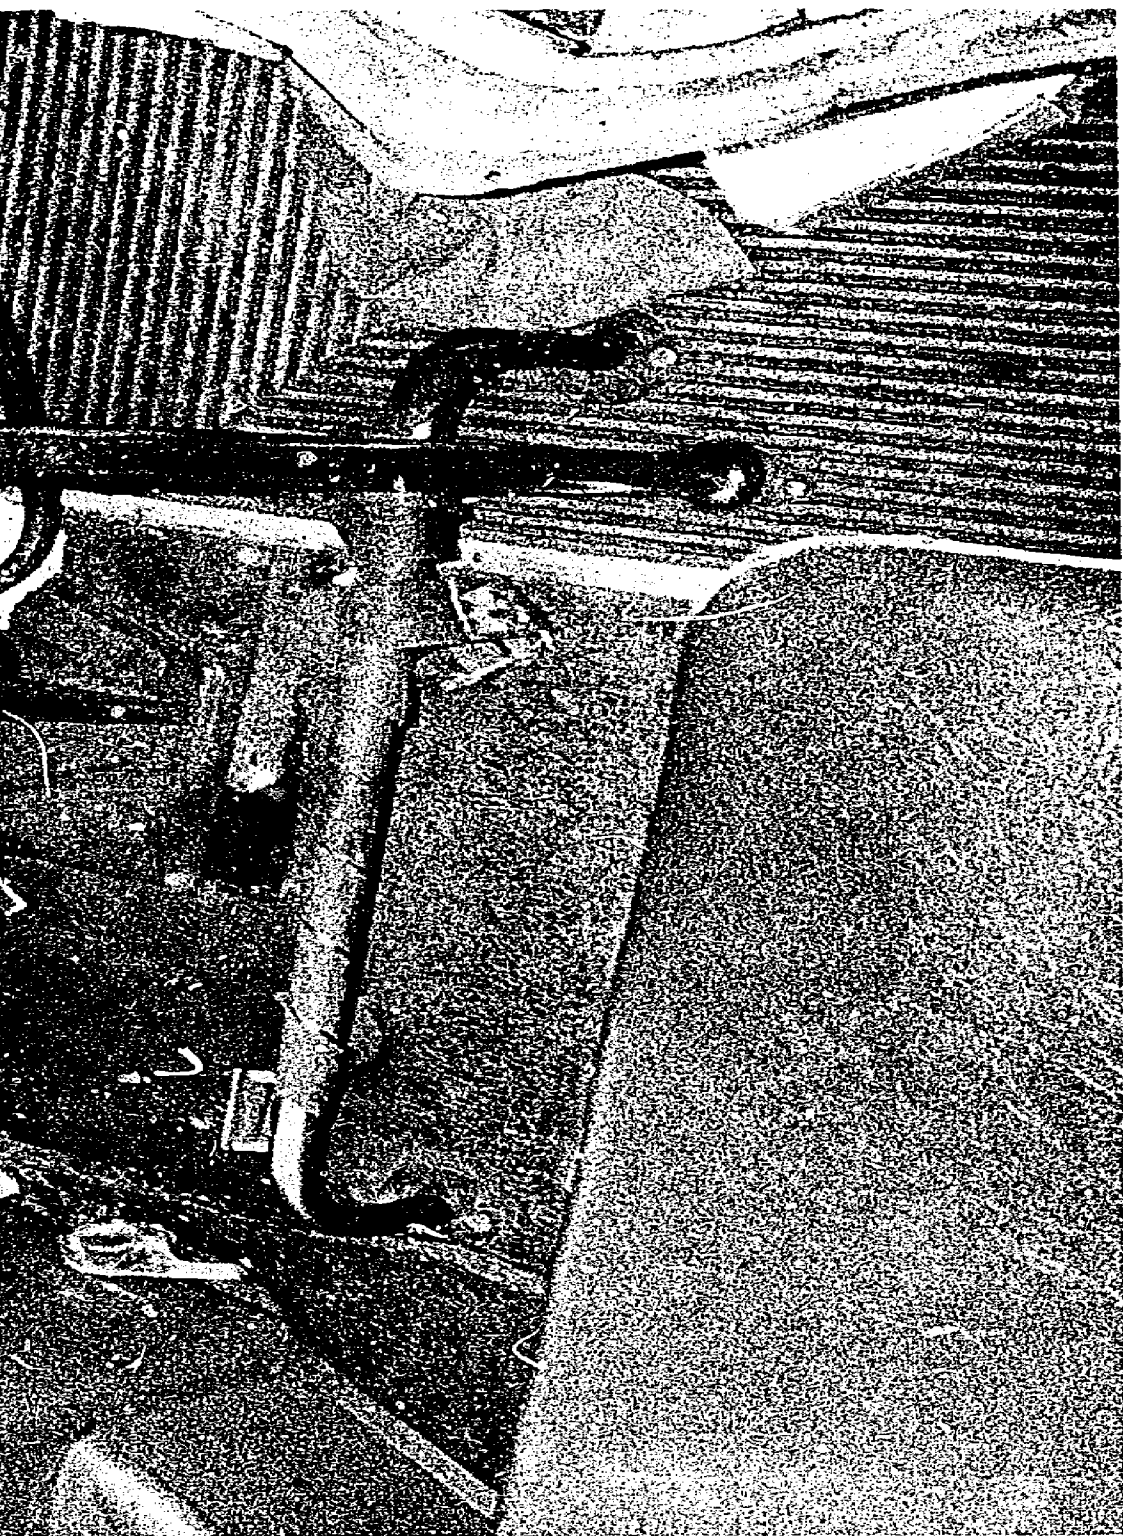
Figure 2: Driver's seatbelts wrapped around footrest bar.

1. The schoolbus driver, female, aged 22, had been driving schoolbuses about 1 1/2 years, was duly licensed and had no recorded traffic violations. This schoolbus was assigned to her, and she kept it parked overnight at her home. She knew of the seatbelts mounted at the driver's seat but said she personally disliked seatbelts and never used them. To the best of her knowledge, no order had been issued prior to this accident to use seatbelts, and "most" of the other schoolbus drivers shared her nonuse of seatbelts.

The fact that Fairfax County installed driver seatbelts in all its schoolbuses in 1966 implies that the use of such seatbelts was intended. All drivers were encouraged to wear them, and their training programs stressed the importance of seatbelt use. However, no direct order (or regulation) was issued requiring schoolbus drivers to use them. Individual drivers said it was a matter of personal and individual choice.

1. All States enact requirements for school districts or administrations within their jurisdiction, through State funding assistance or any other appropriate authority, for the installation of suitable restraint systems (seatbelts or other approved devices) at the driver's position in all schoolbuses, and for the wearing of such restraints (or the use of such devices) at all times when persons are being transported in such schoolbuses.

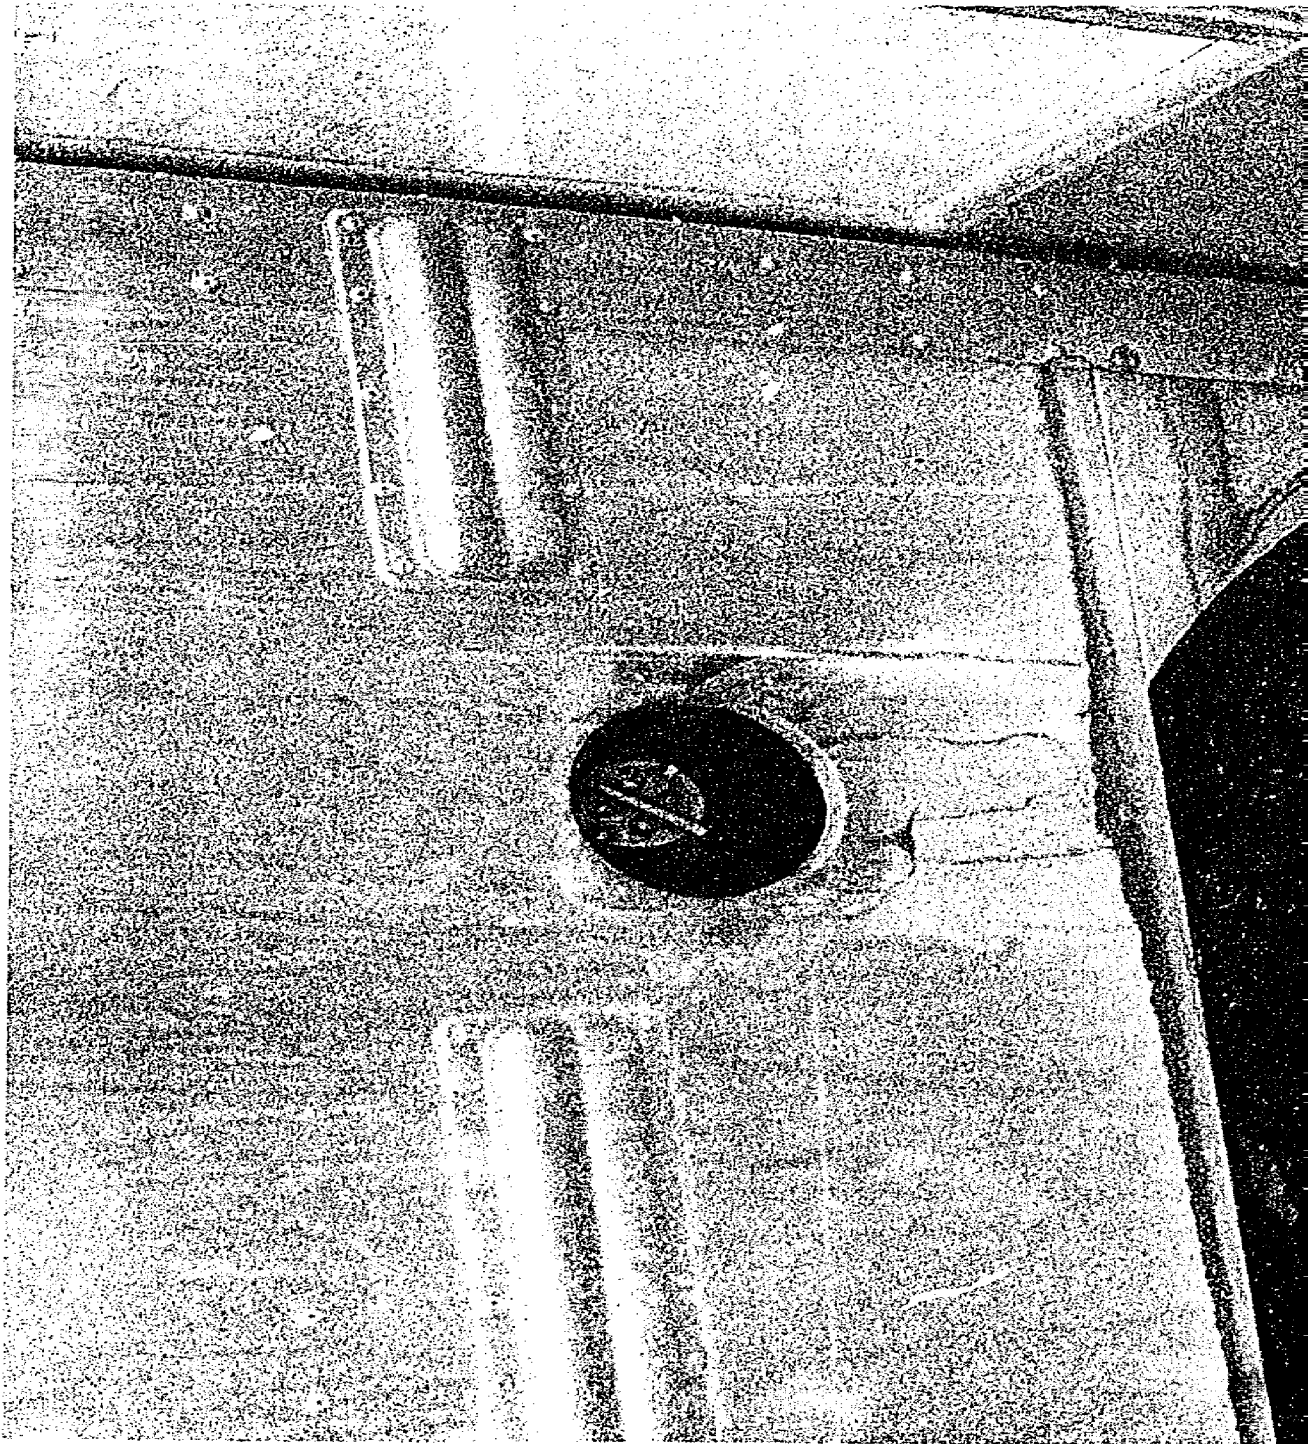
The location of fuel tanks in schoolbuses is not specified in any FMVSS, and the "safest" or "best" location for such tank has not been established by any Federal agency. National Education Association (NEA) standard specifications suggest that the best position is on the right side, directly behind the service door. Truck manufacturers who make schoolbus chassis units have advised that the tanks are located in that position because of the NEA specifications, which have never been superseded, although some manufacturers do not agree that this is the safest location (see Figure 8, 9).

Figure 8: Universal location of school bus fuel tank filler spout,  
shown on a bus body of other manufacture.

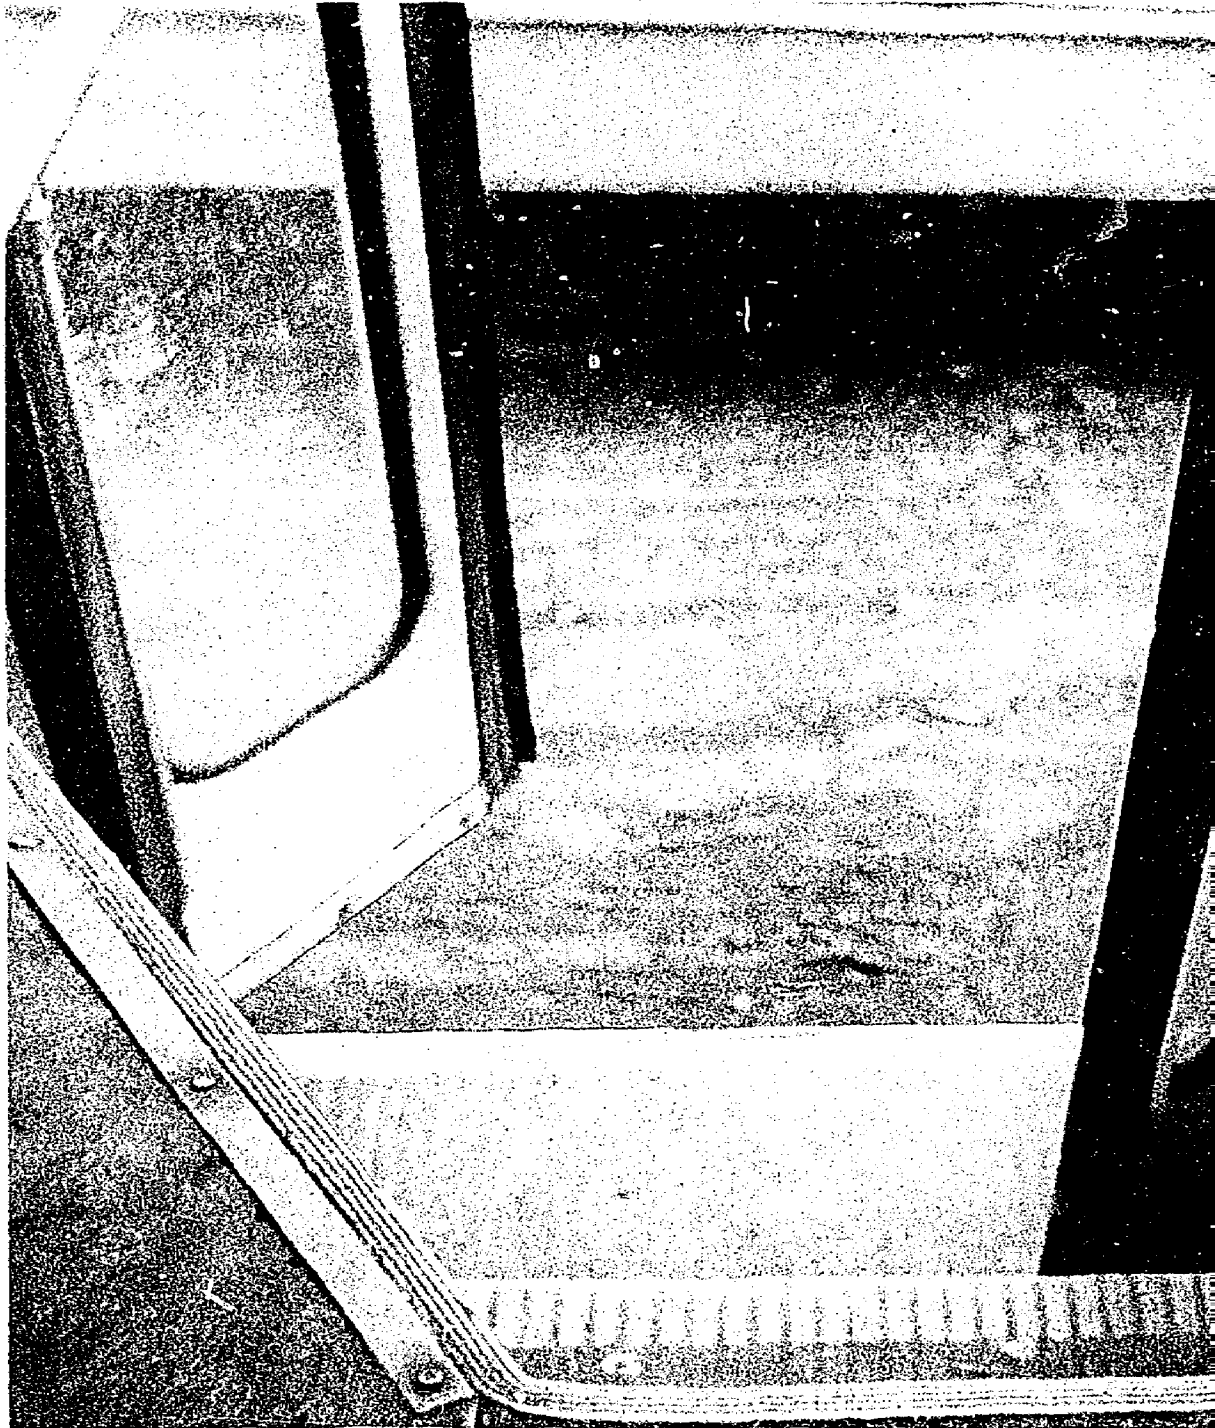
Figure 10: Split-type door, front half swing outward swinging inward (photo taken inside a sis

ERIC and rear half  
steer bus).

3. The National Highway Traffic Safety Administration and the Vehicle Equipment Safety Commission, in consideration of hazards posed by schoolbus service doors which open in such fashion that the pressure of persons from within the bus might hamper or prevent the expeditious opening of such doors in an emergency, act promptly to determine the safest mode of service-door opening and to specify such mode of opening in appropriate standards.

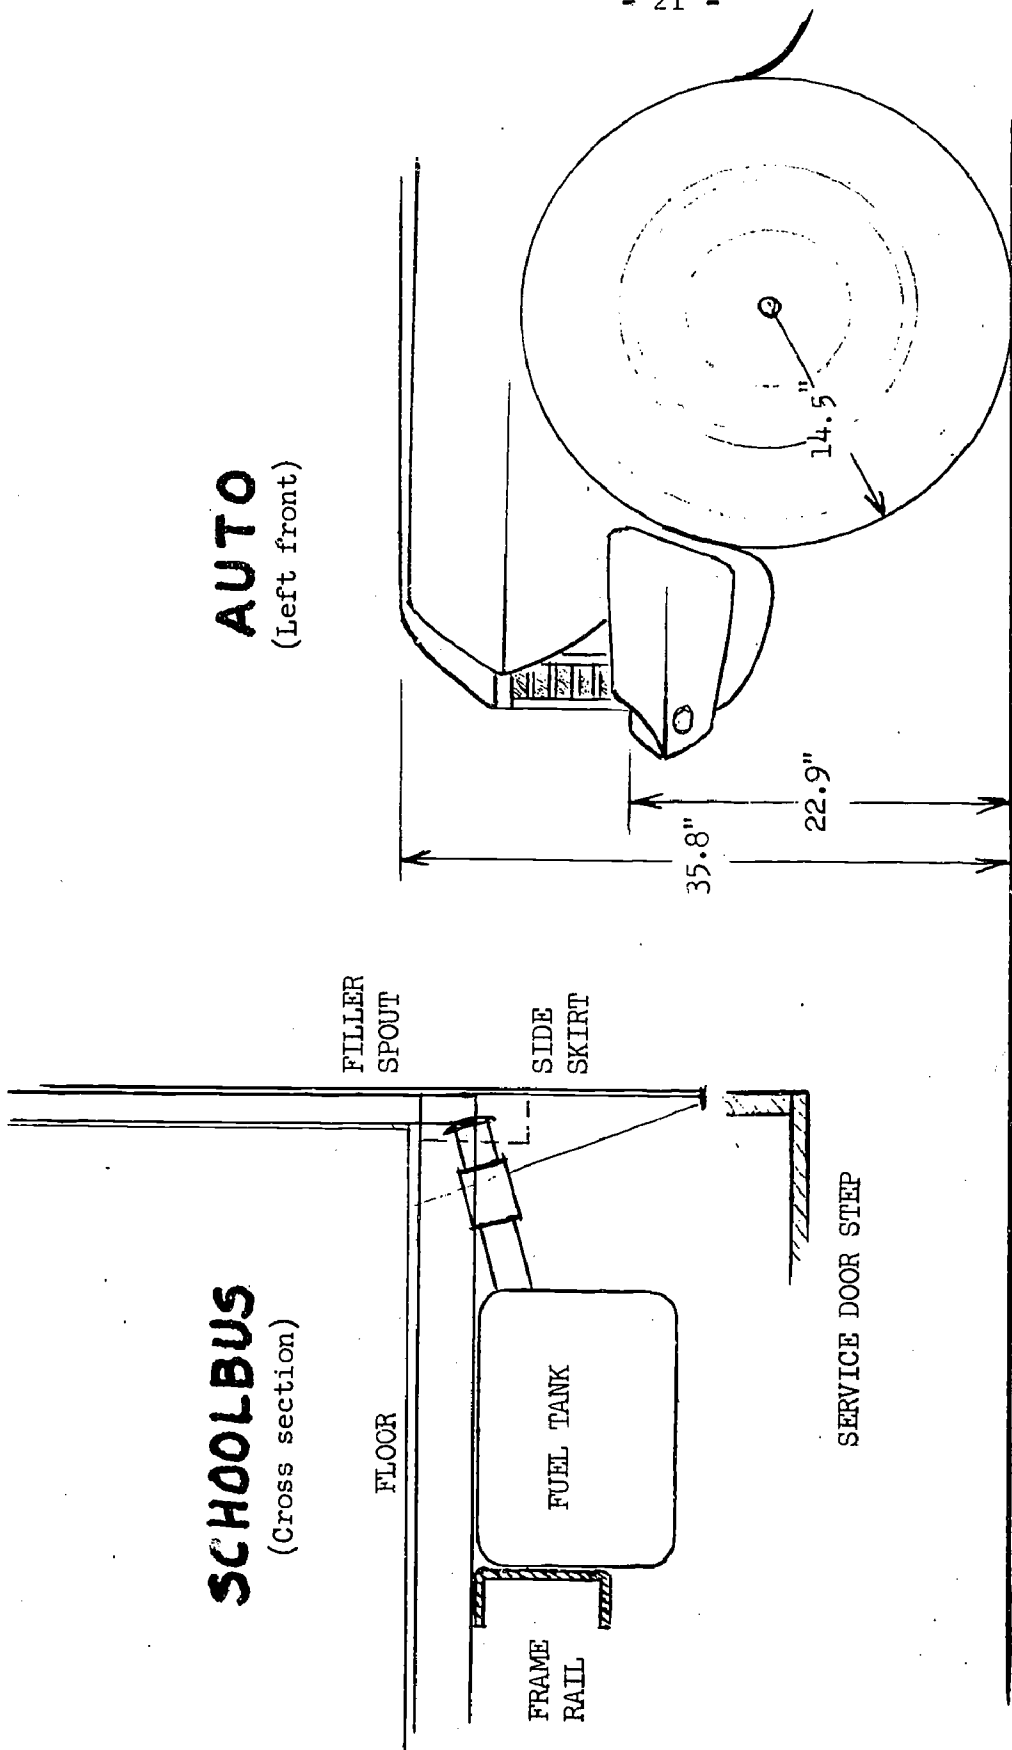
SCALE: Approx. 1 inch = 1 foot

Figure 11: Sketch showing relative heights of schoolbus and automobile components in the area where impact occurred. Dimensions are "at rest;" during severe braking, front end of automobile dipped downward so that bumper passed entirely beneath the bus fuel tank.
