DOT HS-801 529

# **DEVELOPMENT OF A SCHOOL BUS FUEL SYSTEM INTEGRITY COMPLIANCE PROCEDURE**

**Contract No. DOT-HS-4-00872**

**Final Report**

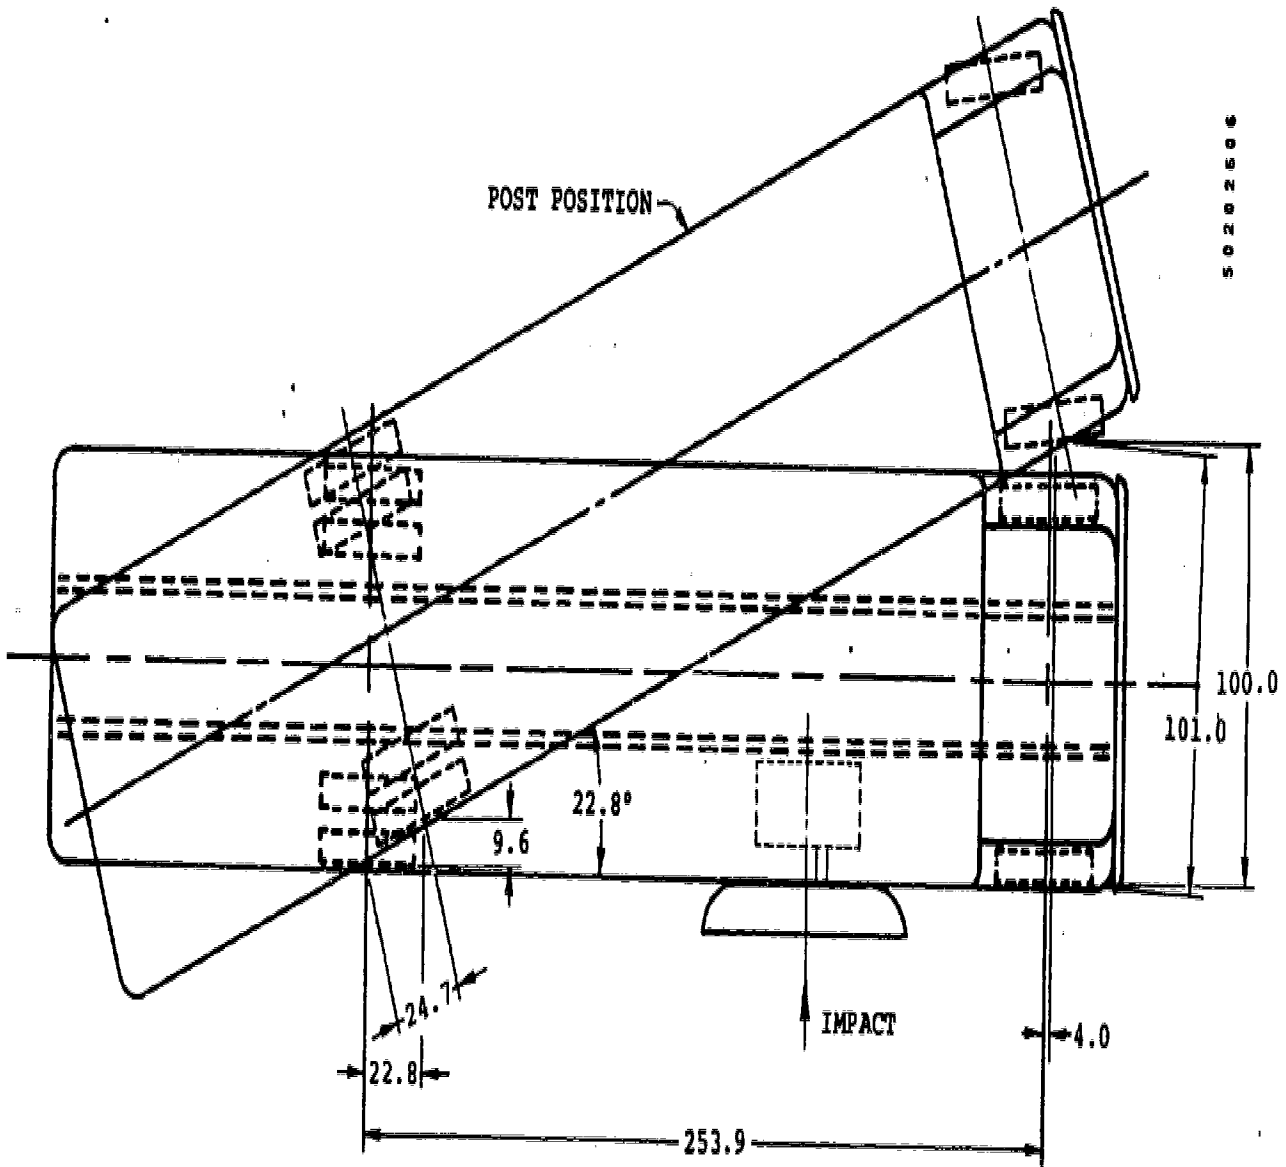
Figure 29. Test 2, Pre- and Post-Test Positions of School Bus.

When all instrumentation and photographic equipment were ready and the detailed checklist had been completed, the barrier was accelerated to  $29.4 \pm 0.5$  miles per hour. The barrier was released just prior to impact at a velocity of 29.06 miles per hour. The barrier impacted the bus and penetrated the fuel tank area as shown in Figure 28. Fuel spillage was immediate and copious (approximately 2 gallons per minute). The school bus rotated 22.8 degrees during impact and the front end was pushed sideways as shown in Figure 29. The maximum roll during the impact was 8 degrees.

The post-test static crush measured 15 inches at the rear post of the service door and 20 inches at the aft end of the fuel tank. The skirt of the school bus was folded up just below the bus floor level (32.5 inches from the ground). The dynamic crush that occurred during the impact measured 17.9 inches at the rear

post of the service door and 24.6 inches at the aft end of the fuel tank.
