TITLE 'Buildings in Use' Study. Technical Factors.  
 INSTITUTION Wisconsin Univ., Milwaukee. School of  
 Architecture.  
 PUB DATE Mar 75  
 NOTE 199p.; For related documents, see EA 009 243-245  
 AVAILABLE FROM School of Architecture, The University of  
 Wisconsin-Milwaukee, Milwaukee, Wisconsin 53201  
 (\$2.00, or \$5.00 for set of 3 reports; make check  
 payable to the School of Architecture and Urban  
 Planning)

# buildings in use study

## technical factors

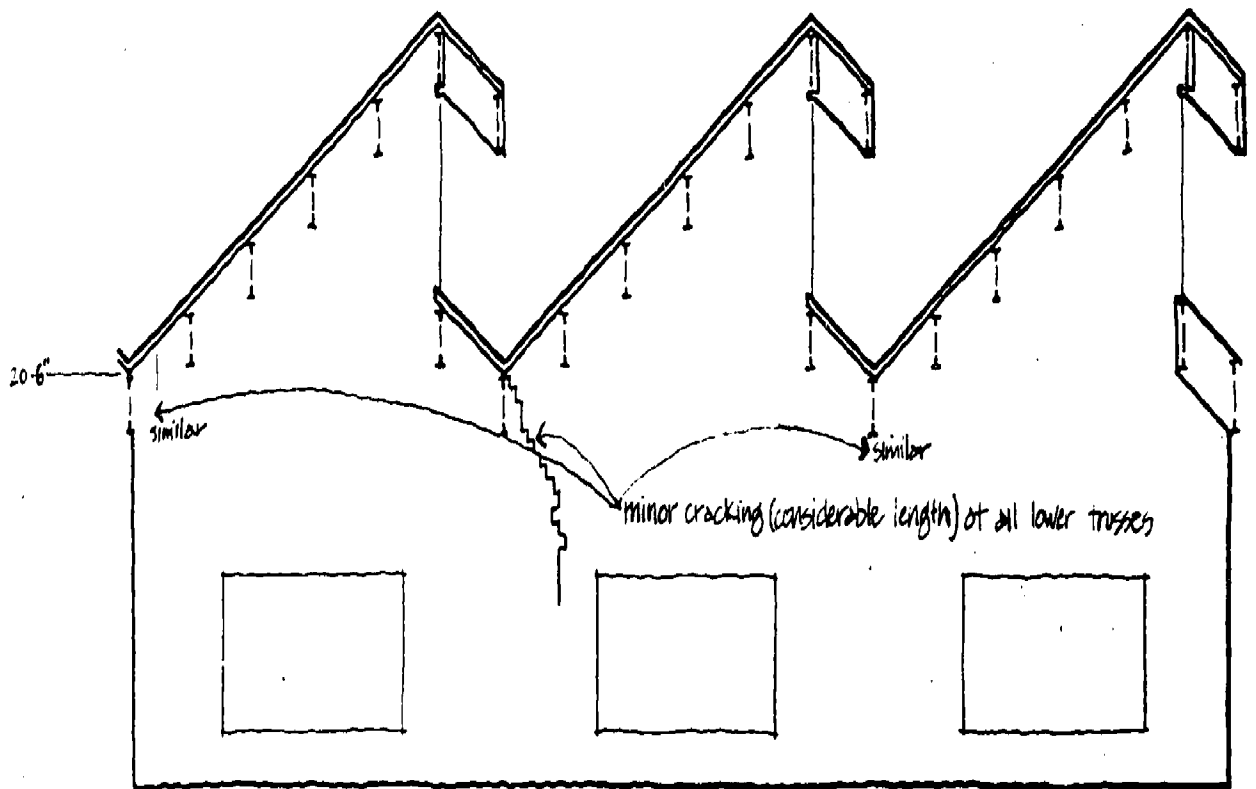
fig. A.5  
RICHARDS SCHOOL / SECTION - MULTIPURPOSE ROOM

Results: Performance was satisfactory at the Parkside and Mt. Healthy Schools. Performance at the Richards School was at the 75-85% level due to cracking evident under major roof truss supports in the multipurpose room.

Probable cause: Richards School. Probably due to actually higher loads than allowable under original design conditions or to expansion of restrained truss.

Discussion: There is a long vertical stepcrack emanating from each of the lowest spanning trusses of the multipurpose room. The cracking is long (over 10' is typical), visible but minor (1/16" or less). Due to the age of the building one can assume that this structural adaptation has been completed and that further consequences will not occur. There are no problems other than aesthetic directly related to this phenomenon, however, there are more serious indirect effects (see roofs). The probable cause of this phenomenon is an excessive loading on this lowest truss due to water trapped in the drainage valley directly above it. Other possible causes are: bearing seat improperly specified or installed; transfer of some loading from upper trusses to this one and; high stresses caused by thermal expansion and the restrained nature of these trusses (see Roof P. B-5).

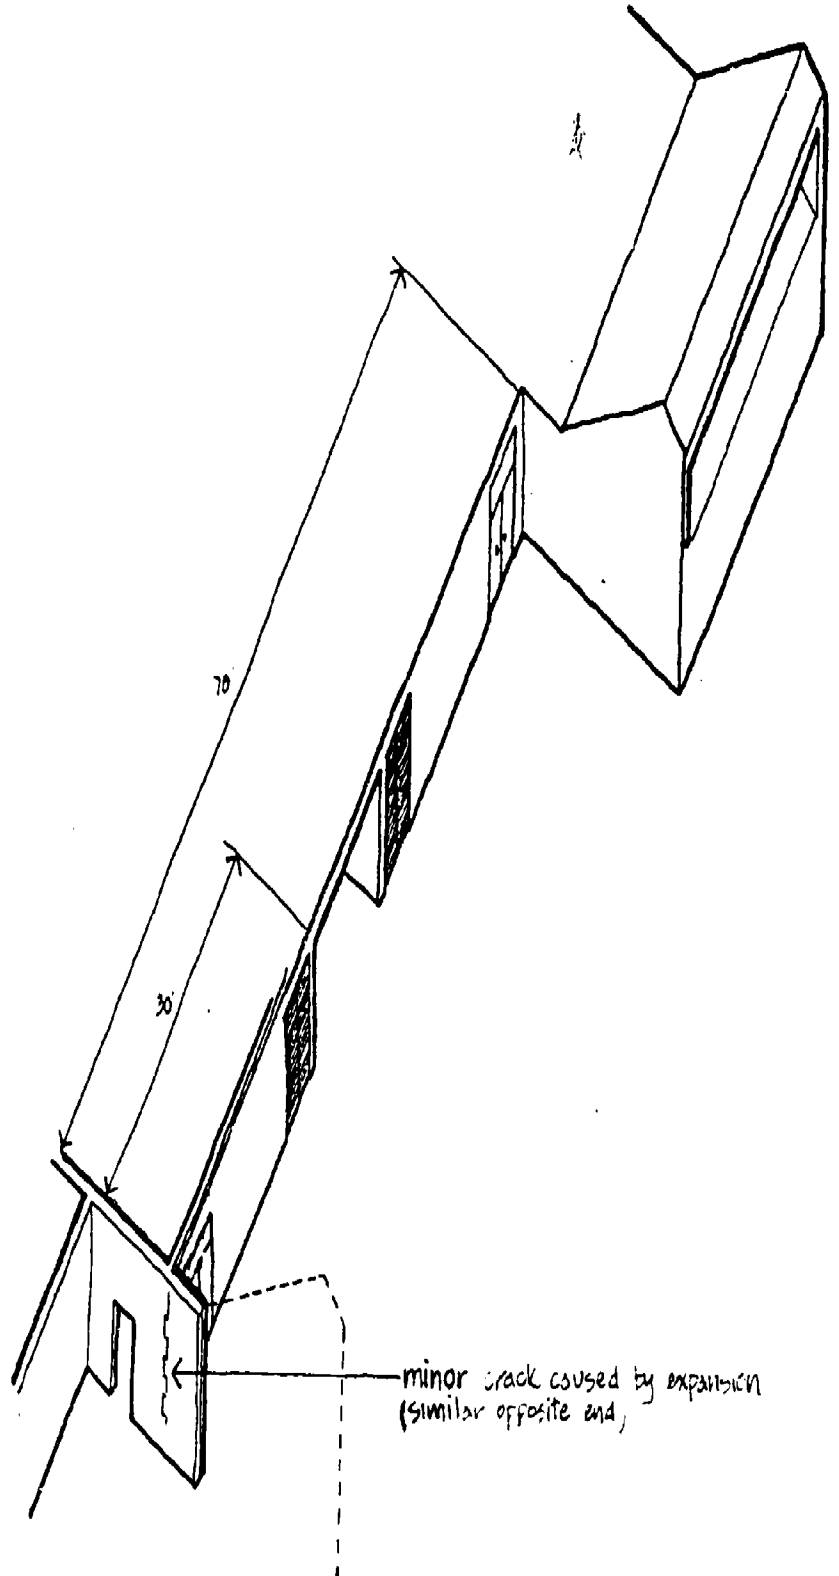
fig. A.6  
RICHARDS SCHOOL / EAST END

The long (78 feet) north-south wall forming the eastern end of the school has expanded and cracked the two perpendicular walls at their common T-joint. This cracking, while easily visible is minor and is only an aesthetic problem. This long wall, while designed without an expansion joint is broken up by entrance doors and an air intake grill. Notwithstanding these potential places which could have provided relief from expansion the wall did expand (fig. A.6)

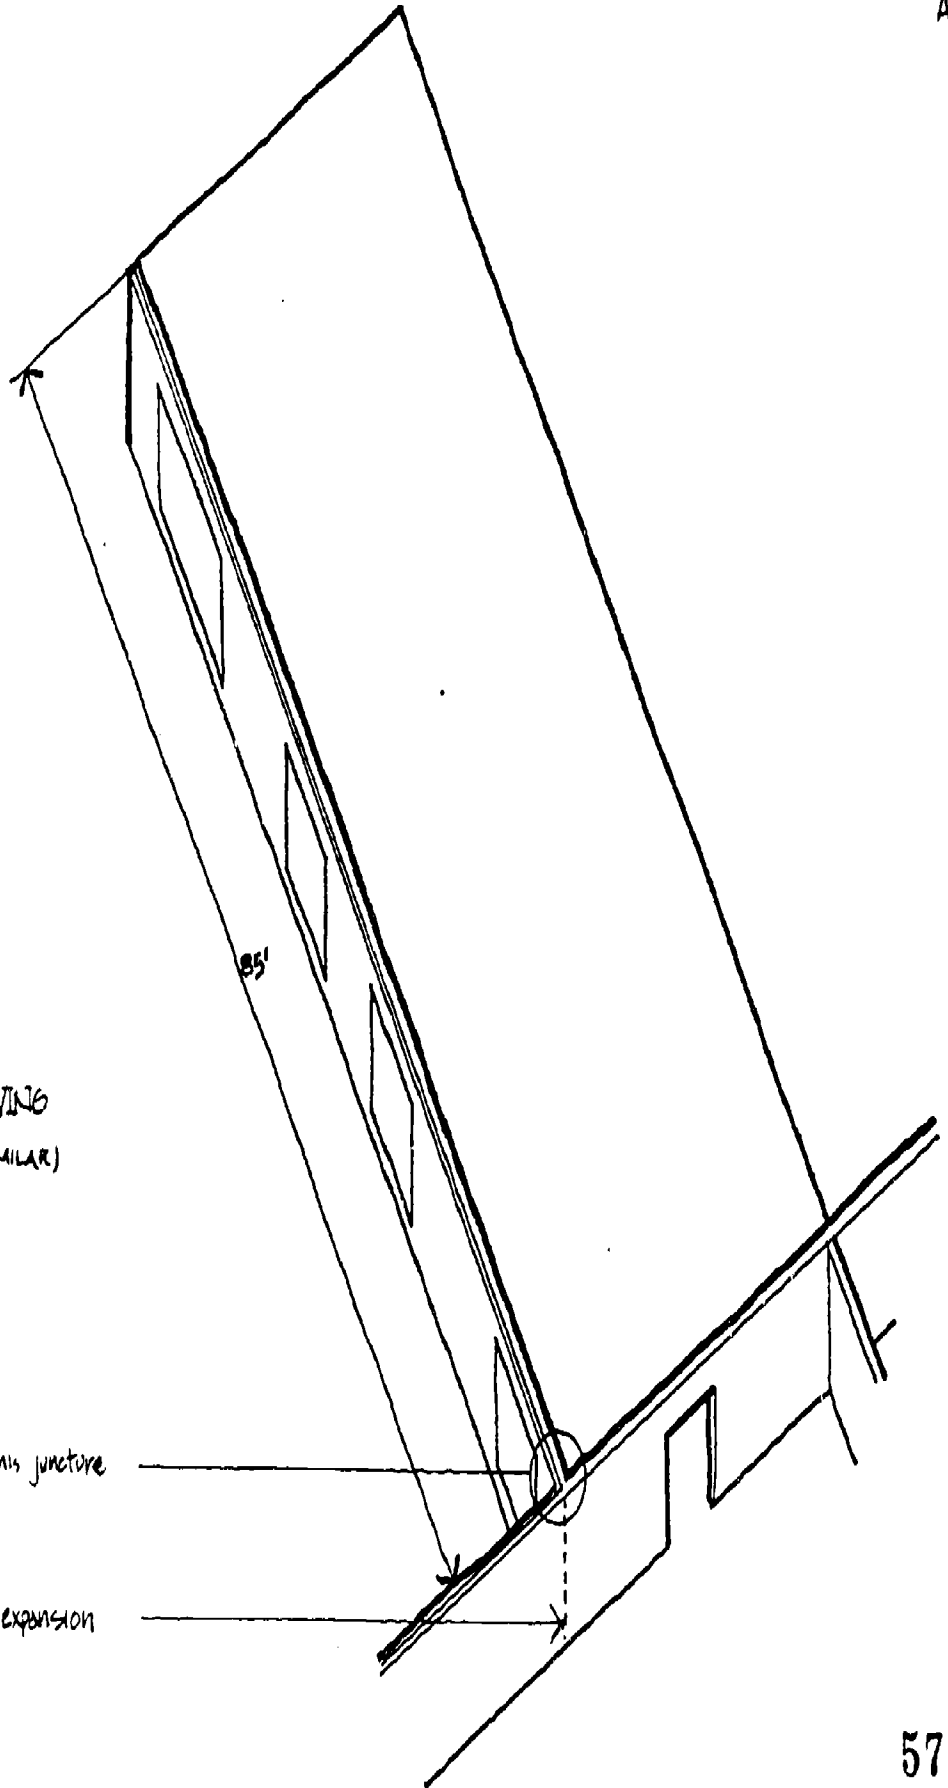
fig. A.7  
RICHARDS SCHOOL/NORTHWEST WING  
(SOUTHWEST WING SIMILAR)

At the west end of the school there are two wings with 84 foot masonry walls perpendicular to the main body of the building. Though an expansion joint is provided at this juncture there is easily visible, though functionally harmless, cracking at this T-joint. Though we have not dissected this area we believe a logical explanation is an incorrectly constructed joint which

expansion joint at this juncture

minor cracking caused by expansion

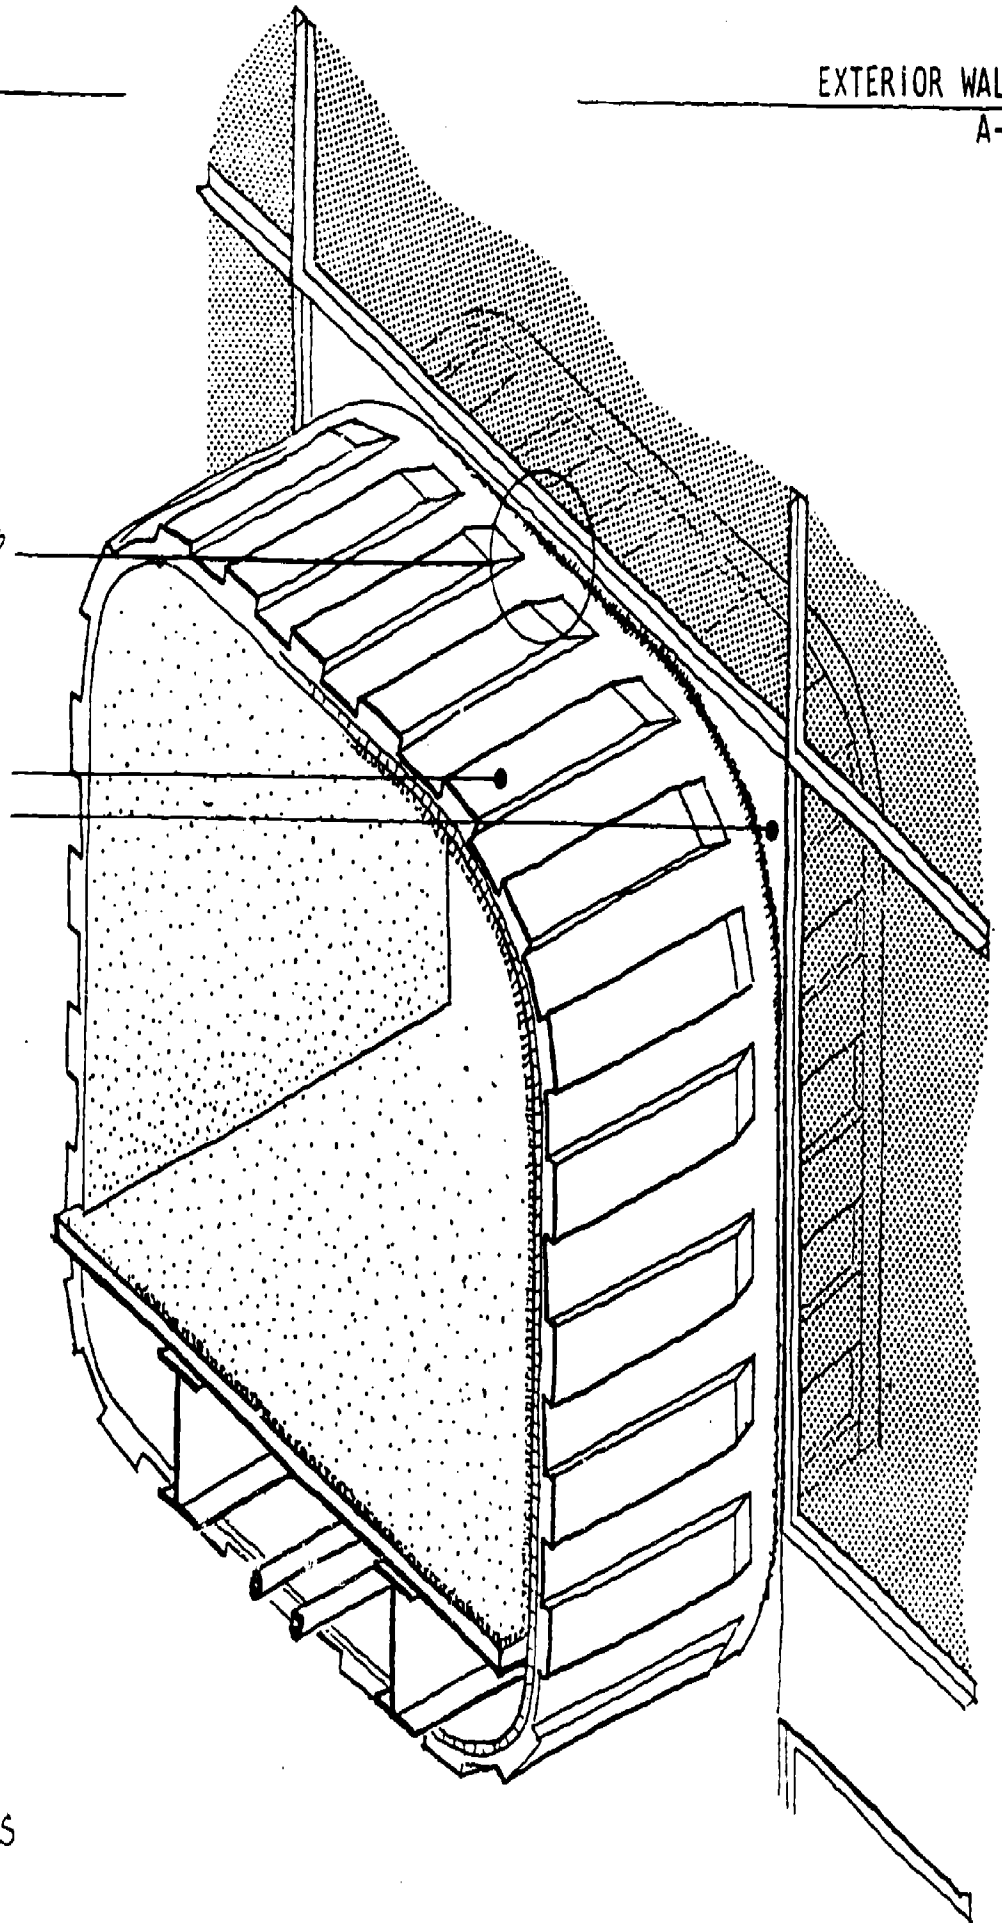
fig. A.8  
SMITH SCHOOL/SLOPED RAMPS

At the Smith School the detail at the lower end of the sloped ramps is extremely difficult to solve with the use of the corrugated steel exteriors. The water races down the valleys of the corrugated metal exterior and is directed with some force at the joint with the curtain wall which could not perform adequately. The original detail has been modified with silicone caulk which seems to be performing adequately. It should be noted that the working drawings examined used the corrugated steel wound around the ramp which would have simplified the detail. The ramps were built with the metal corrugations running longitudinally.

Water running down sloped corrugations enters  
via weel line (or sealant corrected)

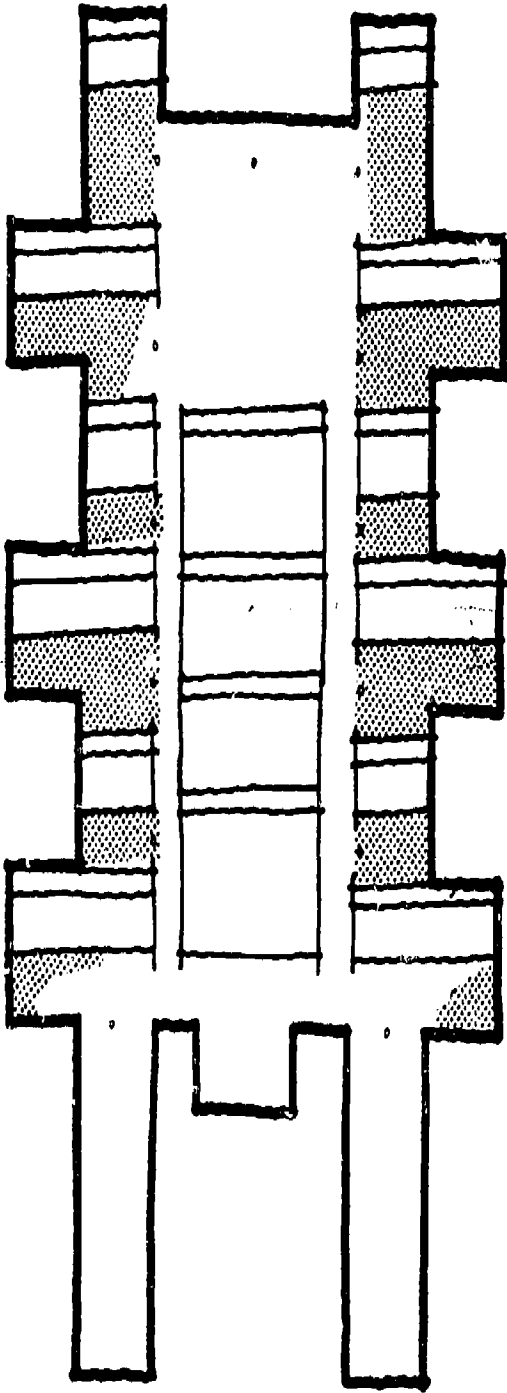
RICHARDS SCHOOL: PONDING  
FIGURE B.2

Discussion: This, of course, is the primary cause of ponding. 'Dead' flat roofs were specified at the Smith and Richards Schools. At Richards the roof actually slopes away from the drain. This, we believe, is caused by some small amount of settlement in the exterior wall or poor construction which at

first caused minor ponding. The weight of this additional water gradually caused the roof membrane to sag in this area and increased its capacity to hold water, producing a cycle of increasing ponding.

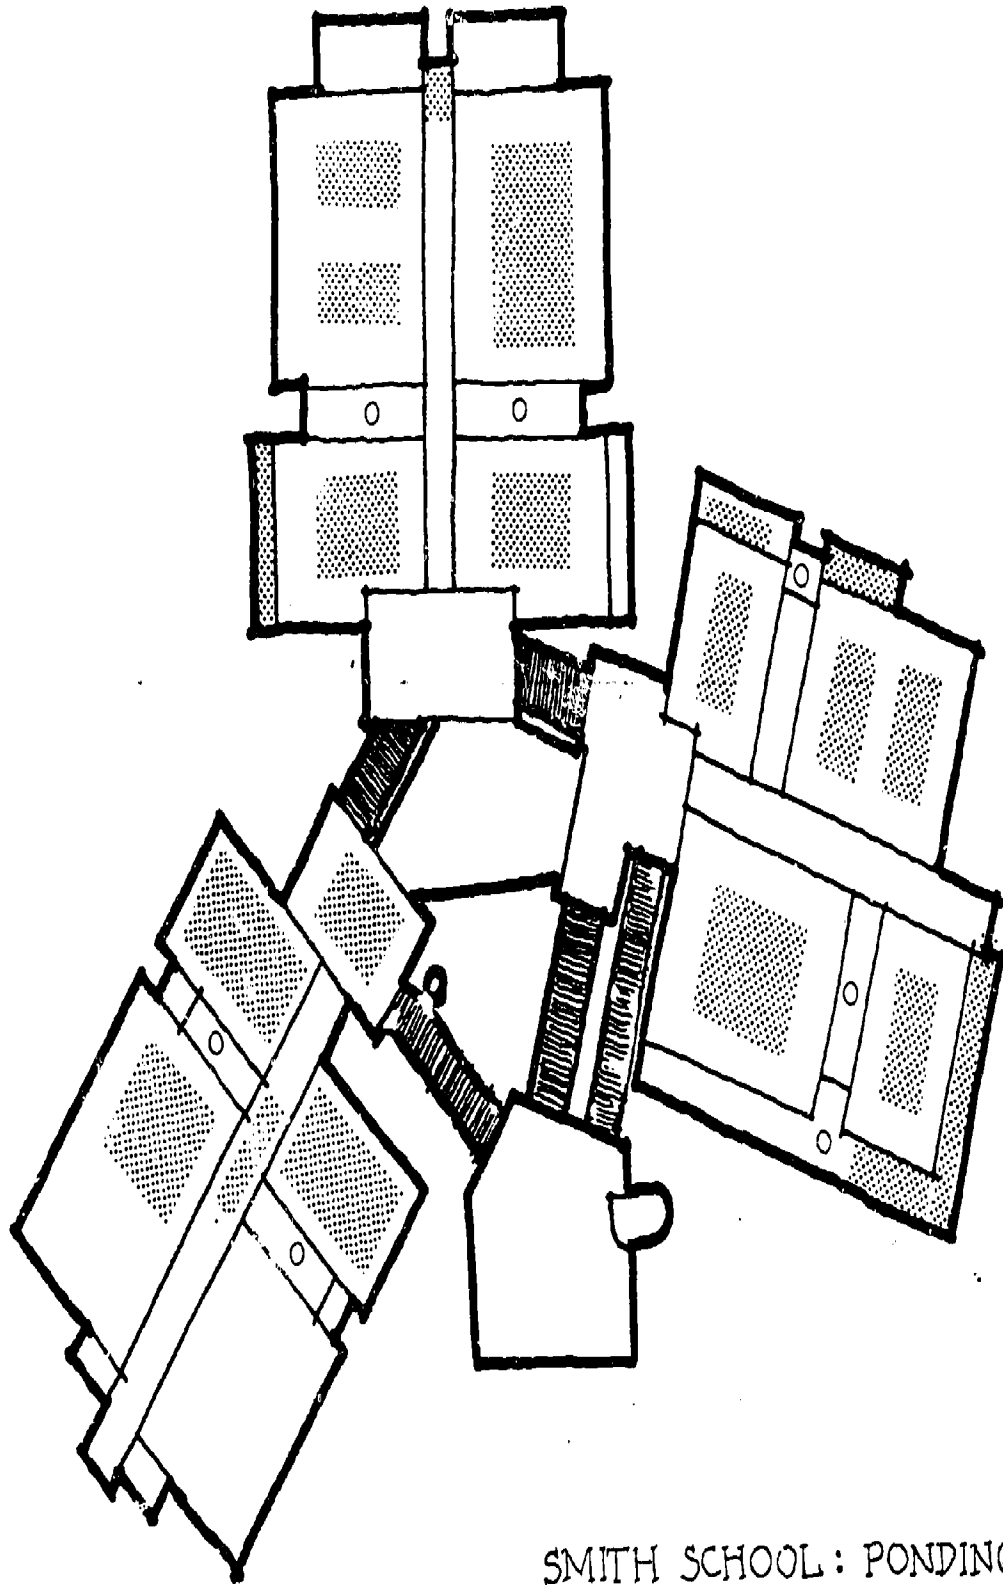
SMITH SCHOOL : PONDING

The Smith School has two roof levels over each typical wing, the higher draining via scuppers to the lower on which are located the roof drains. Ponding is extensive on the upper roof levels. Extensive water protection raises the roof edges enough to prevent water from reaching the scuppers. This results in an extensive pond at the center of each upper roof area. The roof construction, though, is excellent and does not allow any moisture penetration.

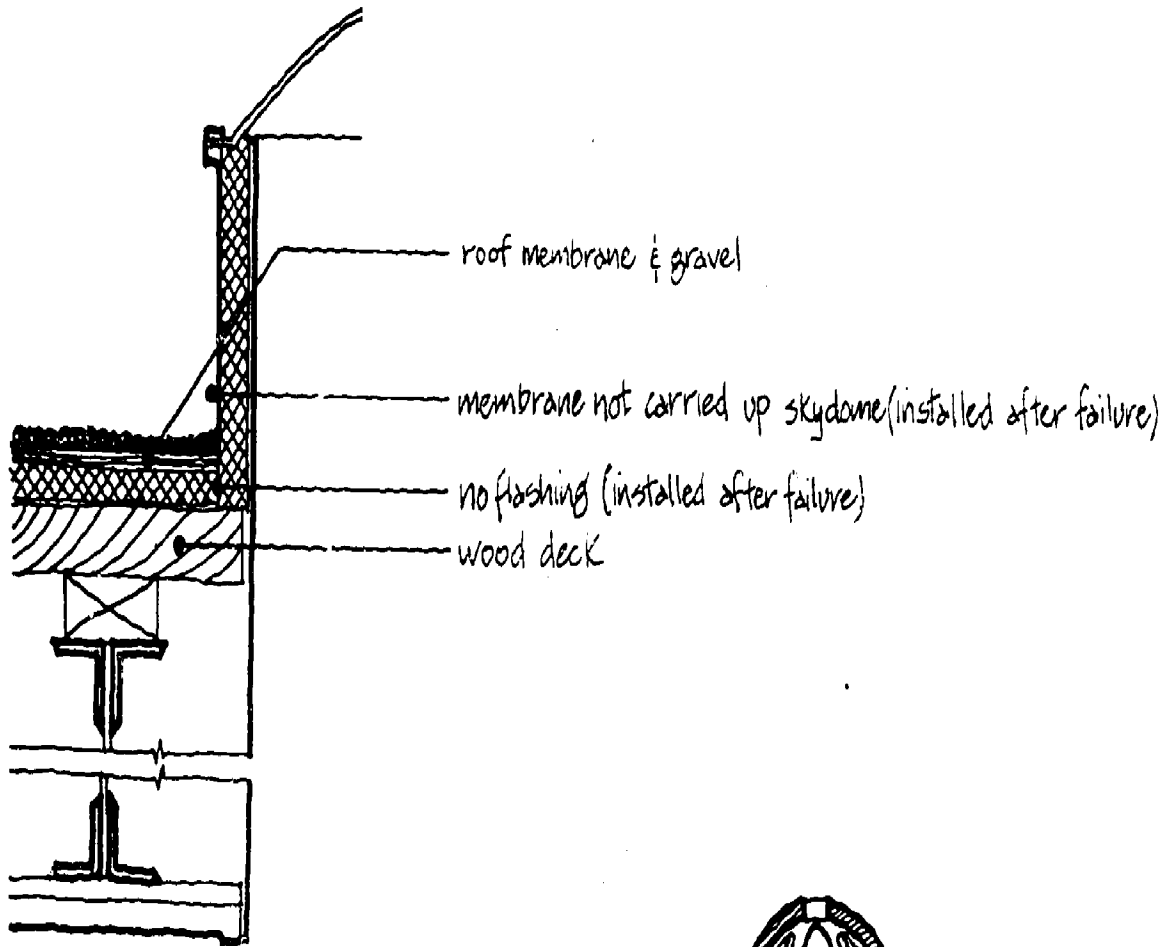
RICHARDS: SKYDOME  
FIGURE B.5

Probable cause: Inadequate detailing and/or unsatisfactory construction practices at locations of potential moisture penetration.

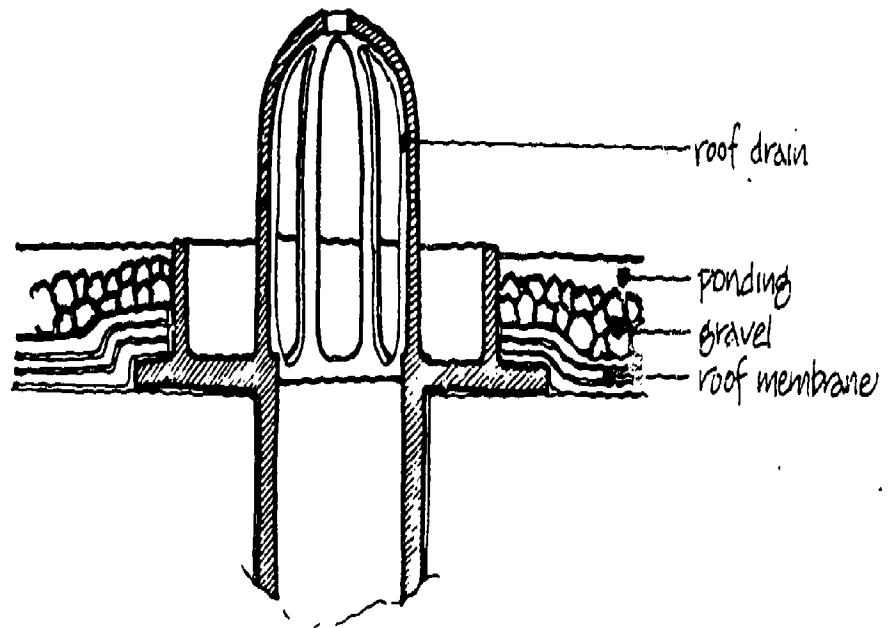
RICHARDS: ROOF DRAIN  
FIGURE B.6

Results: Performance was adequate at all facilities examined. Drains can sometimes be higher than the roof surface due to additional flashing and therefore cause or exacerbate ponding conditions. Gutters between adjacent skylights at Mt. Healthy were found to be a trap for leaves and a potential source of blockage.

Probable cause: Architectural detailing and construction tolerances due to flashing, protection around drains.

Discussion: Typically all openings through the roof are protected by additional layers of roofing felt and flashing materials. This causes the roof to pitch up slightly at the drain. If a drain is chosen or installed in a manner which also raises it above roof level--the combination of the higher drain and the additional protection can actually be 2-3" above the roof level which will cause ponding in this location.

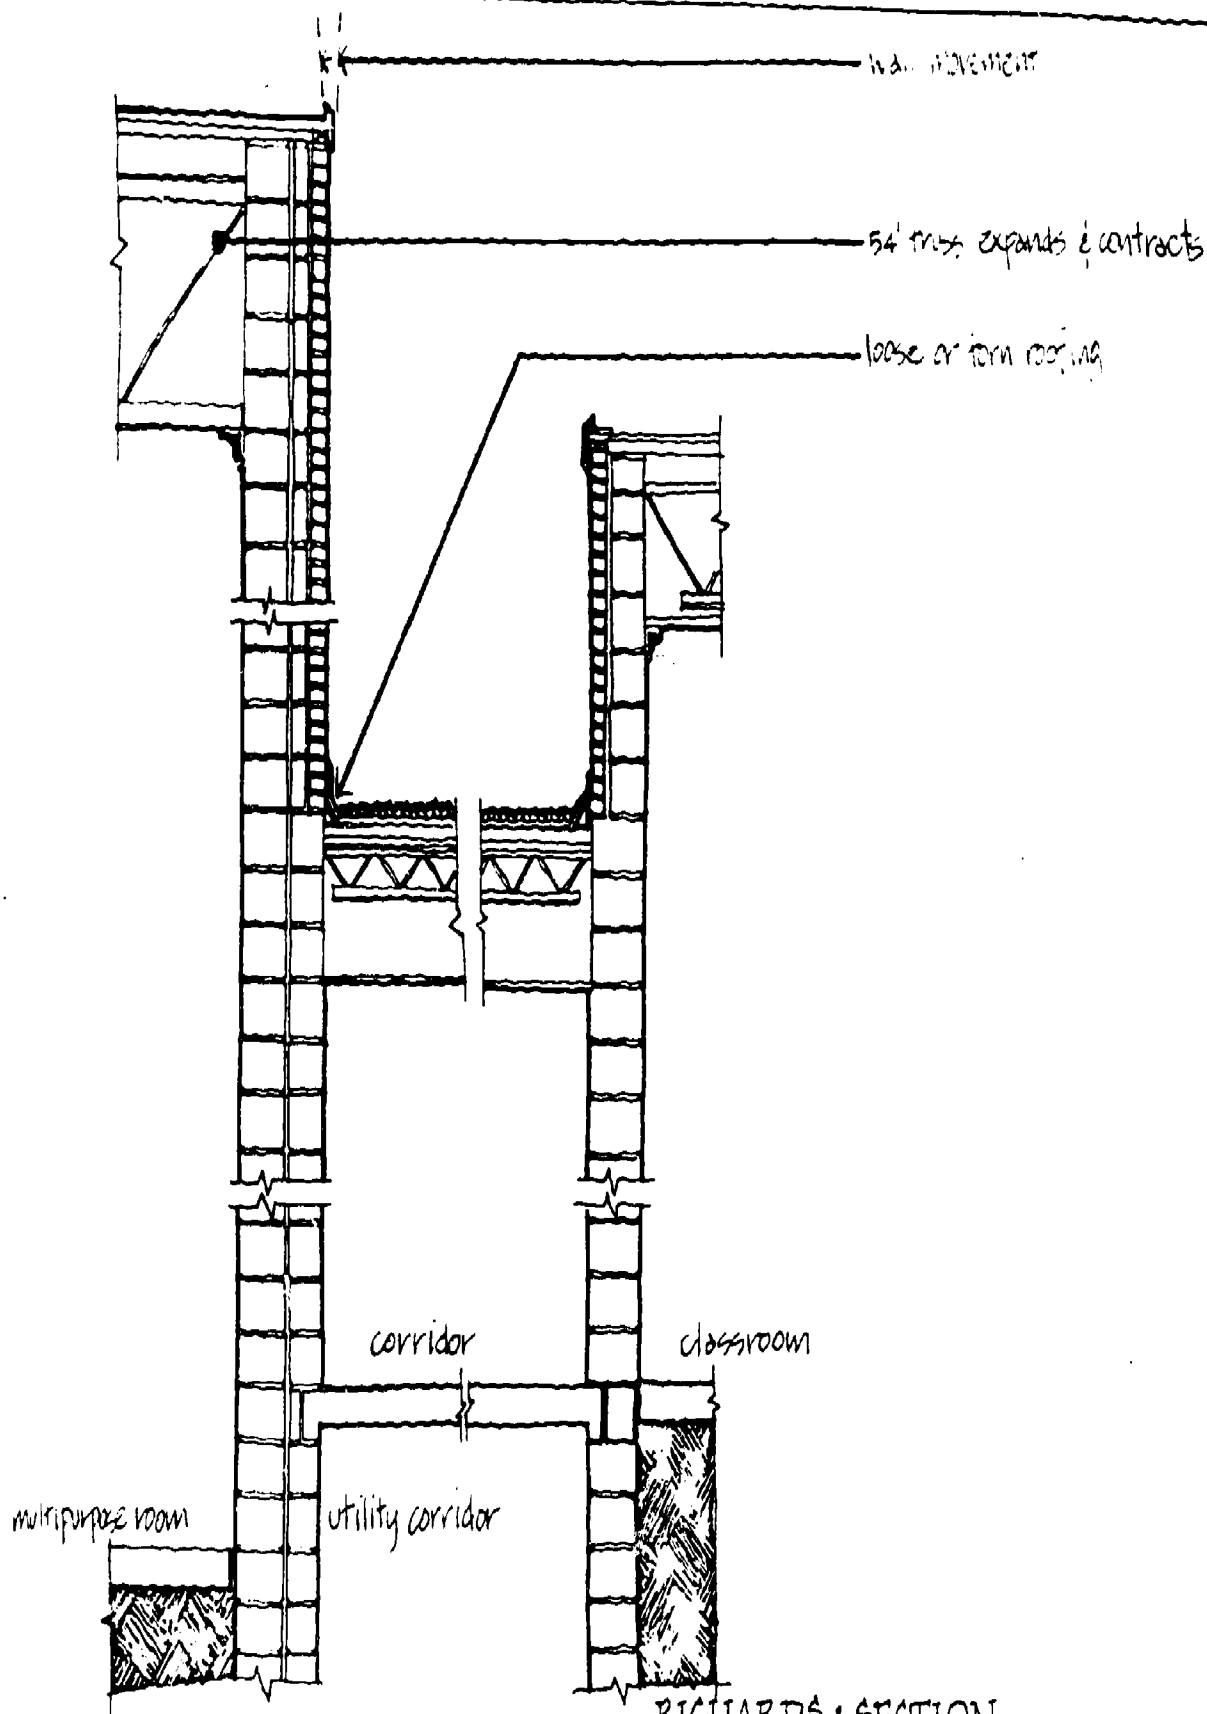
RICHARDS: SECTION  
FIGURE B.8

At the Richards School, a number of problems due to thermal movement have occurred. The first concerns the roof trusses spanning the multipurpose room. These 54 foot trusses are restrained at their ends causing wall movement and real leakage problems as described in the 'Roof' section of this report (See P. B-7).
