TITLE Energy Conservation Measures for the Charles E. Shea Senior High School, Pawtucket, Rhode Island. Public Service Report.

Energy Conservation Measures for the Charles E. Shea Senior High School, Pawtucket, Rhode Island

a public service report by the
New England Innovation Group
39 Pike Street, Providence, Rhode Island 02903
July 1979
Robert A. Cox, Director

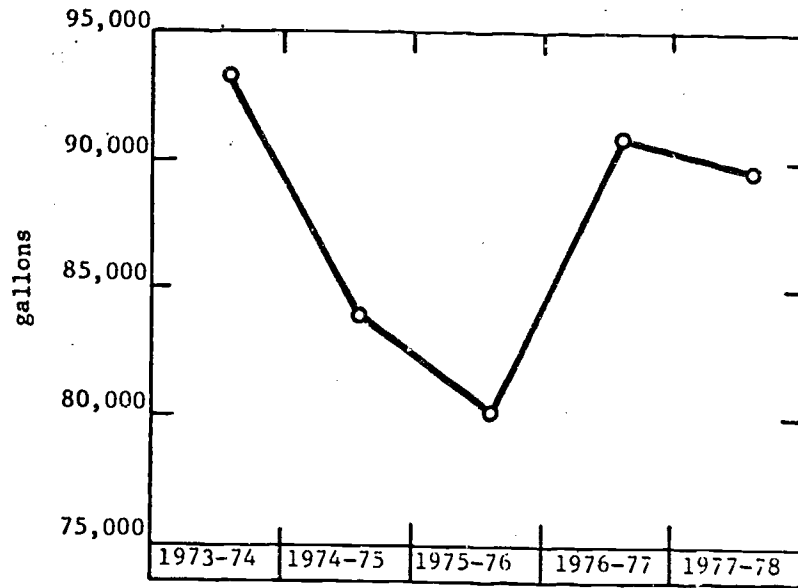
Figure 1. Fuel Oil Consumption, 1973-78

Although attempts have been made at Shea High School to reduce the volume of the air changes and to achieve temperature setbacks, Figure 1 shows that a reduction in consumption of only 1 percent has been achieved since July 1976. The difficulty encountered in further reducing consumption is undoubtedly due to the problem of controlling the temperature, a problem caused in part by the malfunctioning of the unit ventilators.

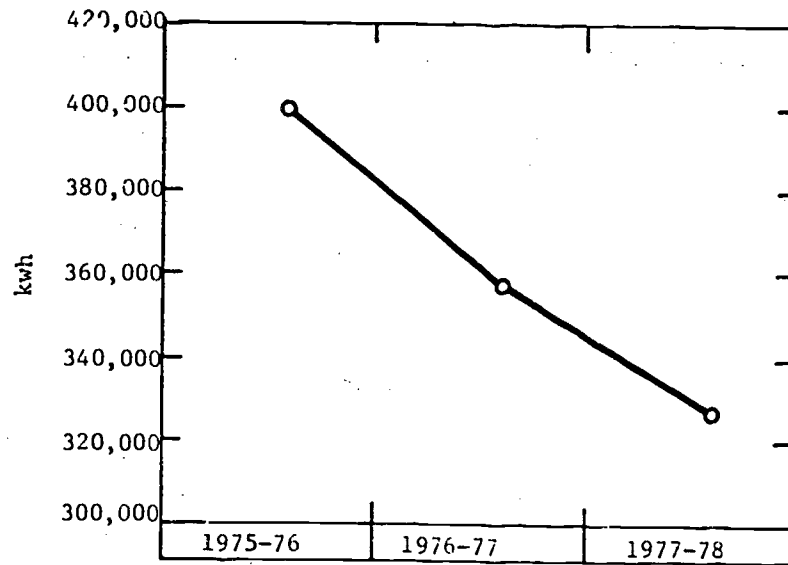
Figure 2. Electric Consumption, 1975-78

Figure 2 shows a steady decrease in electrical consumption at the Shea High School during the 1975-78 period. This 22 percent decrease has resulted in a 21 percent decrease in cost.

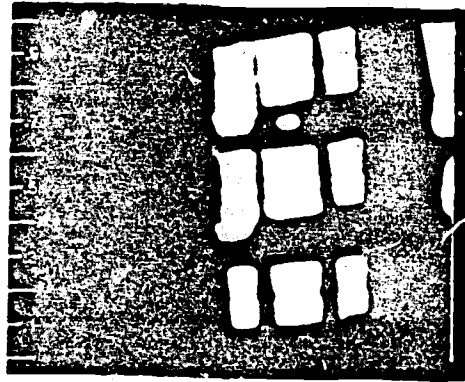
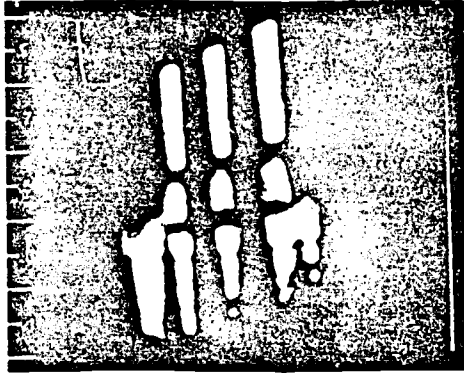
The thermographic inspection also indicated that a number of faulty damper linkages on unit ventilators are a secondary cause of excessive fuel consumption. All of these malfunctioning unit ventilators were located on the second and third floors of the north, east, and west sides of the building (thermograms 9, and 11-16). A total of nine malfunctioning unit ventilators were identified.

The unit ventilators should be restored to optimum working condition by repairing the equipment and installing economy cycle temperature controls. From an inspection of the existing units, a feasible approach would be to add new damper motors and automatic radiator valves, repair the leakages, and replace the thermostats with the new vandal-proof types available. The implementation of this retrofitting program would require the assistance of an organization that specializes in heating and ventilating control systems.

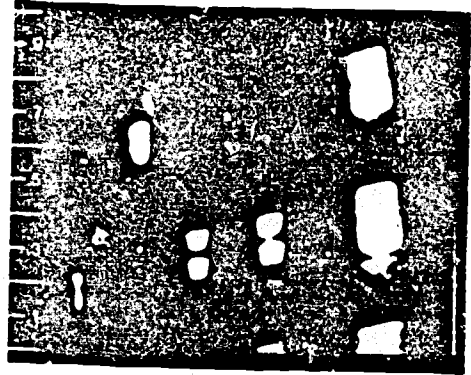
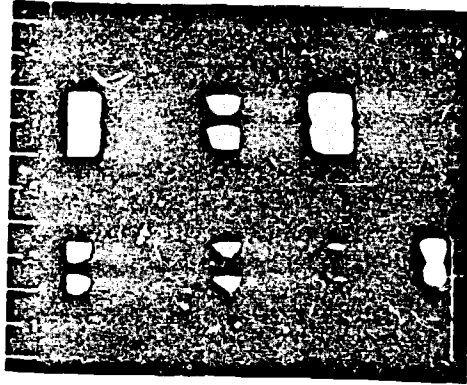
- 20.-21. Excess heat loss from overheated hallways after normal school hours

During the thermographic inspection, the temperatures in the corridors were above 70°F at 6 PM. The radiator in the stairwell was heating when no classes were in session. As is the case in the classrooms the radiators in the hallways cannot be shut down either because the valves are missing or because the valves were never installed in the first place.
