Educational Facility Evaluations of Primary Schools in Rural Honduras Departments of Cortes and Meambar

in cooperation with
Council of Educational Facility Planners, International
and
Heart to Honduras

In April 1997, a team of eleven educational facility planners and architects from the United States and Canada conducted a facility evaluation of schools in rural Honduras, in the departments of Meambar and Cortes. Team members were all members of the Council of Educational Facility Planners, International and traveled to Honduras under the auspices of a Christian mission group, Heart to Honduras.

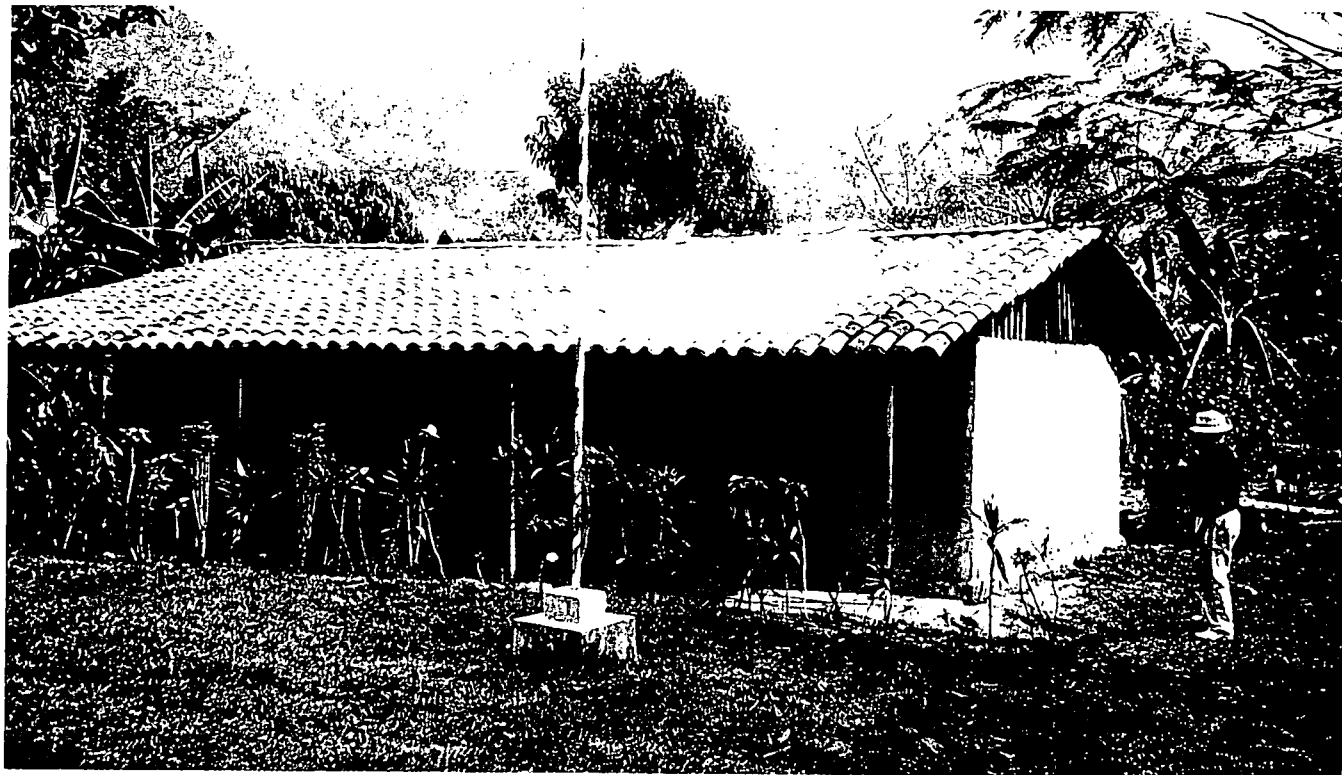
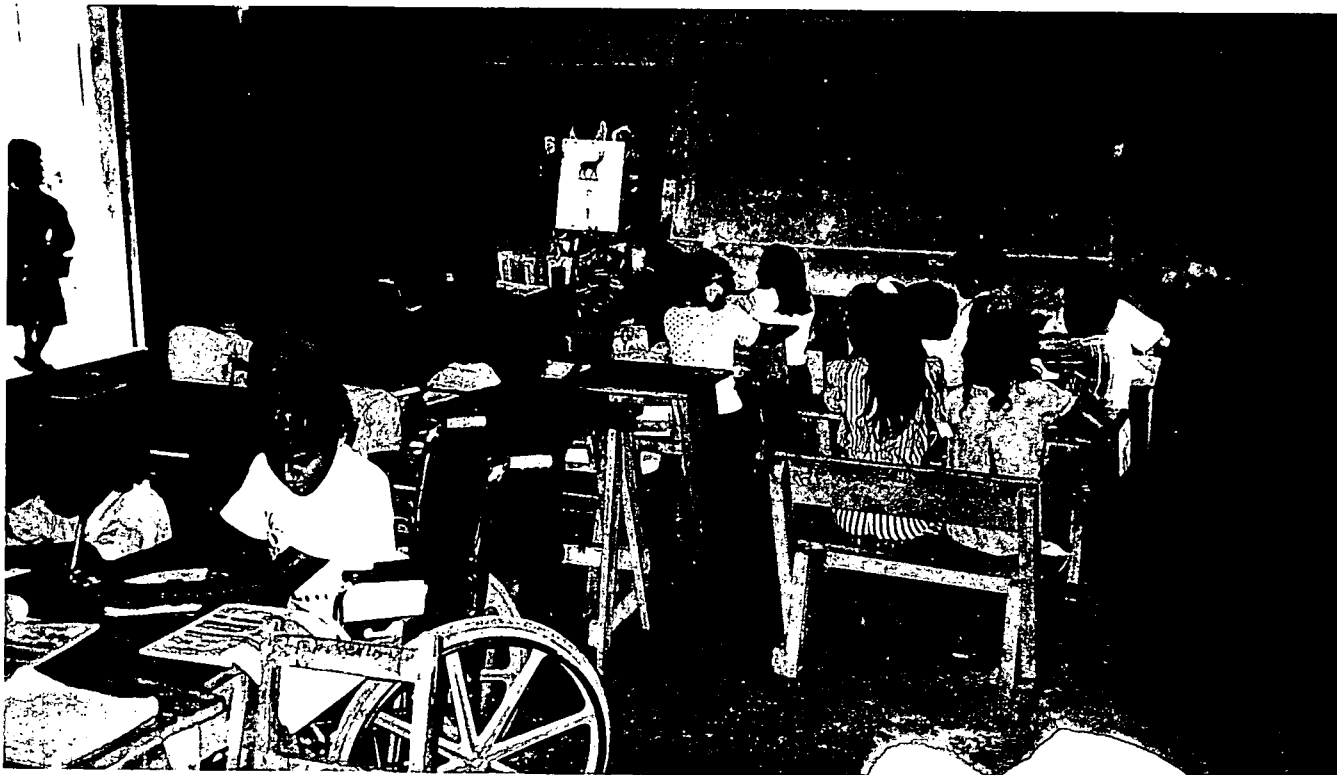
Canchias Primary School

The recently replaced roof is sagging.

Recommend additional teaching space; the current space does not allow space for additional supplies or program delivery options. Improve lighting. Lavatory needs to be replaced (at the very least the hinges should be put back on the door).

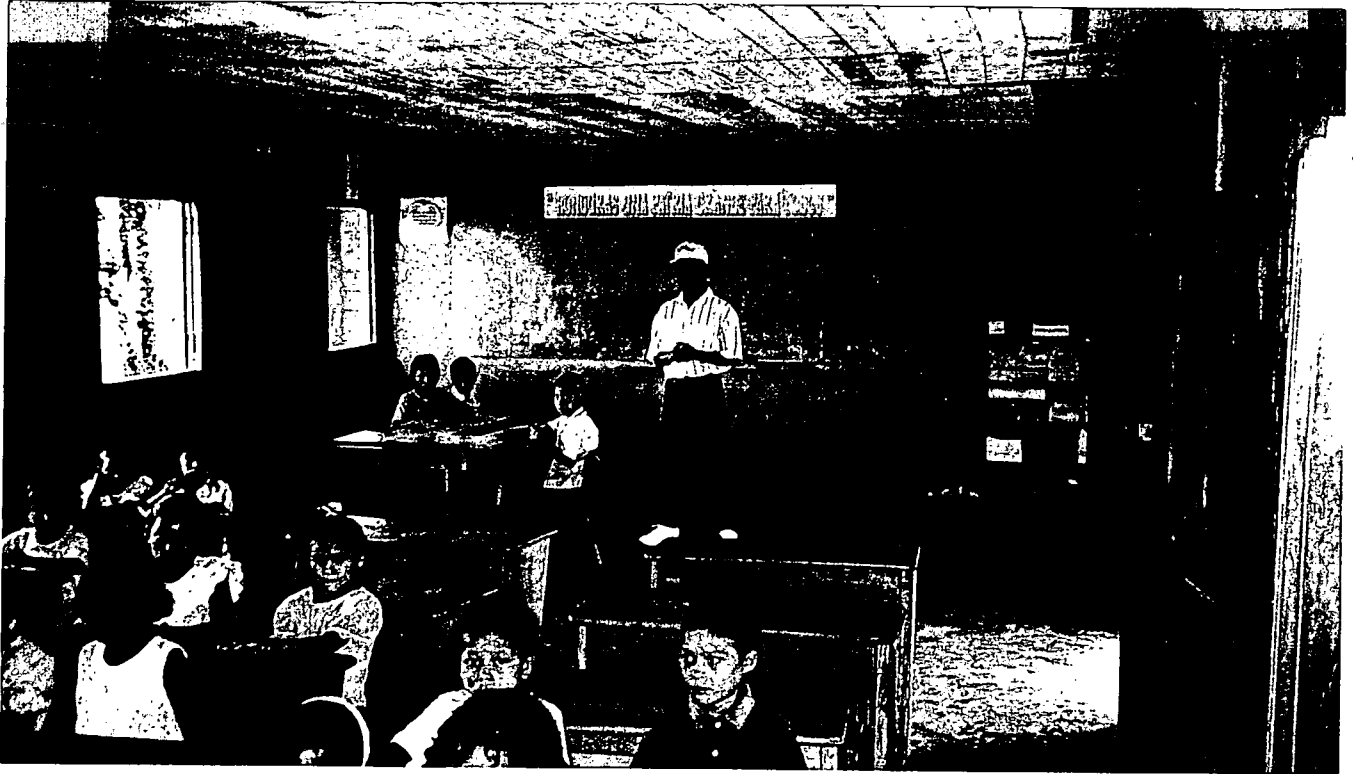
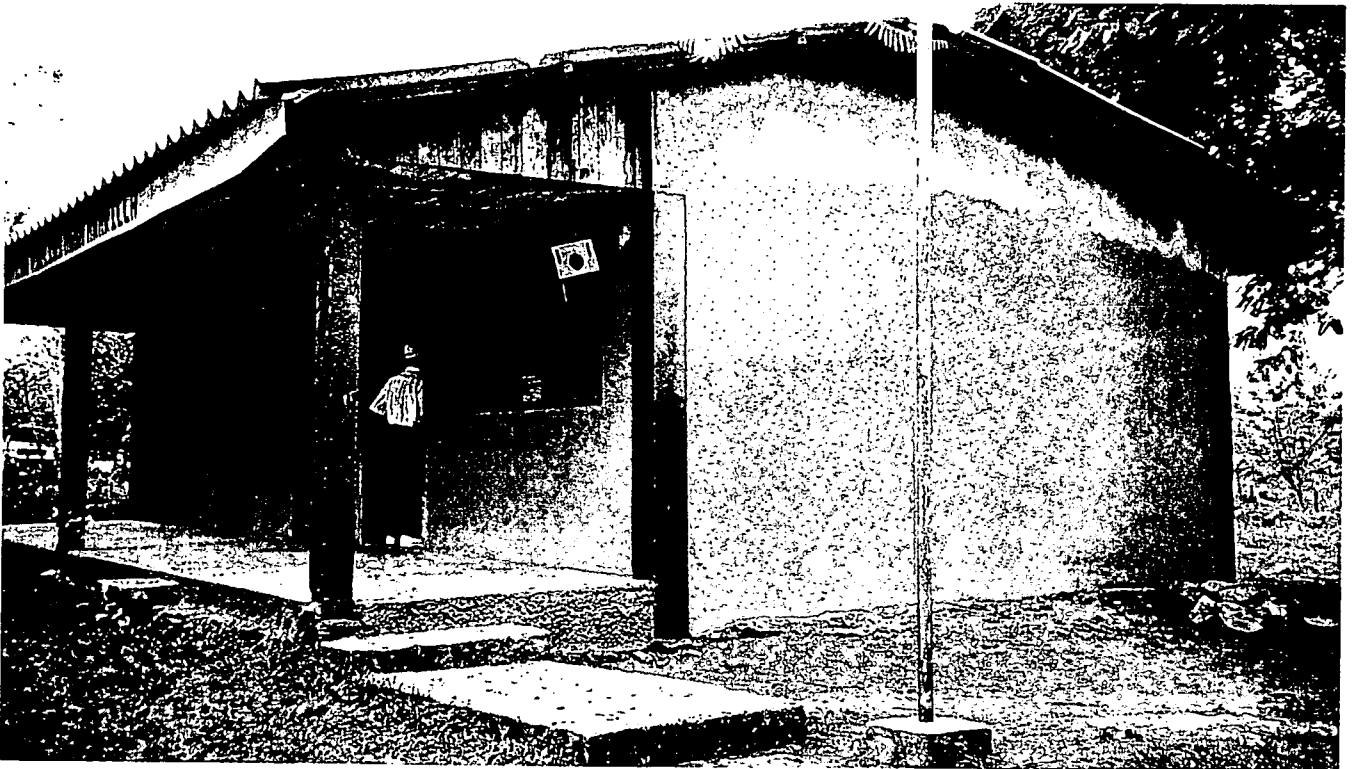
Agua Amarilla Primary School

There is a large, level playing field in the back of the building. Part of the field is used as an instructional garden area. A barb wire fence surrounds the site. There are two classrooms on the site, both very near the road. Only one of the classrooms is used; the older, smaller classroom is used for storage.

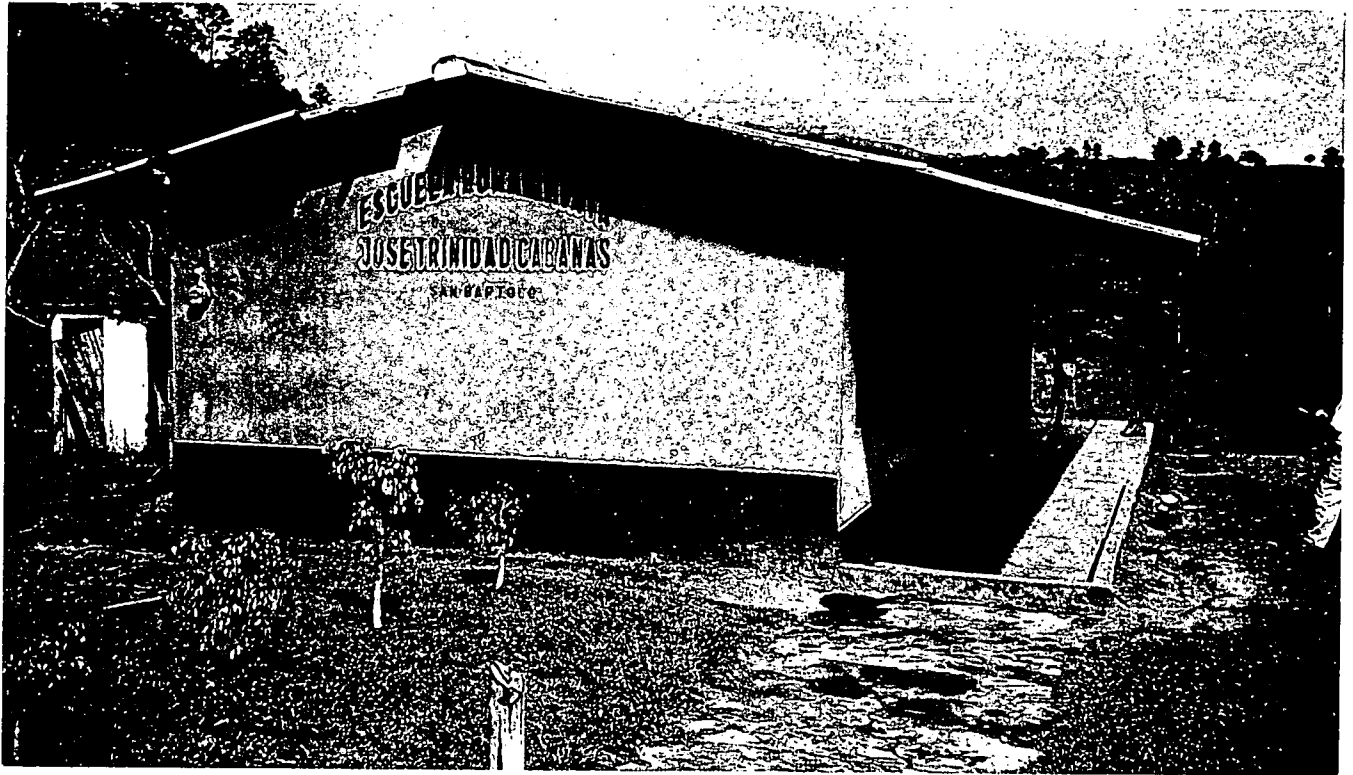
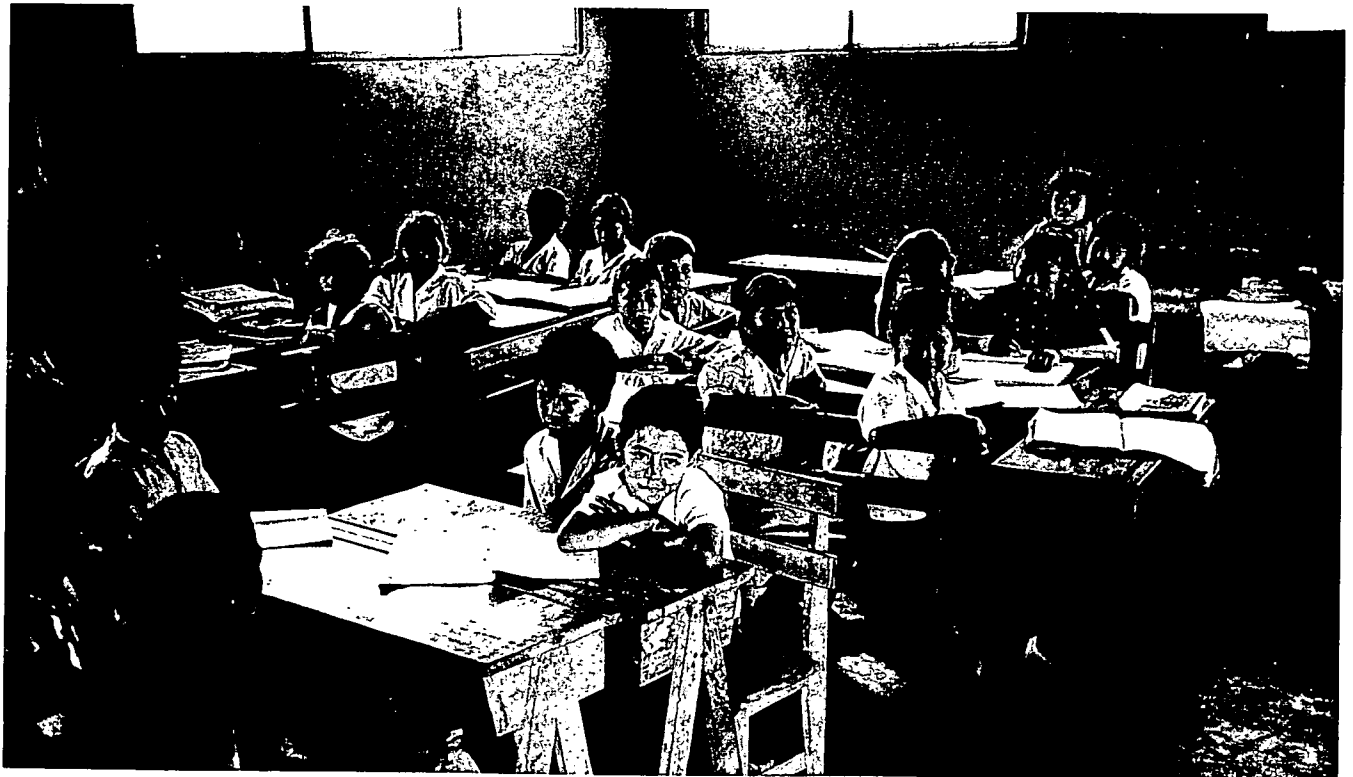
Bartolo Primary School

Some children come from far away: one child walked for over 3 hours to get to school.

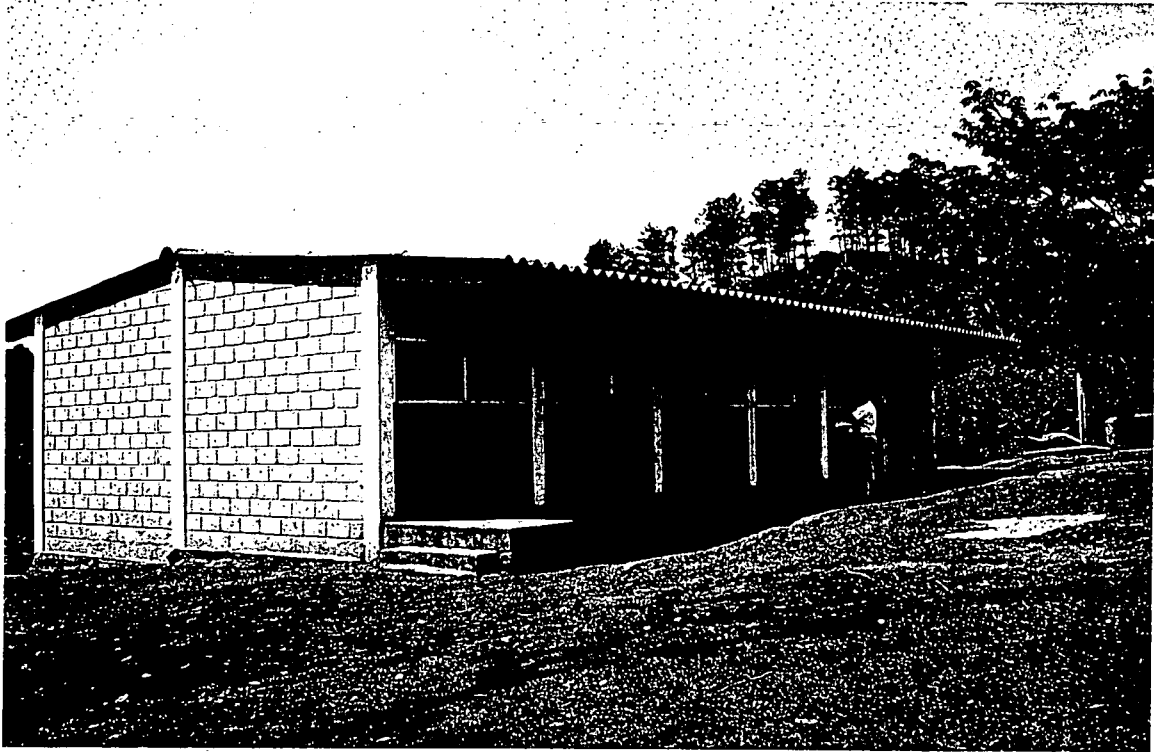
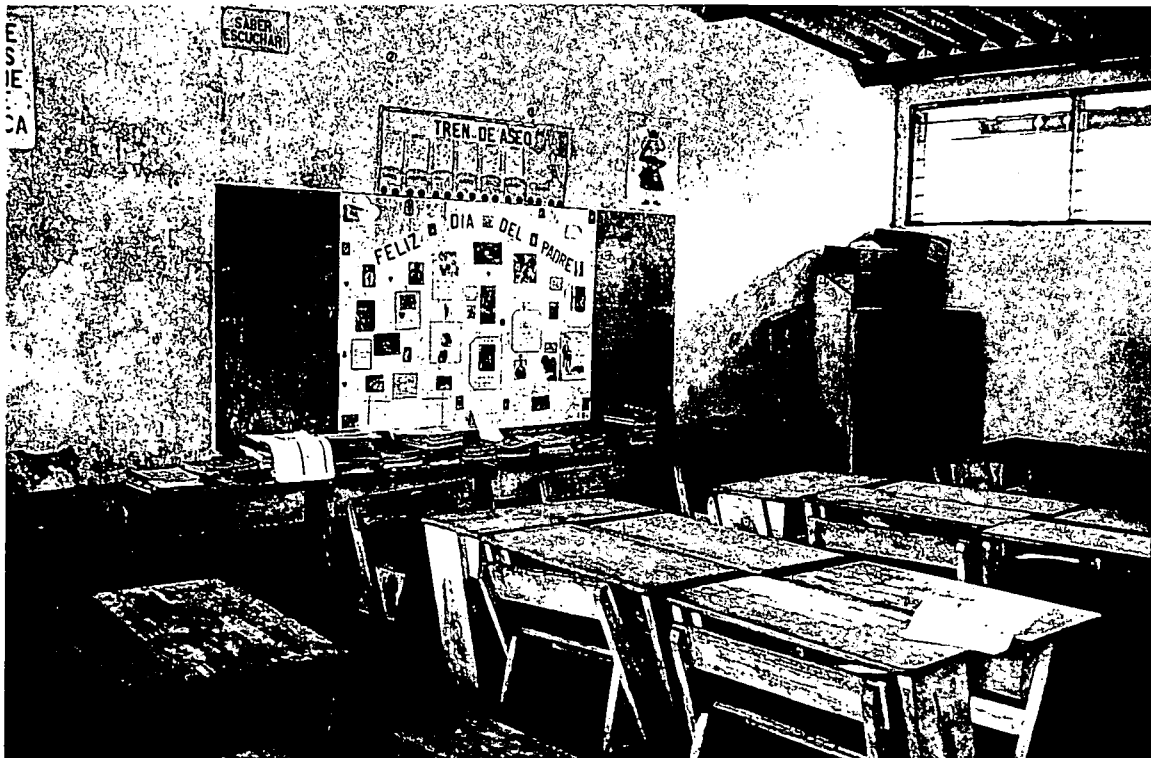
La Victoria Primary School

The site is shared by a small Catholic Church annex. The play field consists of a large soccer field on a fairly steep grade.

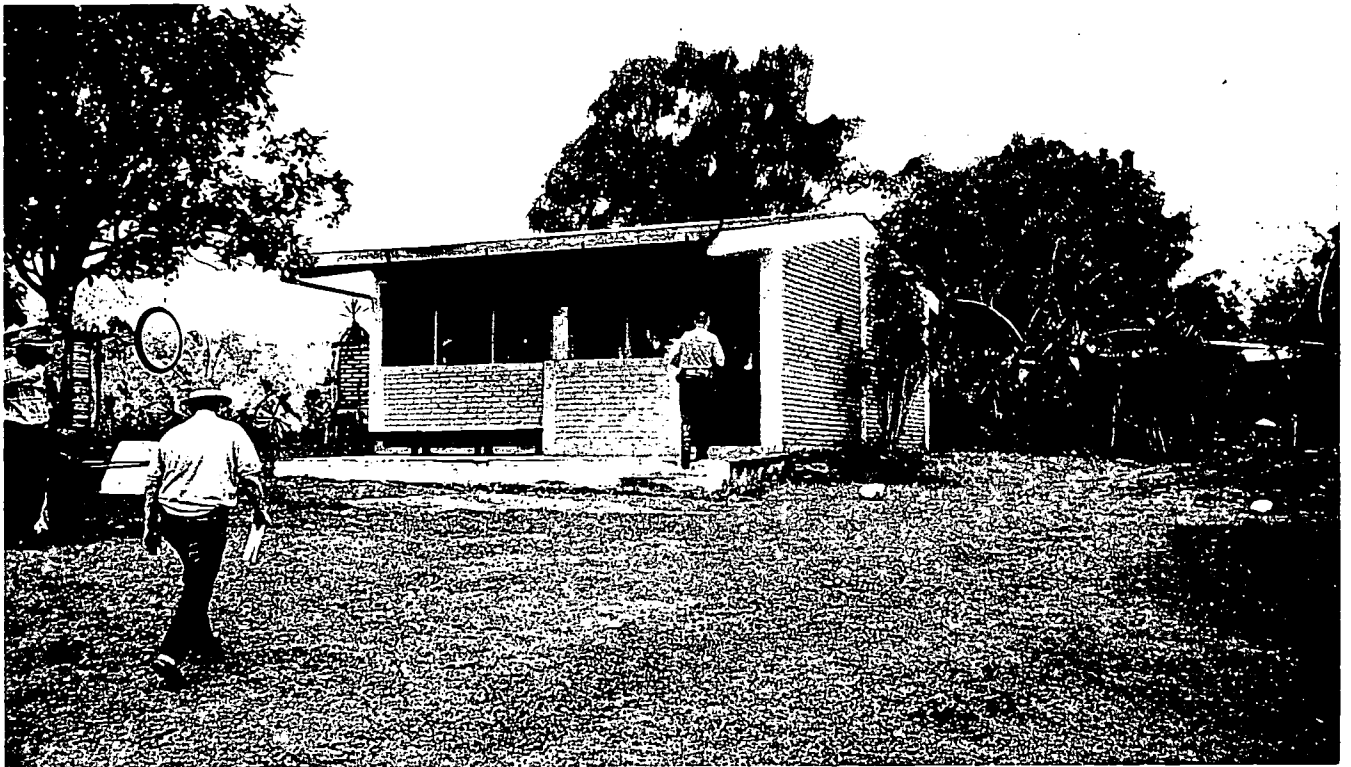
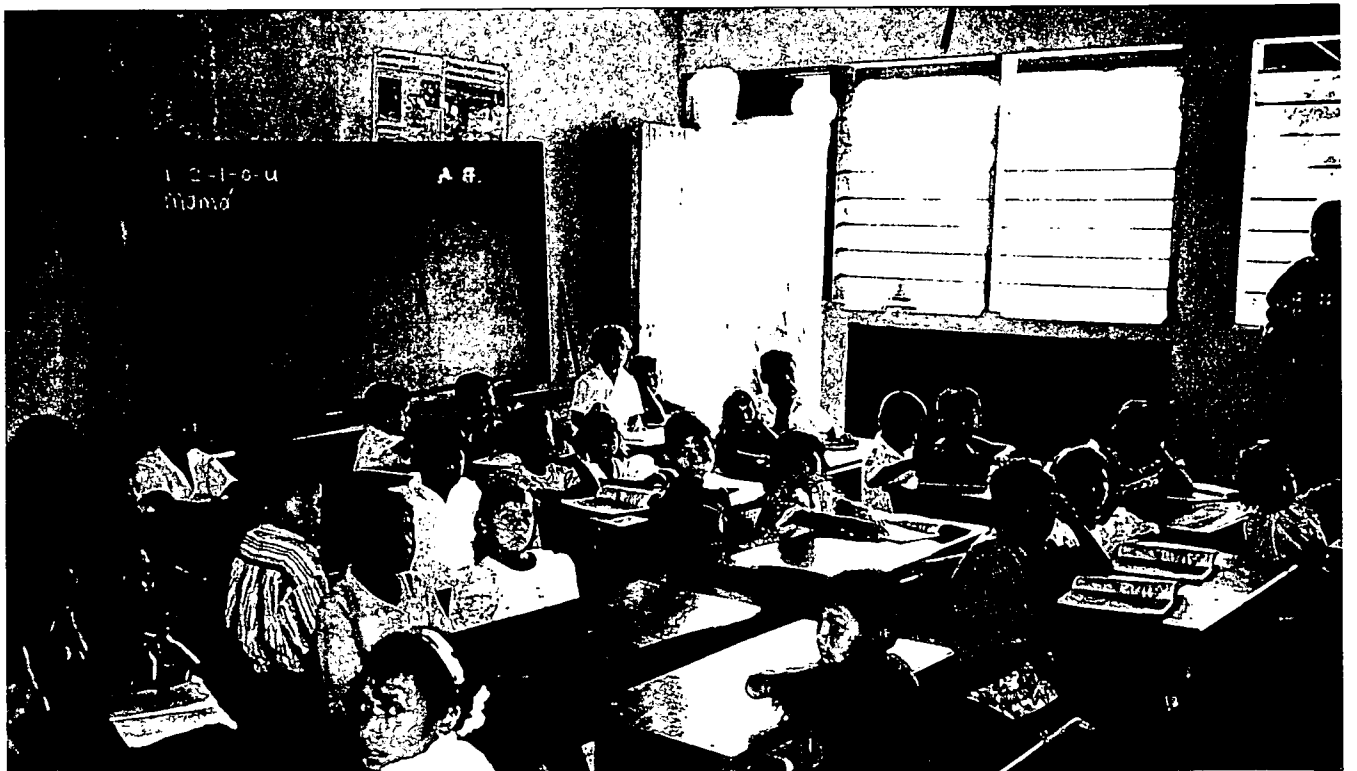
Montañuela Primary School

The building needs some interior painting and additional space. There are currently 232-student tables and 4 in storage. In the front of the room, there is an 8' section of writing board. There is also a table with supplies.
