TITLE Crashworthiness of Small Poststandard School Buses: Safety Study.

REPORT NO NTSB-SS-89/02

Crashworthiness of Small Poststandard School Buses: Safety Study

October 11, 1989

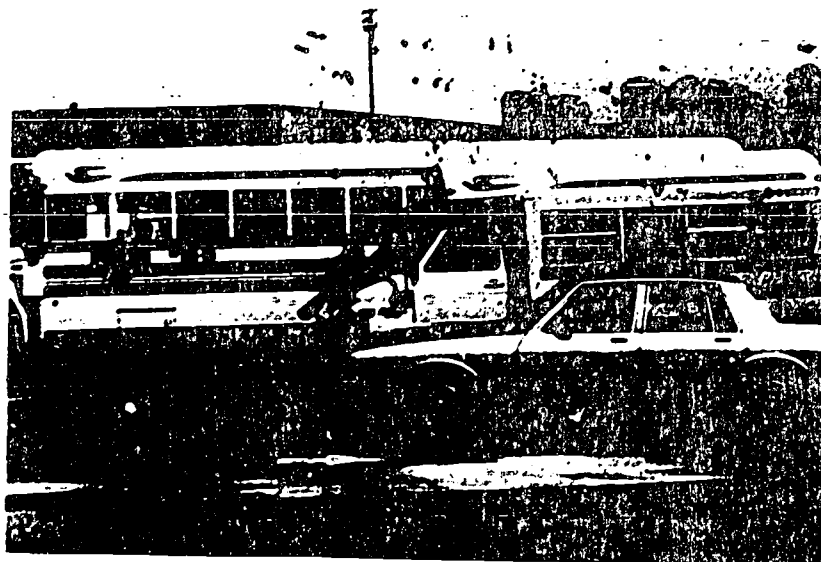
Figure 2.--A small school bus is closer in size and weight to a passenger car than to a large school bus. In this photo, a 66-passenger school bus and a 22-passenger school bus are parked alongside a Chevrolet Caprice. If a school bus is involved in a collision with a car, the crash forces experienced by passengers riding on the small school bus will be much more severe than if they had been riding on the large school bus.

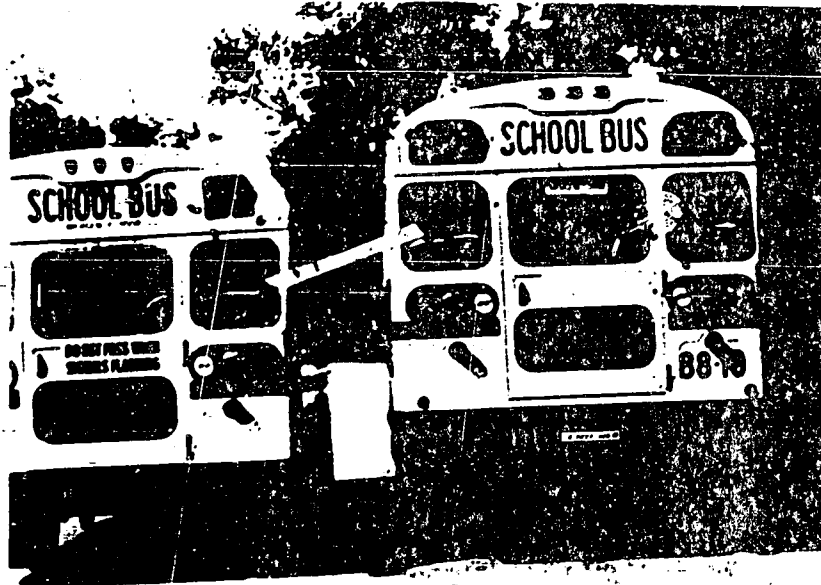
Figure 3.--Passengers seated in a small school bus are closer to the ground, and closer to the level at which a passenger car would impact, than passengers seated in a large school bus. (A school van is pictured at left; a large school bus is at right. The difference in heights of seatbacks from road level is indicated.)

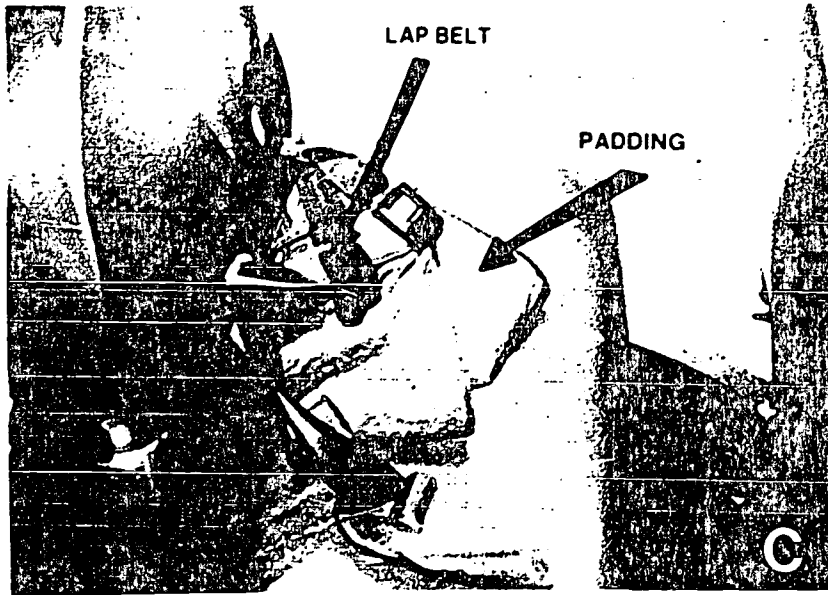
Figure 5.--Such "restraints" pose danger to the occupants. The jury-rigged loopbelt (A) and unusual three-point restraint (B and C) were found in case 24. Neither was secured to the seat or floor. Other examples of improper installation were shared seatbelt anchorages (D) and unusual configuration of buckles and latchplates (E).

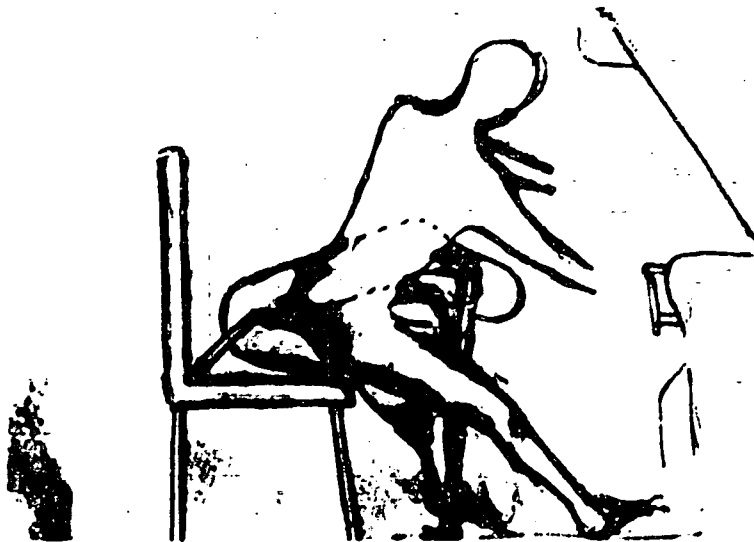
Figure 8.--Artist's sketch of body movements of the two fatally injured passengers in case 17 at the moment of initial impact.

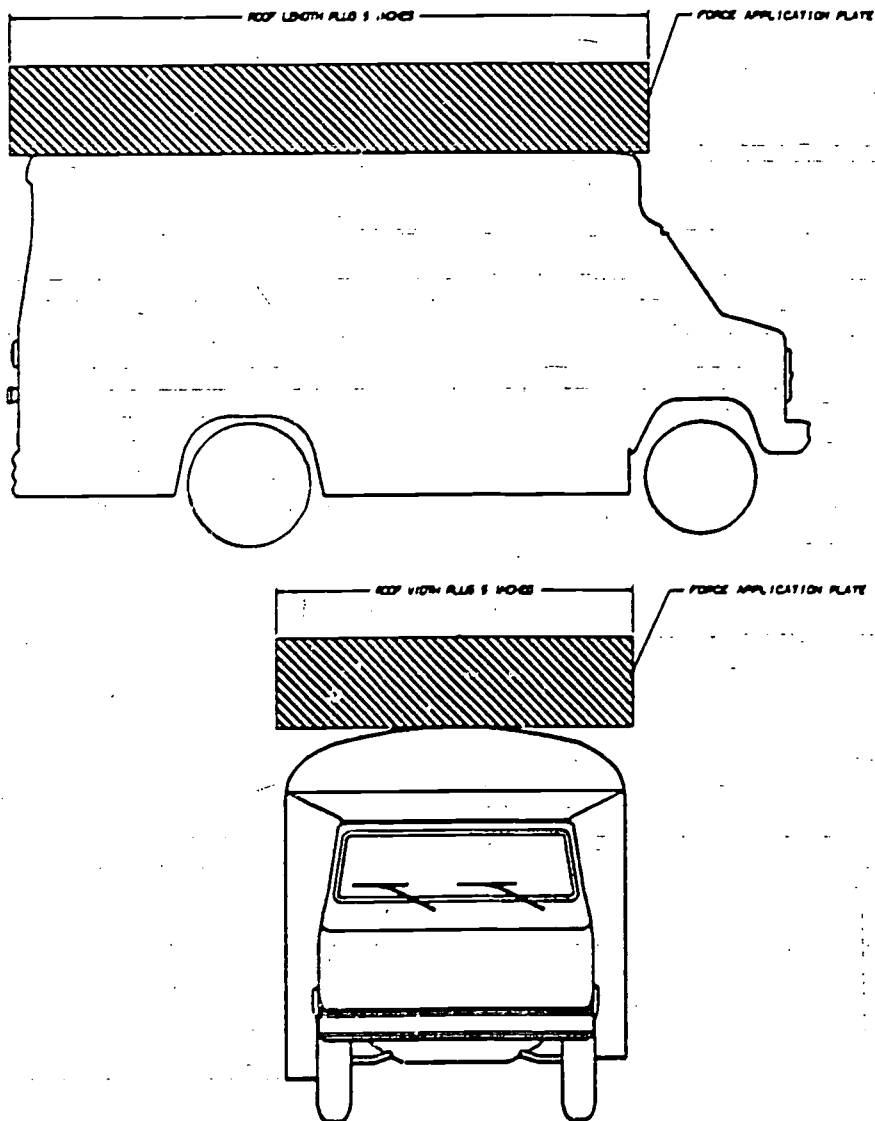
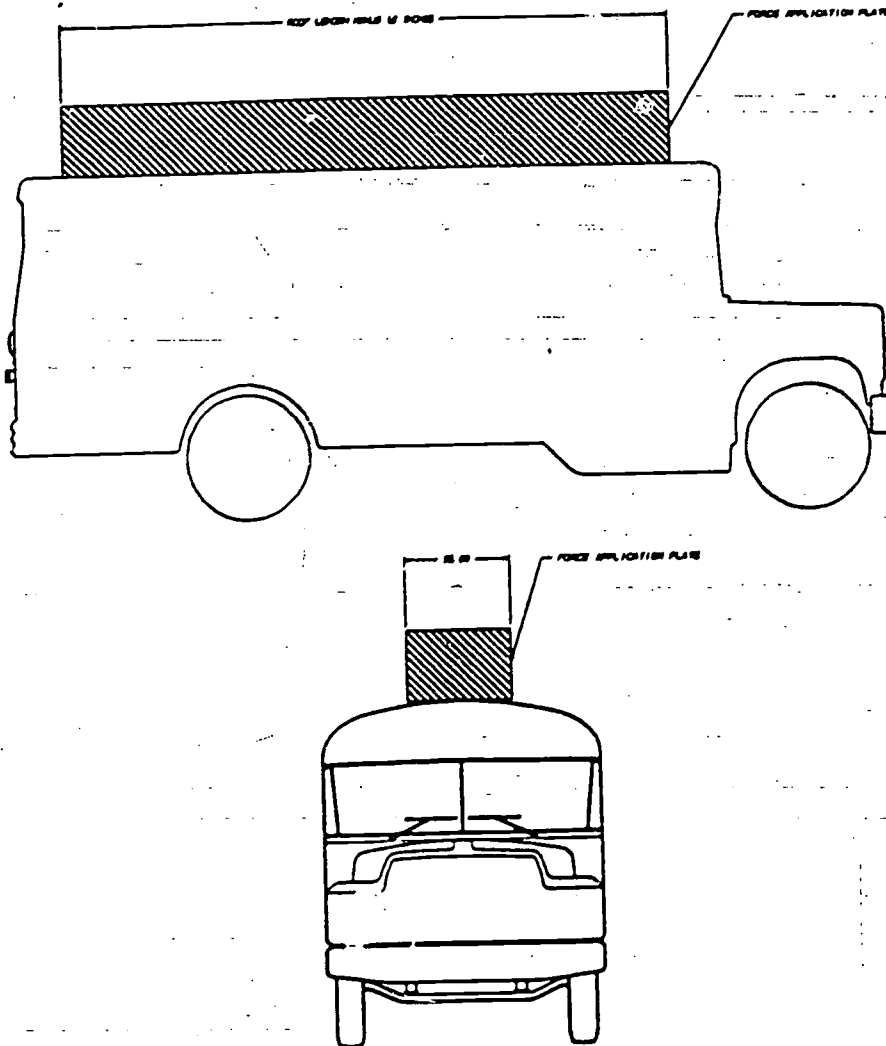
Figure 15.--A larger force application plate is used to test roof strength in small school buses compared to that used in tests of larger school buses. The result is that the roof of a small school bus must pass a less stressful test of roof rollover performance. (Source: School Bus Manufacturers Institute 1999.)
