TITLE What's Left After a Tornado.

INSTITUTION Lawrence Inst. of Tech., Southfield, Mich.

a project of the SCHOOL OF ARCHITECTURE Southfield, Michigan Lawrence Institute of Technology

July, 1975

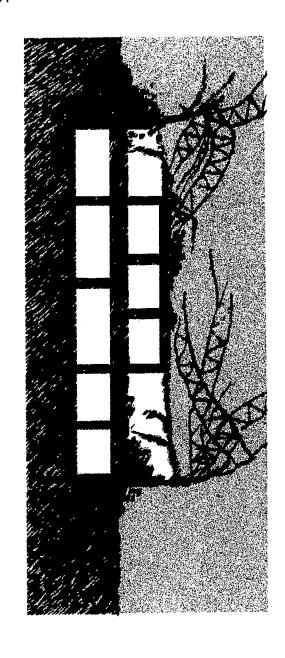
LOAD-BEARING WALLS are the sole support for floors or roofs above. If the winds cause

the supporting wall to fail, part or all of the roof or floor will collapse. The most dangerous locations are usually along the south and west sides and at all corners of a building.

Masonry construction is not immune to wall collapse. Most masonry walls are not vertically reinforced and can fail when high horizontal forces such as winds or earthquakes occur.

Masonry exterior walls in excess of 10 feet in height are potential hazardous elements.
