Progress Report 2: February

Project Addressing Climate Change:

Solar Powered Ventilation with Controlled Airflow for Parked Cars

Department of Electrical & Computer Engineering Technology (ECET)

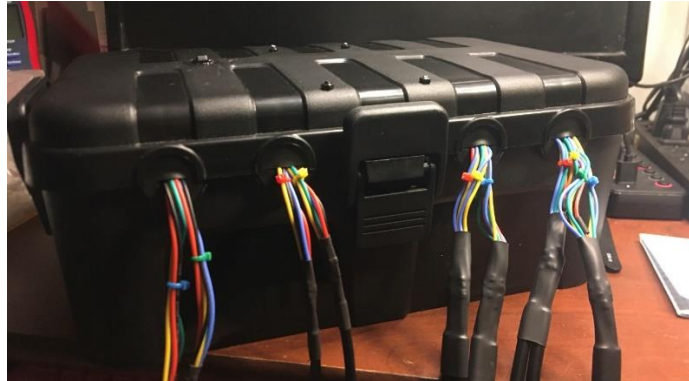
Figure 4 - Control module placed in control box

Once the control module was fully connected, it was placed in a box with cabling outlets. The PWM Charge Controller was mounted to the lid of the control box along with a SPDT switch. With this, the control module build was complete and ready for testing.

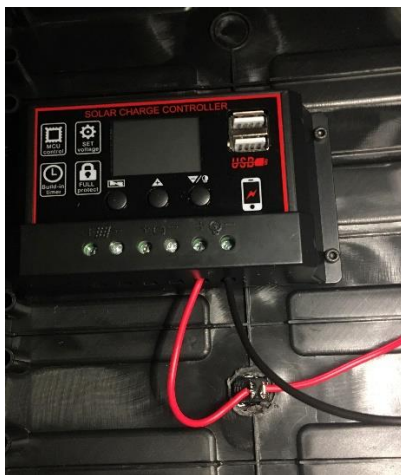
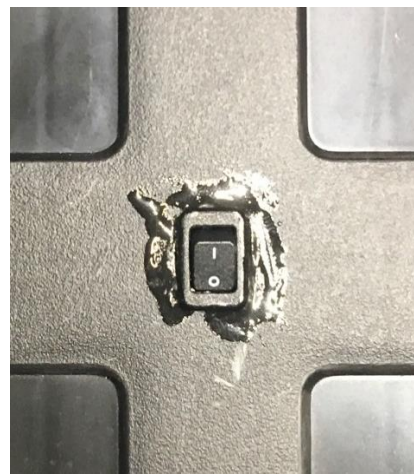
Figure 5 - (a) PWM Controller mounted to control box lid (b) SPDT switch installed in lid

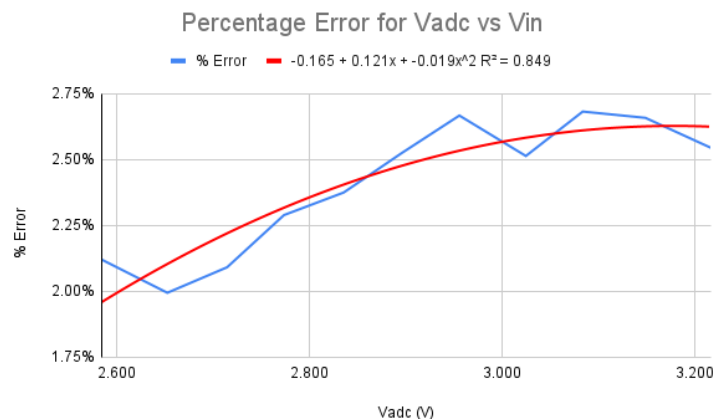
Figure 6 - Chart of the % Error between V_{adc} and V_{in}

Testing the battery monitor revealed that the ADC voltage was not only bouncy, but it was also inaccurate. The voltage read by the ADC is not accurate to the actual input voltage. The group saw an approximately 200mV drop in the ADC reading compared to the DMM-measured voltage. Furthermore, the drop appeared to increase as the input voltage increased. To gather data on this phenomenon, Ian set up a power supply. Starting at 12 V and increasing the voltage by 0.3 V until 15 V, Ian measured the voltage at the ADC with a DMM (V_{in}) and the average voltage read by the program (V_{adc}) over 1000 samples. Then, the % error was calculated between V_{in} and V_{adc} for each supply voltage level. A polynomial trendline was then produced for the % error using Google Sheets.

The equation for the trendline was then used to adjust V_{adc} . The correction was implemented into the battery monitor program and tested. After adding a small offset, the voltage read by the program was accurate within about 10 mV, which was expected due to the bounciness of the ADC.

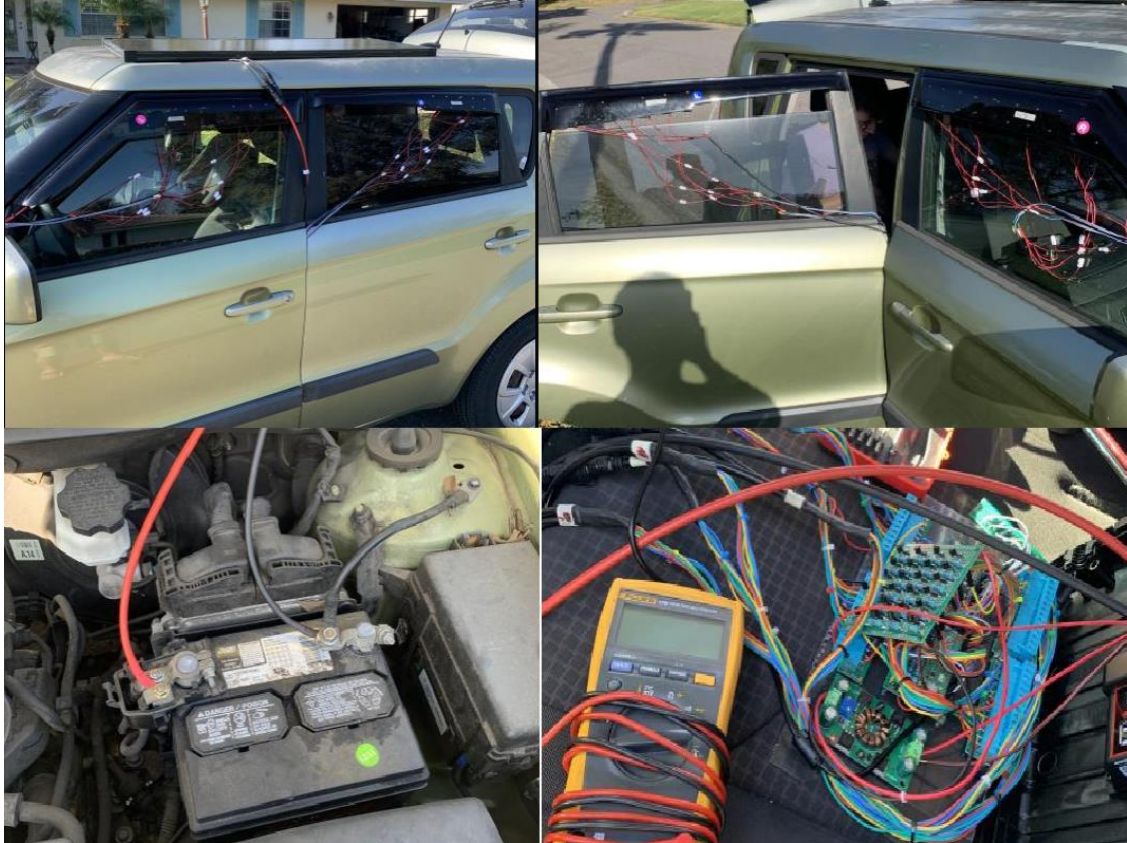
Figure 11 - Full system mock testing

After all sensors were confirmed to be working and that control of the fans was possible through the code, a mock test was performed by attaching the vent visors to the test vehicle and integrating the Solar Panel, Car Battery, and PWM Charge Controller which would provide power to the system. Initial testing indicated that the Thermistor Circuitry and Fan Controls were nominal, however issues related to the Battery Level Voltage monitoring and IR Sensors were found. The Battery Level Monitoring was off by $\sim 100\text{mV}$ from the expected value during the mock test and further correction in the code would be needed to offset the difference as the voltage going into the ADC was confirmed to match that of the battery voltage on a DMM. The IR sensors were found to have an exceptionally weak signal at the input to the ADC from the photodiodes. Initial assumptions were that the 3v3 pin of the Pico may not be providing sufficient current for the emitters to function properly. Additional troubleshooting would be performed to find the root cause of the issue.

On 2/27/2023, a secondary mock test was performed following corrections made to the Battery Level Monitoring code and a possible solution to the IR sensor issues experienced being implemented. The Battery Level Monitoring code was now successfully reading the proper voltage from the battery with only a 10mV to 20mV inaccuracy on occasion. The IR sensors were still experiencing issues, however. It was determined during the second mock test that the IR sensors could not be used in their current configuration as the ambient IR light provided by the sun was sufficient to saturate the photodiodes making it difficult to detect any of the reflected IR light from the emitters.
