# **Switching Transients, Transformer Failures and Practical Solutions**

David D. Shipp, PE  
Fellow, IEEE  
Capstone Engineering  
3300 Tarr Hollow Rd.  
Murrysville, PA 15668  
daviddshipp@gmail.com

Thomas J. Dionise, PE  
Senior Member, IEEE  
Eaton Electrical Group  
130 Commonwealth Dr.  
Warrendale, PA 15086  
thomasjdionise@eaton.com

**2016 IEEE Houston Section  
Continuing Education on Demand  
Houston, TX  
February 9 – 10, 2016**

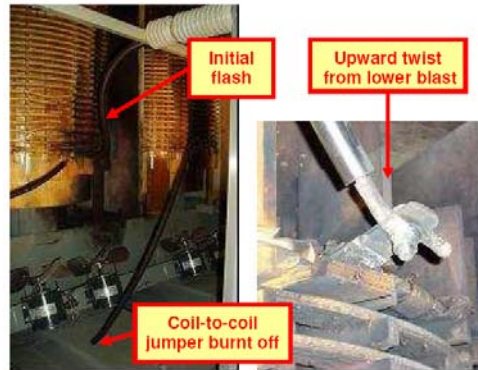
## Transformer Failure #2 - Energization

- Examination of primary windings
  - Coil-to-coil tap burn off
  - Winding showed an upward twist
  - Burn marks from the initial blast
  - Transient on first turns of windings

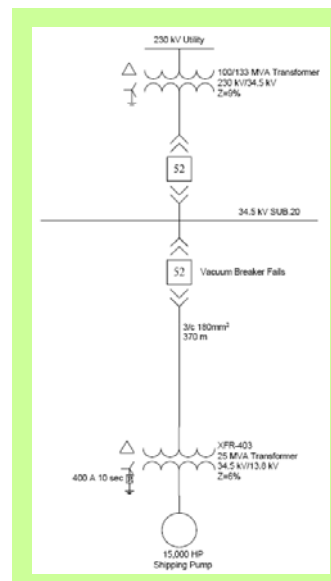
## Case 14 – another highly inductive circuit Breaker Failure – TRV / RRRV

- 34.5 kV Vacuum Breaker Feeding Slave Transformer
- 13.8 kV 15,000 HP Motor
- VCB opened during starting sequence

- VCB interrupts highly inductive current at 3cy
- Transient overvoltage
- Excessive TRV & RRRV
- Causes breaker failure

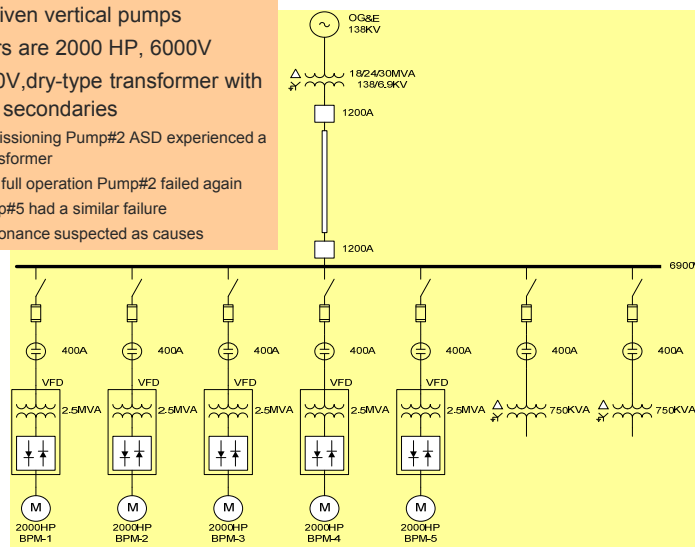
## Pipeline Pump Station ASD Transformer Failures

- 5 x 6.9kV ASD driven vertical pumps
- Main pump motors are 2000 HP, 6000V
- 2.5MVA, 6900/750V, dry-type transformer with 5 x phase shifted secondaries
  - During dry commissioning Pump#2 ASD experienced a failure of the transformer
  - 7 months later at full operation Pump#2 failed again
  - 2 days later Pump#5 had a similar failure
  - Transients or resonance suspected as causes

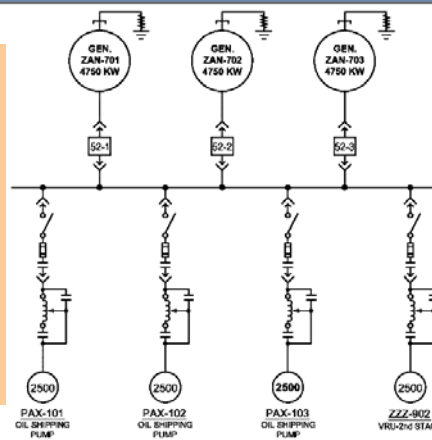
- 4 x 5937 kVA, 4.16 kV generators
- 4 x 2500 HP, 4.16kV pumps
- 8 RVAT failures from 2001 to 2013
- Teardown/Failure analysis indicated layer-to-layer failure
- Internal resonance identified as a possible failure mode
- Undertook Transient Study coupled with SFRA testing to determine root cause of failures & find solution

**Model predicted switching transients to compare with transformer resonant frequencies**

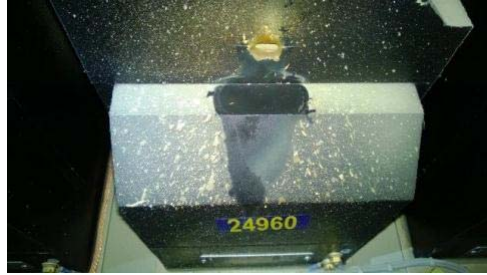
## PT failure – damage limited to PT

- PTs and CPTs applied in new 26.4kV system
- Failed during commissioning

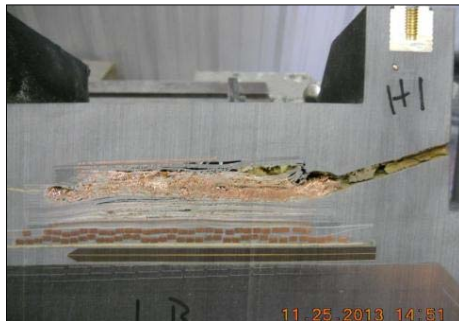
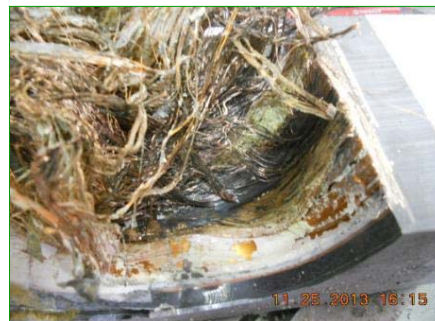
## Insulation failure

- When the dielectric rating of the insulation is exceeded, adjacent windings short together, heat and pressure build-up, and the VT housing ruptures.
- Could take days to weeks before the external evidence occurs.

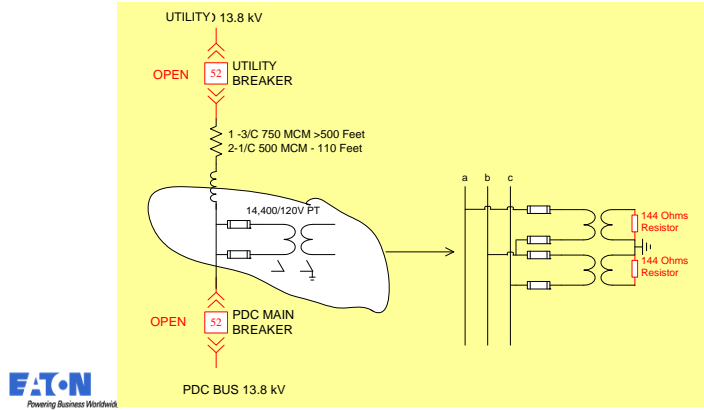
## Special Condition: PT Ferroresonance – Damping Resistor Commercial Bldg – NY City

- Corrective measures:
  - RC snubber
  - **Damping resistor**

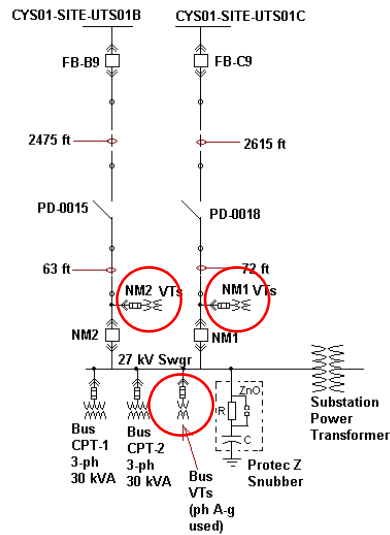
## Data Center Wyoming VT failures

- Two line-end VTs at 24.9 kV in the switchgear failed on Nov. 18, 2013 which initiated our investigation
- During the investigation, the bus VTs for the same gear failed on Dec. 28, 2013.

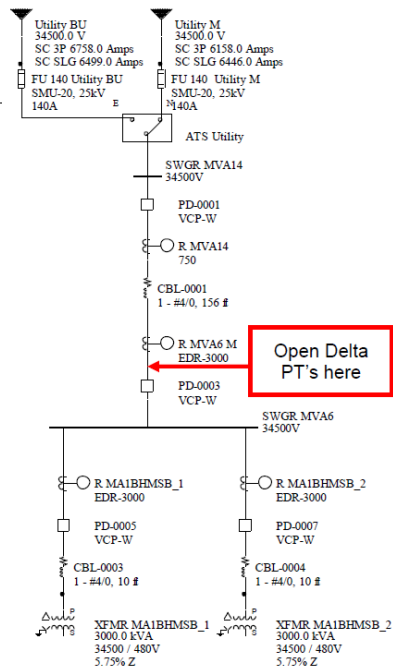
## University Campus VT failures

- Line-end open-delta PTs at 34.5 kV in the switchgear failed on Oct. 3, 2014 which initiated our investigation
- PTs failed catastrophically taking out switchgear bus and breaker
- Collateral damage to switchgear room

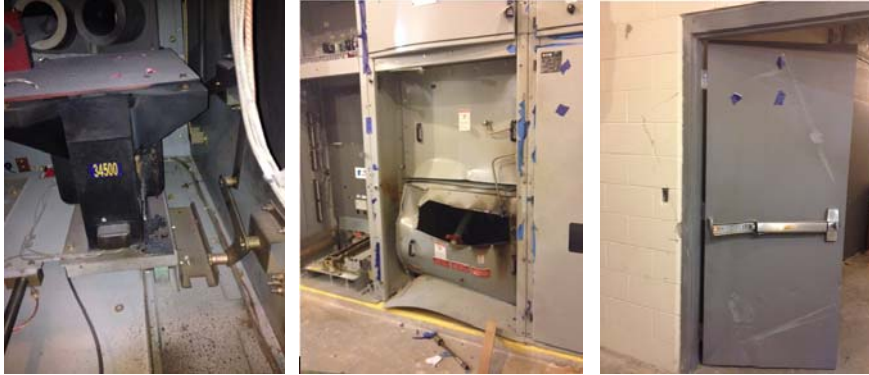
## University Campus PT failure – catastrophic

- PTs applied in new 34.5kV system
- Failed shortly after startup

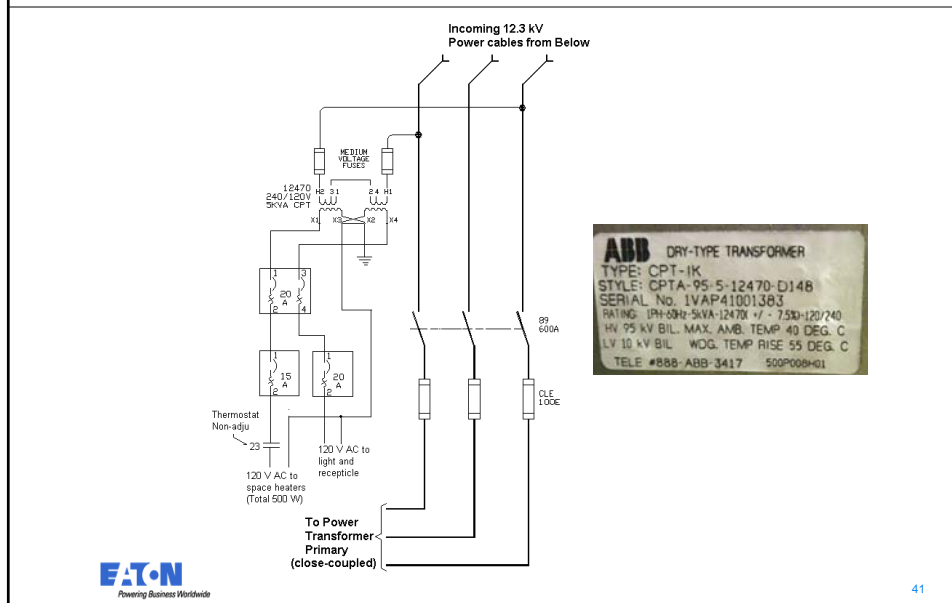
## Train Station - Primary Switch Three Line Diagram (Typical for Sub 6C and 7A)

- Electrical fault occurred in incoming cable compartments of MVS Sub 6C and Sub 7A.
- CPTs in both subs were connected on source side across phase A –C. Both CPTs were damaged.
- Both subs were being fed from the same utility source.
- Power Fuses installed in upstream utility equipment cleared the fault.

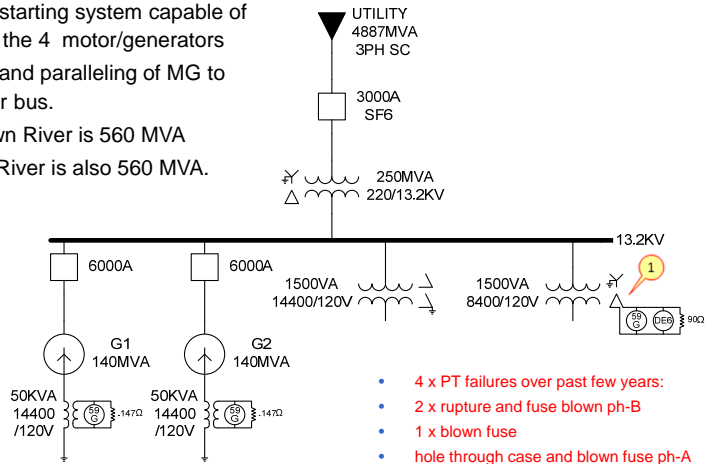
## Pumped Hydro Station – PT Failures

- 2 x 13.2 kV transformer busses
- 2 x 140 MVA generator/motor per bus
- common SFC starting system capable of starting any of the 4 motor/generators
- synchronizing and paralleling of MG to the transformer bus.
- No. 1 Bus Down River is 560 MVA
- No. 2 Bus Up River is also 560 MVA.

- 4 x PT failures over past few years:
- 2 x rupture and fuse blown ph-B
- 1 x blown fuse
- hole through case and blown fuse ph-A

- Removed wye-grounded / broken-delta PTs from the Transformer Busses Nos. 1, 2, 3 and 4.
- Installed grounding transformer wye-grounded 13.8 kV primary and broken delta 120V secondary.
- Connected 4 Ohm resistor in the broken delta to give about 1.3 A GF current at 13.8 kV.
- If GF occurs before the generator is connected, then it alarms but does not trip.
- When generator comes online, each generator is a source of about 15 A of GF current.
- If GF occurs with one or two generators online, then the GF is detected then cleared.

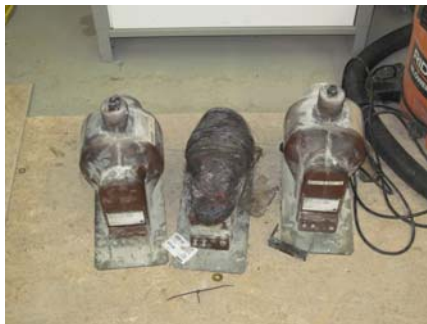
## Utility Substation Canada VT failure due to HV winding open circuit

- New 230kV substation suffered a VT failure at the 35kV level within the secondary SWGR.
- Occurred about 15 minutes after initial energization.
- The VT is for revenue metering within the utility compartment.
- Findings: The H2 connection to ground on the PT's was not made prior to energization. The PT's were energized with the HV winding open circuit!

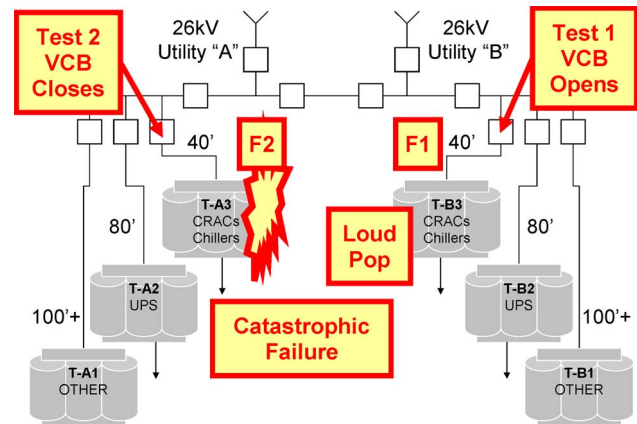
Fig. 1. Simplified electrical distribution system for data center.

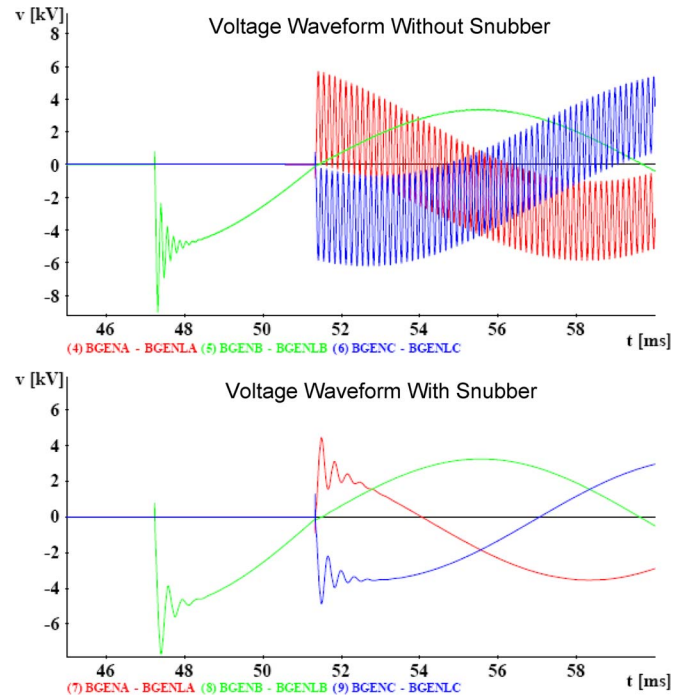
Fig. 8. TRV leading to reignition during energization of drive transformer with and without snubber.

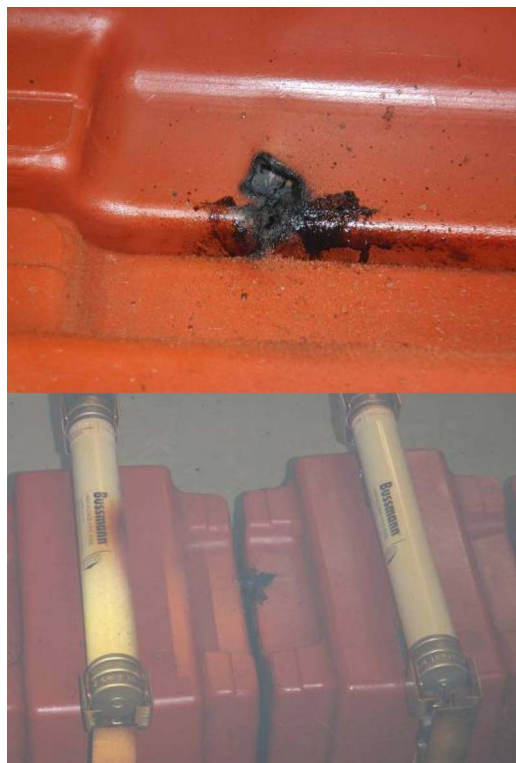
Fig. 1. Damage to PT but fuses remained intact.

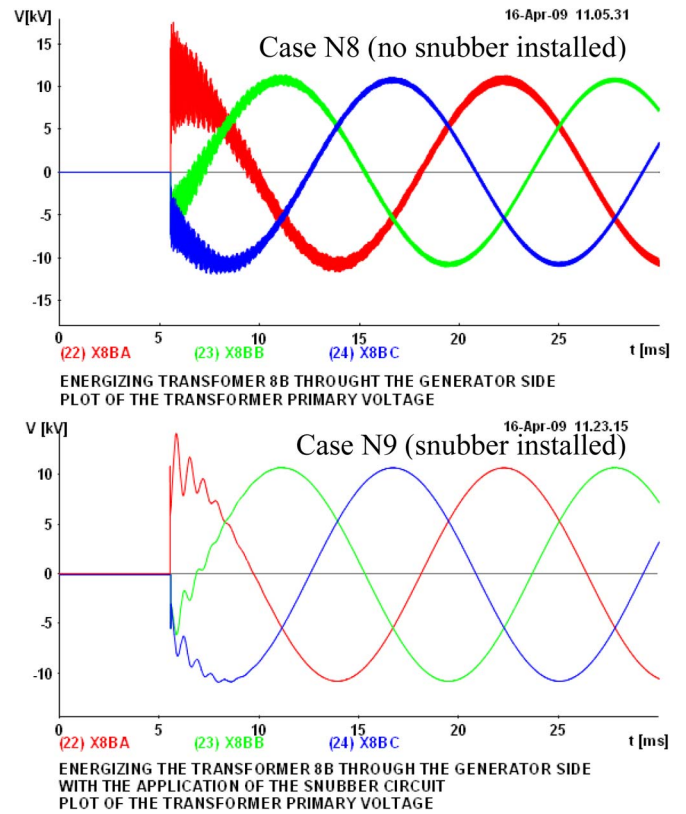
Fig. 6. TOV at USS8B during energization of transformer T-8B from the generator with and without snubber protection.

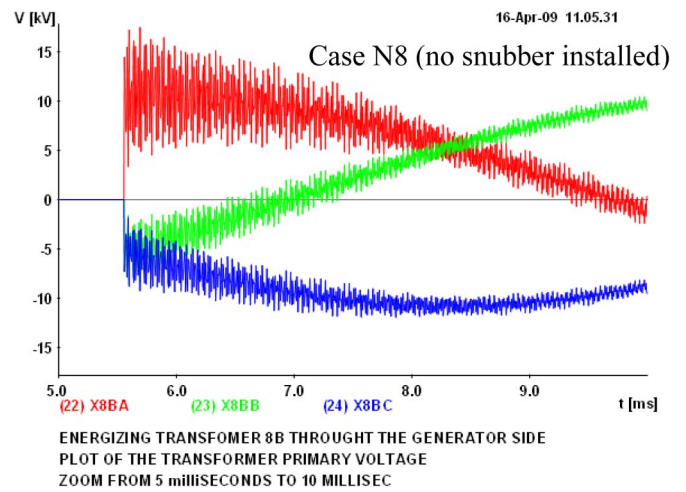
Fig. 7. TOV at USS8B during energization of transformer T-8B from the generator with and without snubber protection (zoom of ferroresonance).

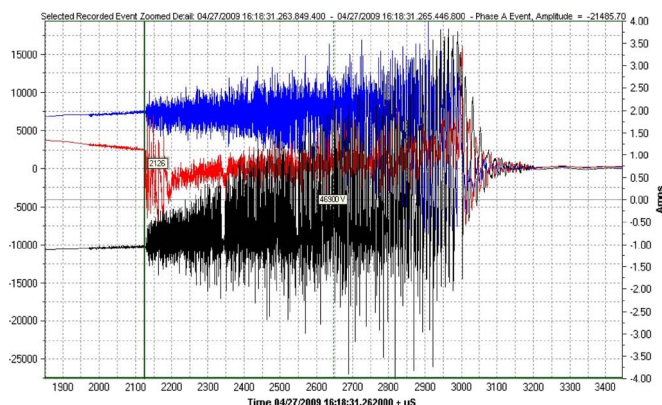
Fig. 12. Switching transient capture at PT.

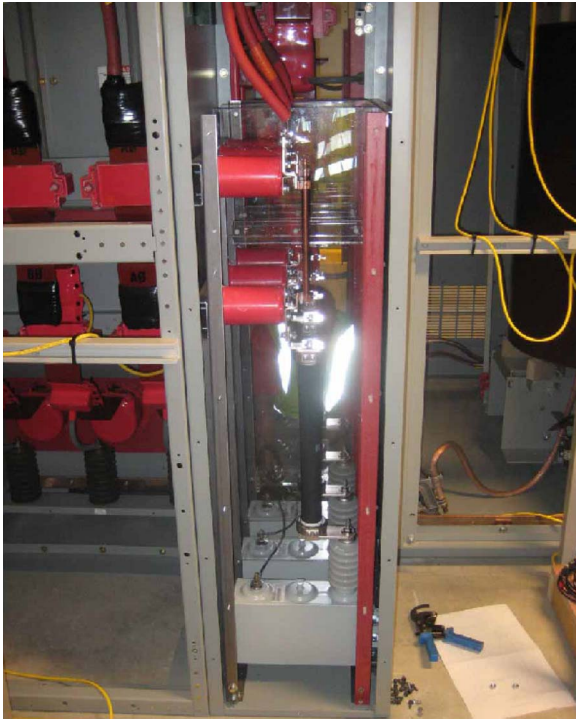
Fig. 15. RC snubber (typical installation for this facility).

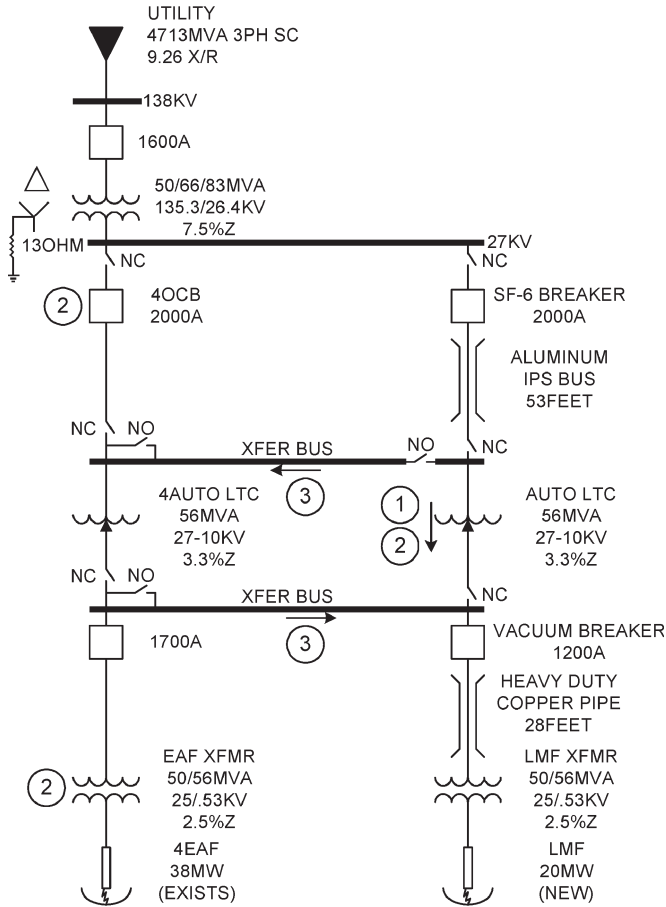
Fig. 1. Simplified electrical distribution system for new LMF.

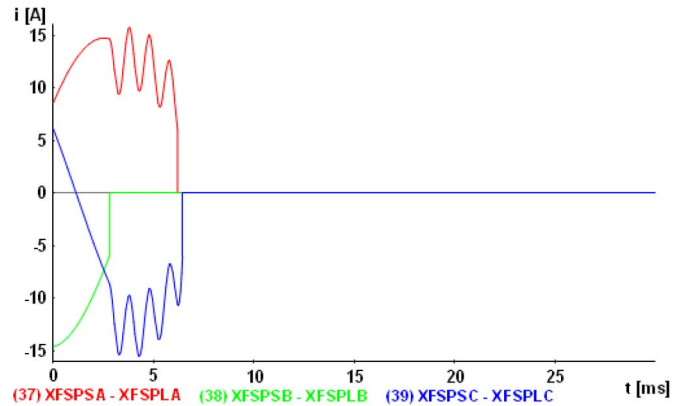
Fig. 2. Current chop for the vacuum breaker.

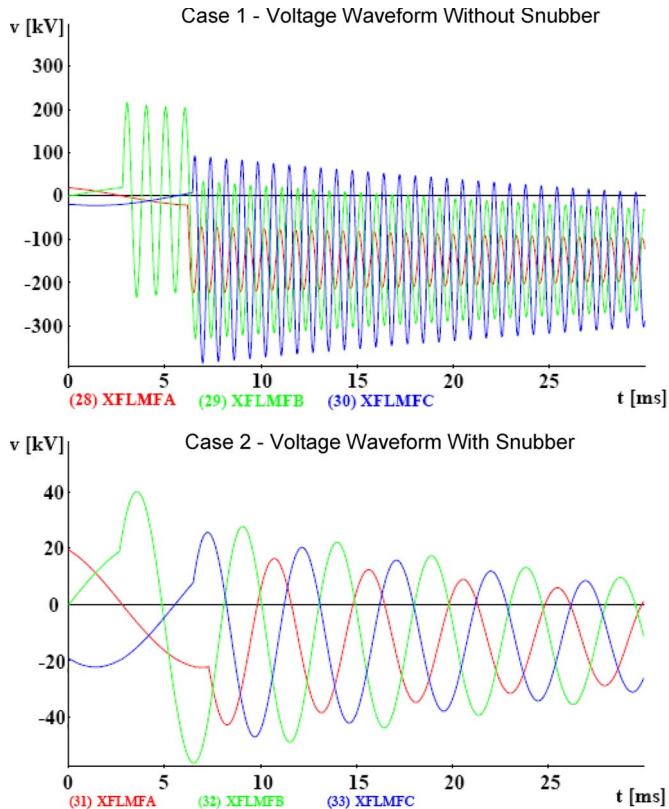
Fig. 3. TOV during de-energization of LMF transformer by the vacuum breaker with and without snubber protection.

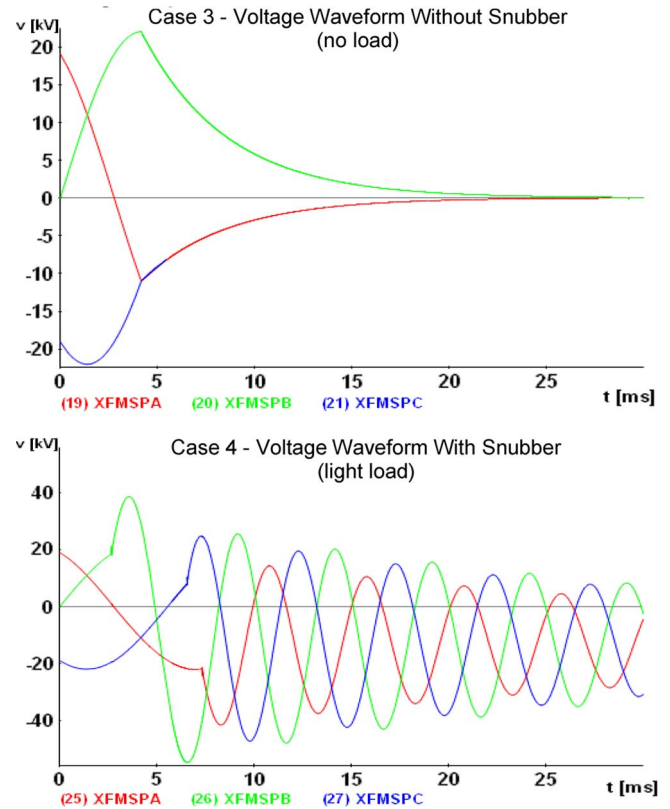
Fig. 4. TOV during de-energization of LMF transformer by the SF-6 breaker with and without snubber.

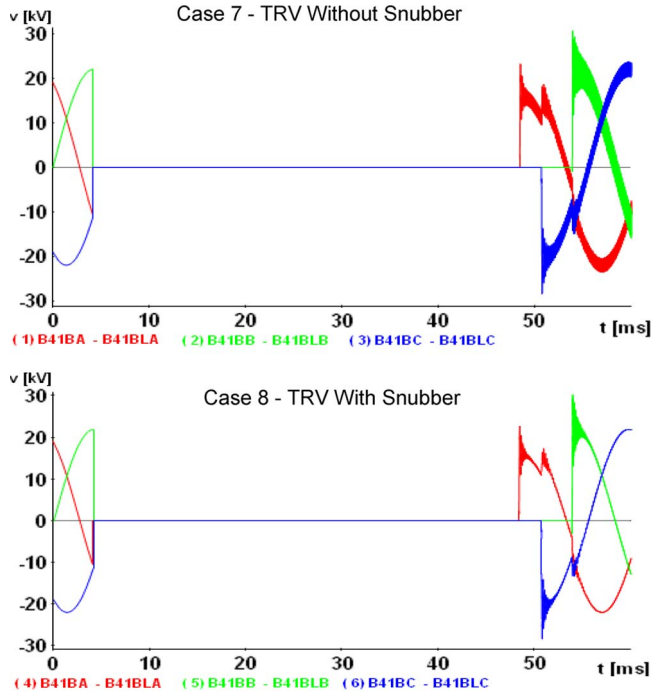
Fig. 7. TRV across SF-6 breaker during interruption of autoregulating transformer inrush current with and without snubber protection.
