DOT HS-801 529

# **DEVELOPMENT OF A SCHOOL BUS FUEL SYSTEM INTEGRITY COMPLIANCE PROCEDURE**

**Contract No. DOT-HS-4-00872**

**Final Report**

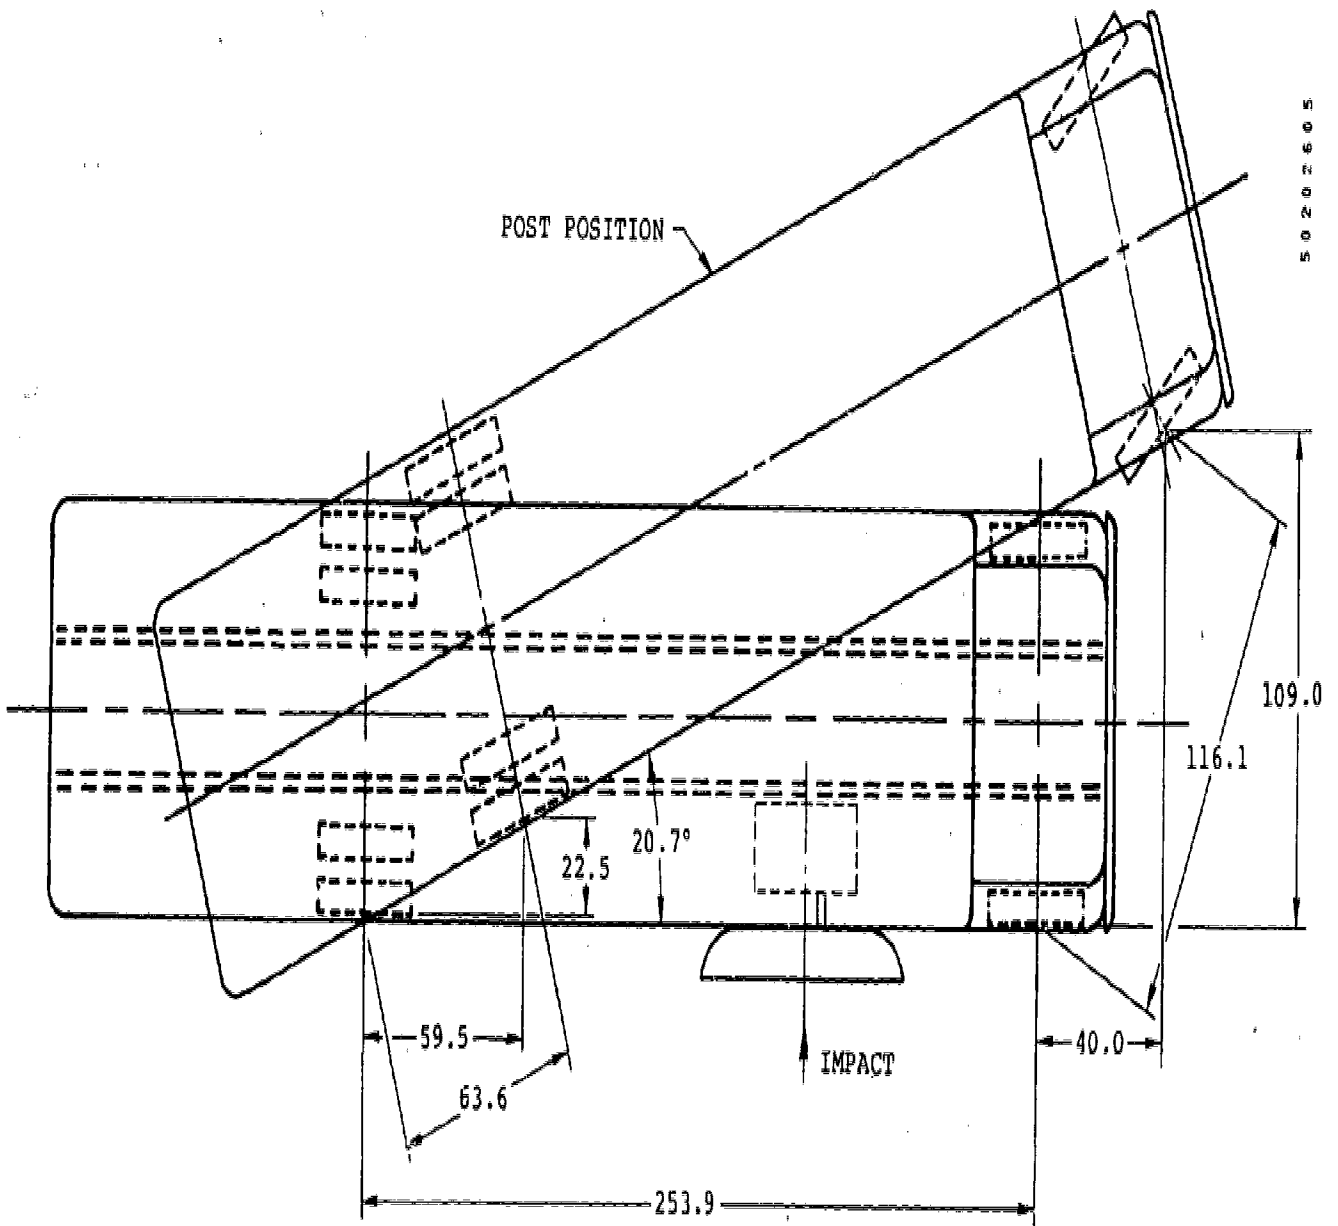
Figure 5. Test 1, Pre- and Post-Test Positions of School Bus.

When all of the instrumentation and photographic equipment was ready, the moving barrier was accelerated to a speed of  $29.4 \pm 0.5$  miles per hour. The barrier was released just prior to impact, and impact velocity was 29.38 miles per hour. The barrier impacted the bus and then rebounded straight backward because of the barrier guide shoes. The school bus rotated 20.7 degrees during impact and was pushed sideward several feet as shown in Figure 5. The maximum roll that occurred during the event was 9 degrees. Fuel leakage was immediate, the first timed sample being started as soon as test personnel could get to the leakage. The fuel spillage was measured in four two-minute samples, as listed in Table II. The fuel leakage occurred from an area on the filler spout that was partially separated from the fuel tank. The failure was in the union of the angle fitting of the filler spout to the main tank, as shown in Figures 6 and 7.

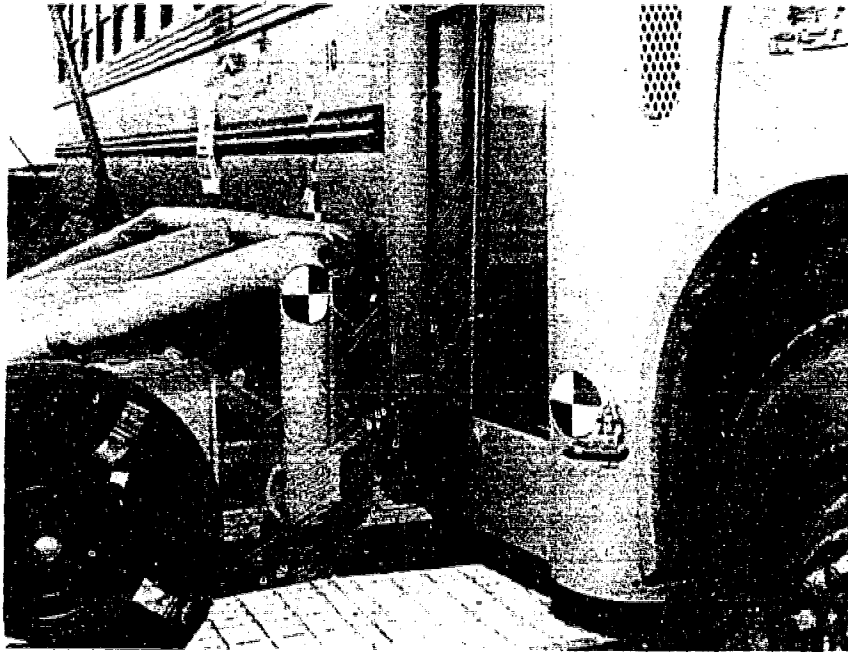
Figure 15. Test 1, School Bus and Barrier Interface, Close-up View.

The impact of the moving barrier was primarily resolved by the floor support structure as shown by the high acceleration levels on the floor and the lateral shift of the floor structure inside the bus. The alignment of the moving barrier to the

school bus is shown in Figures 15, 16, and 17. The lateral shift of the floor structure is shown in Figure 18 and the exterior impact is shown in Figure 19. Penetration of the moving barrier in relation to the fuel tank is shown in Figure 20.

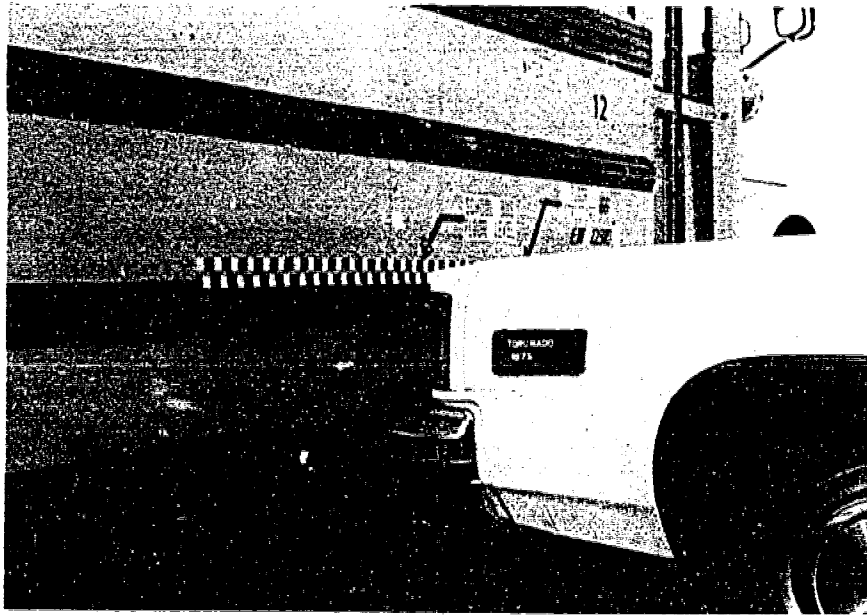
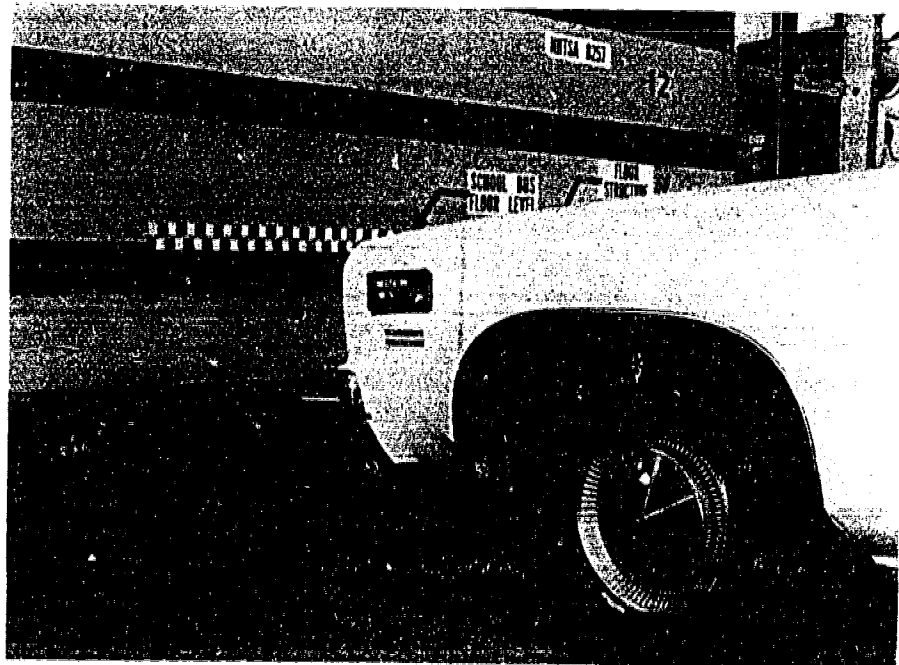
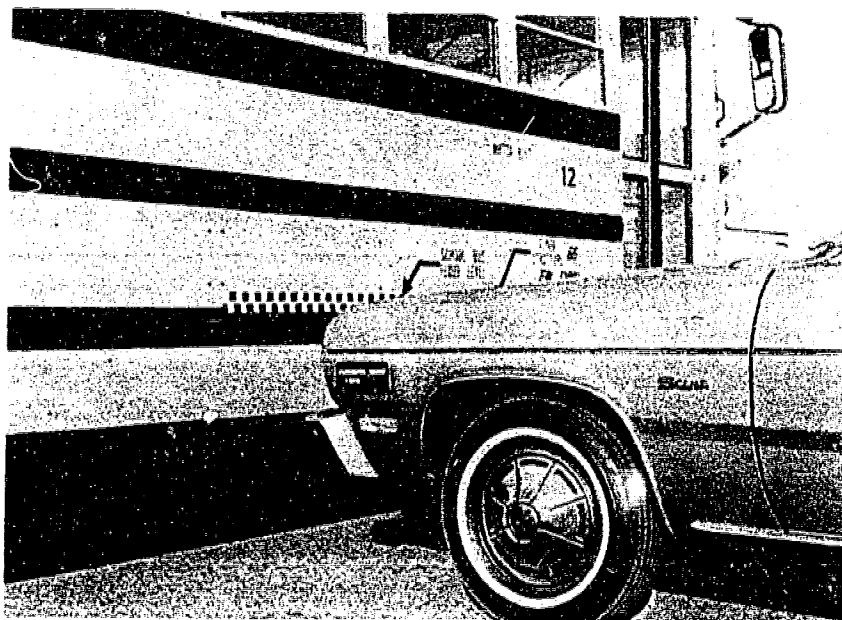
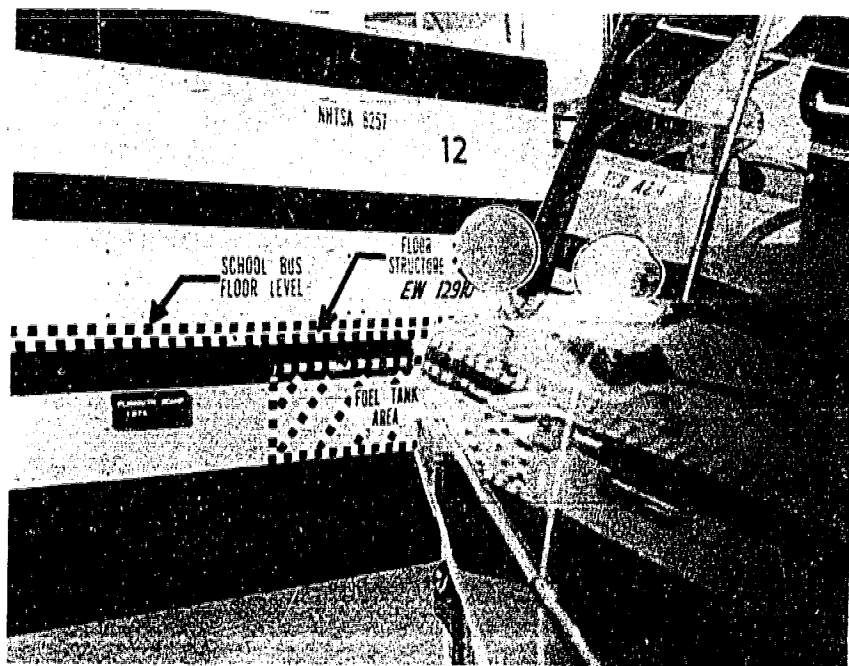
2. An evaluation of Test 1 indicates that the majority of the impact energy from the moving barrier was resolved through the floor of the school bus. A brief survey of 1975 automobiles indicated that the hood would probably pass under the floor and the floor structure during an accident. Figures 21, 22, 23, and 24 show the relationship of the school bus floor and floor structure to the various automobiles. This relationship is also indicated in Accident Report NTSB-HAR-72-2 where a 1961 Chevrolet Impala sedan impacted the side of the school bus and passed under the floor, rupturing and dislodging the fuel tank from the school bus with a resulting fire. The barrier impact for the second test could be made more representative of the vehicle interface by using a lower contoured moving barrier that would represent the height of the substantial structure of an automobile's front end.
