Educational Facility Evaluations of Primary Schools in Rural Honduras Departments of Cortes and Meambar

in cooperation with
Council of Educational Facility Planners, International
and
Heart to Honduras

In April 1997, a team of eleven educational facility planners and architects from the United States and Canada conducted a facility evaluation of schools in rural Honduras, in the departments of Meambar and Cortes. Team members were all members of the Council of Educational Facility Planners, International and traveled to Honduras under the auspices of a Christian mission group, Heart to Honduras.

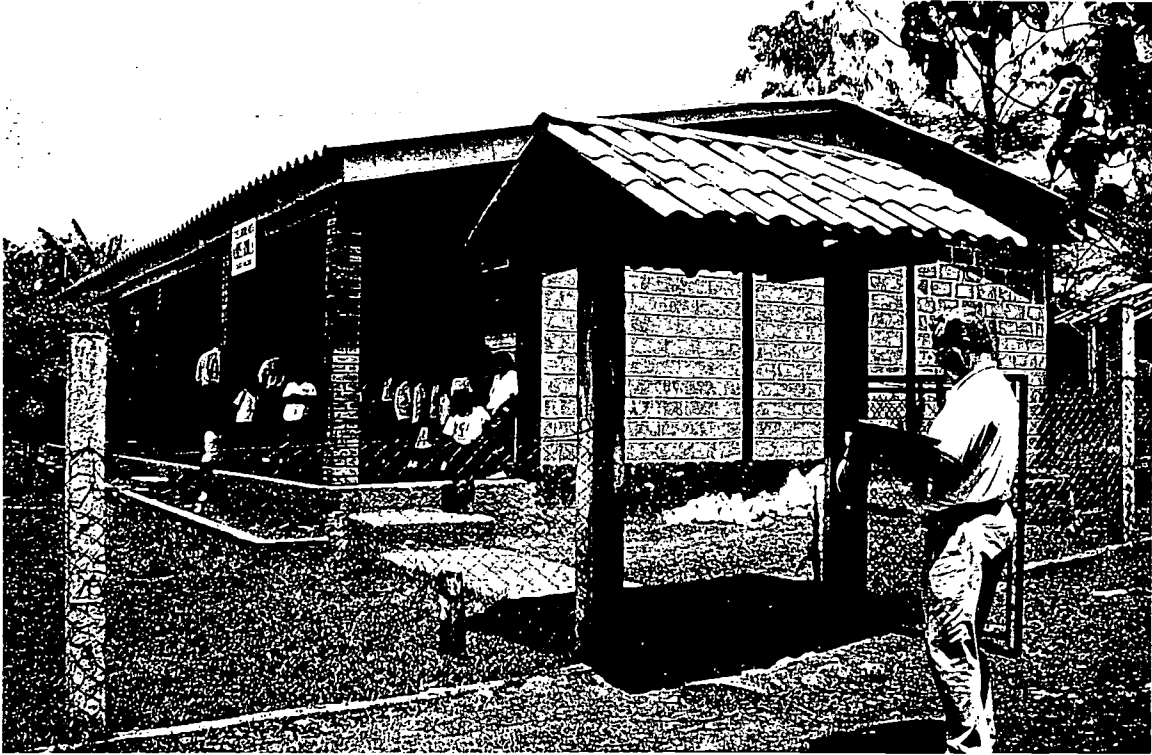
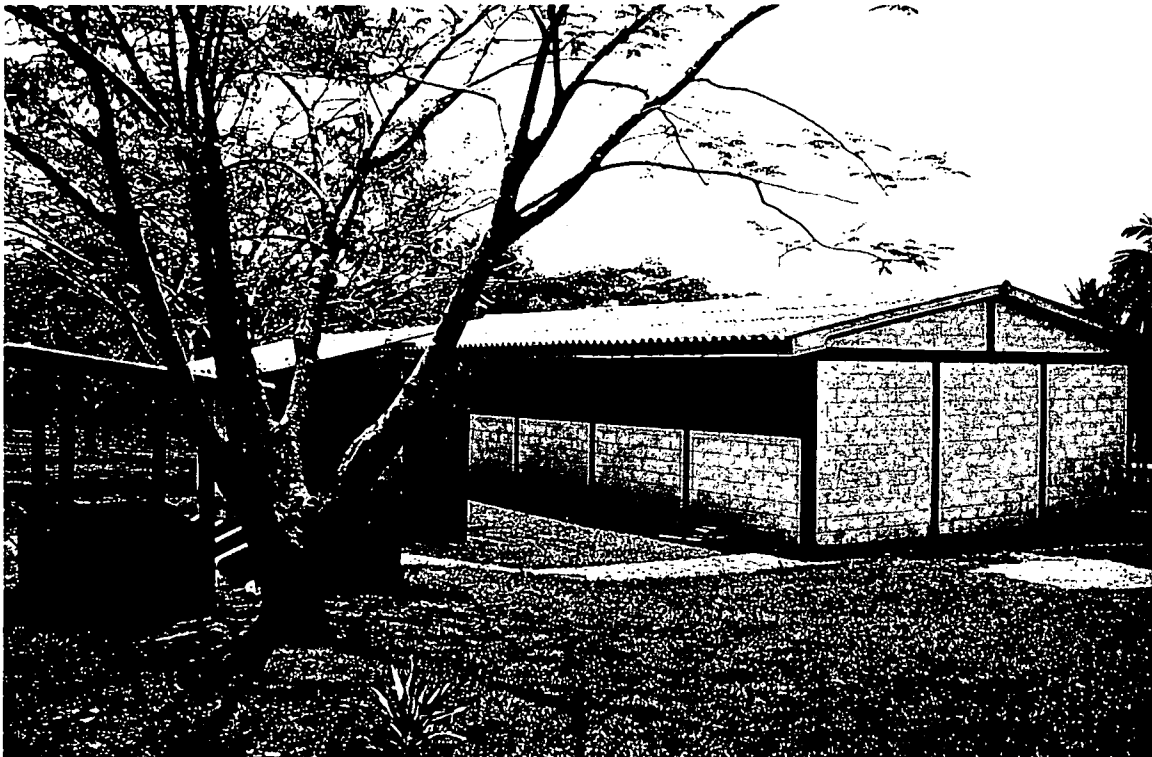
Las Casitas Primary School

The patranota's office is directly behind the school.

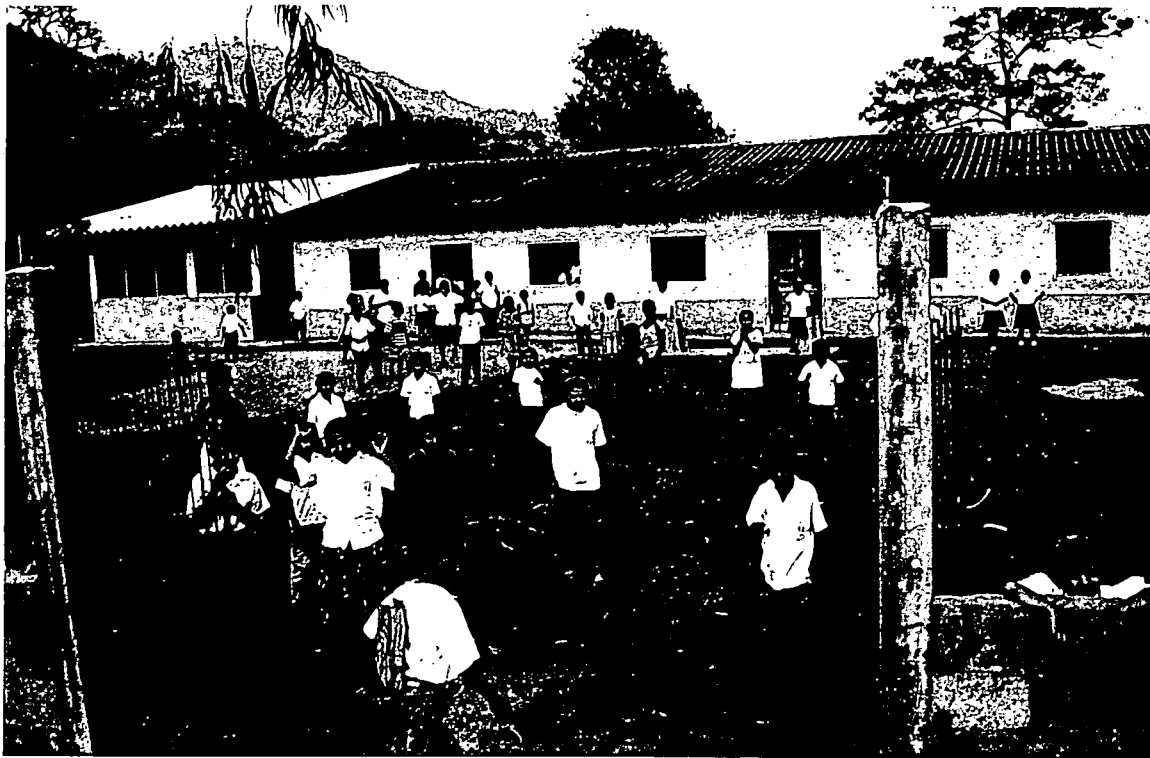
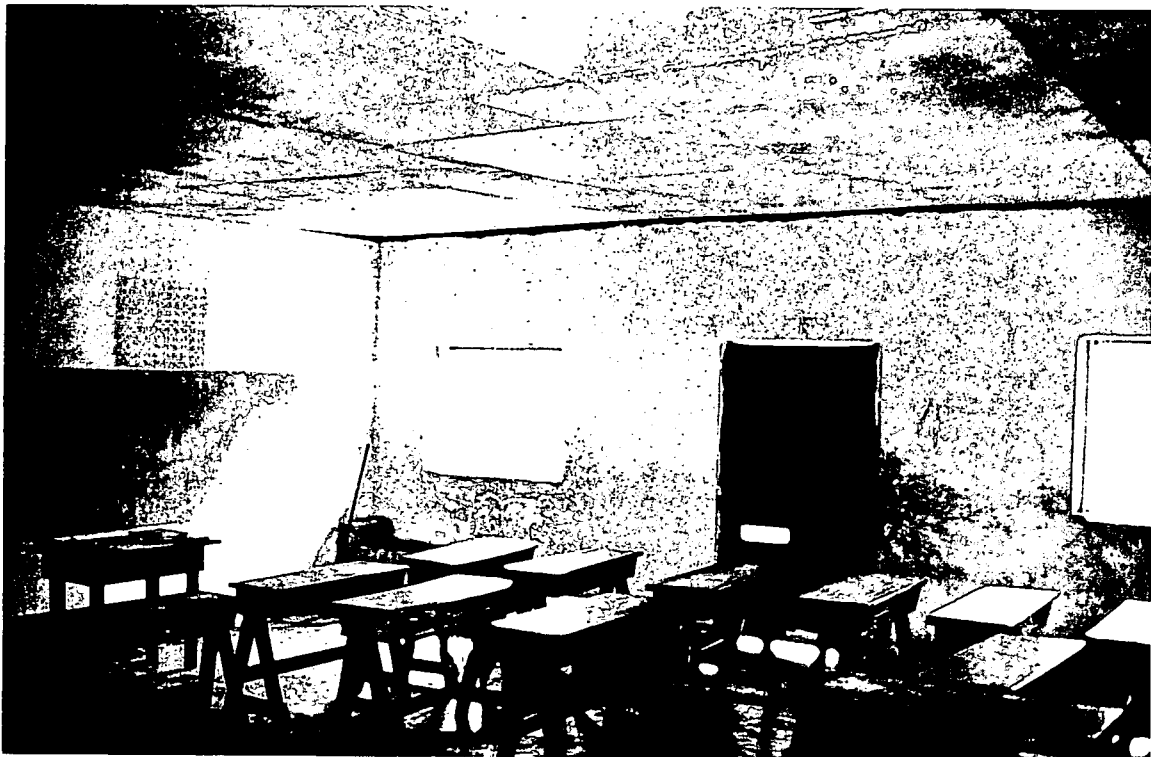
Las Delicias Primary School

- There is a kitchen but appears to be unused.
- There is no kitchen

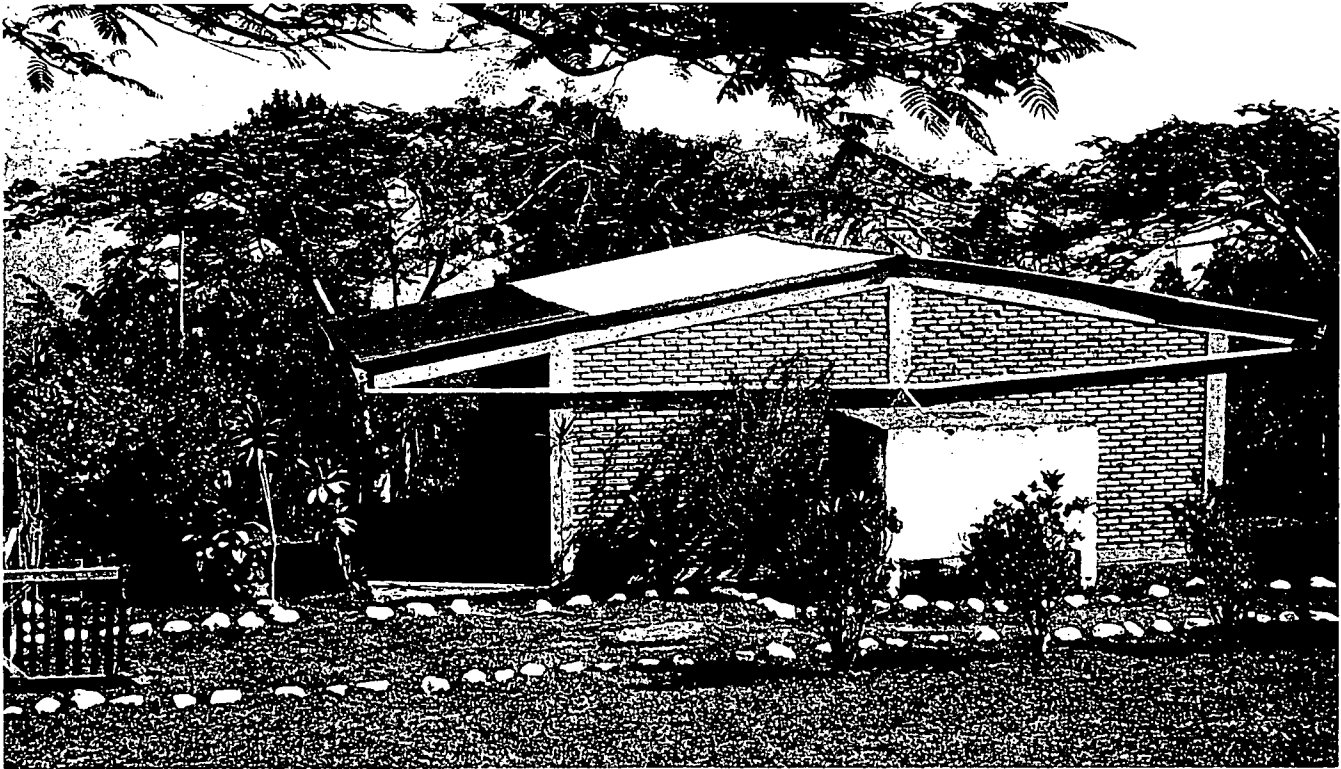
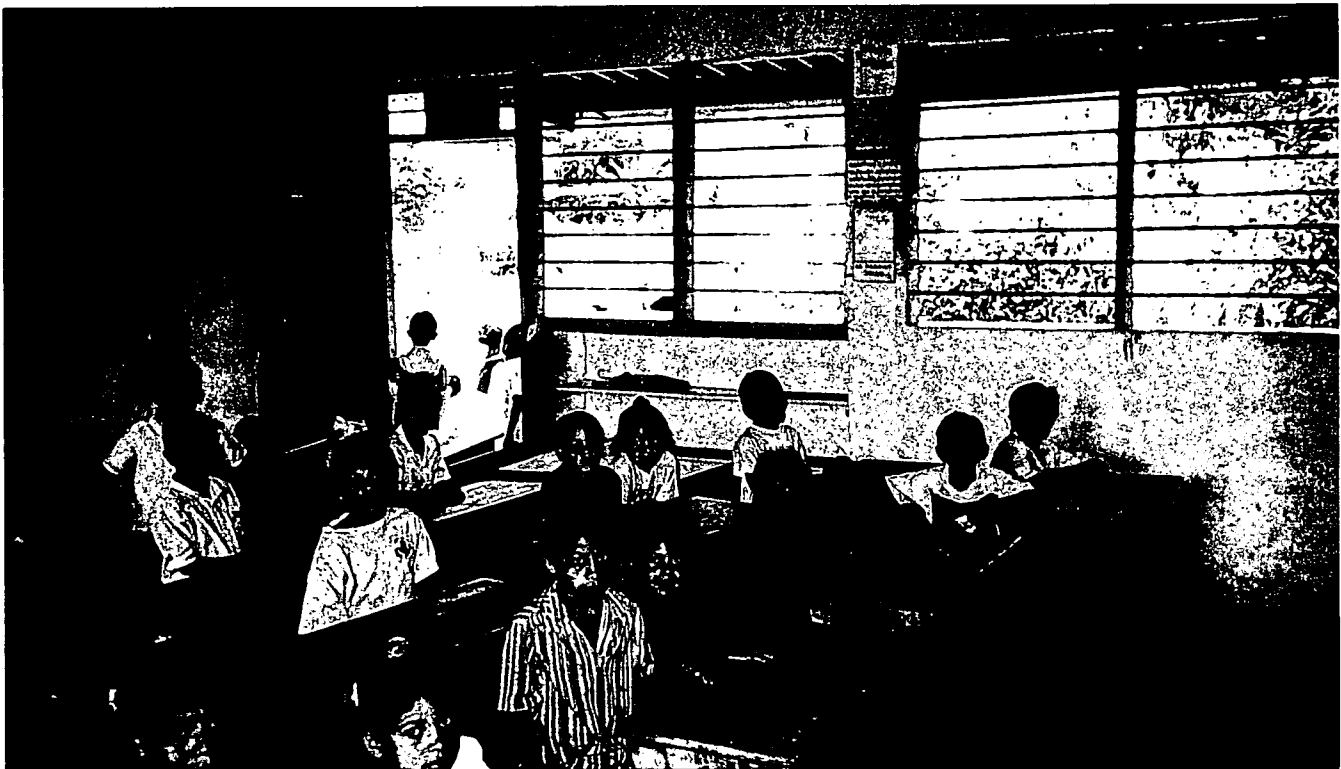
Los Globos Primary School

Outdoor instructional area
Has old school building on site; now used for storage and teacher housing.

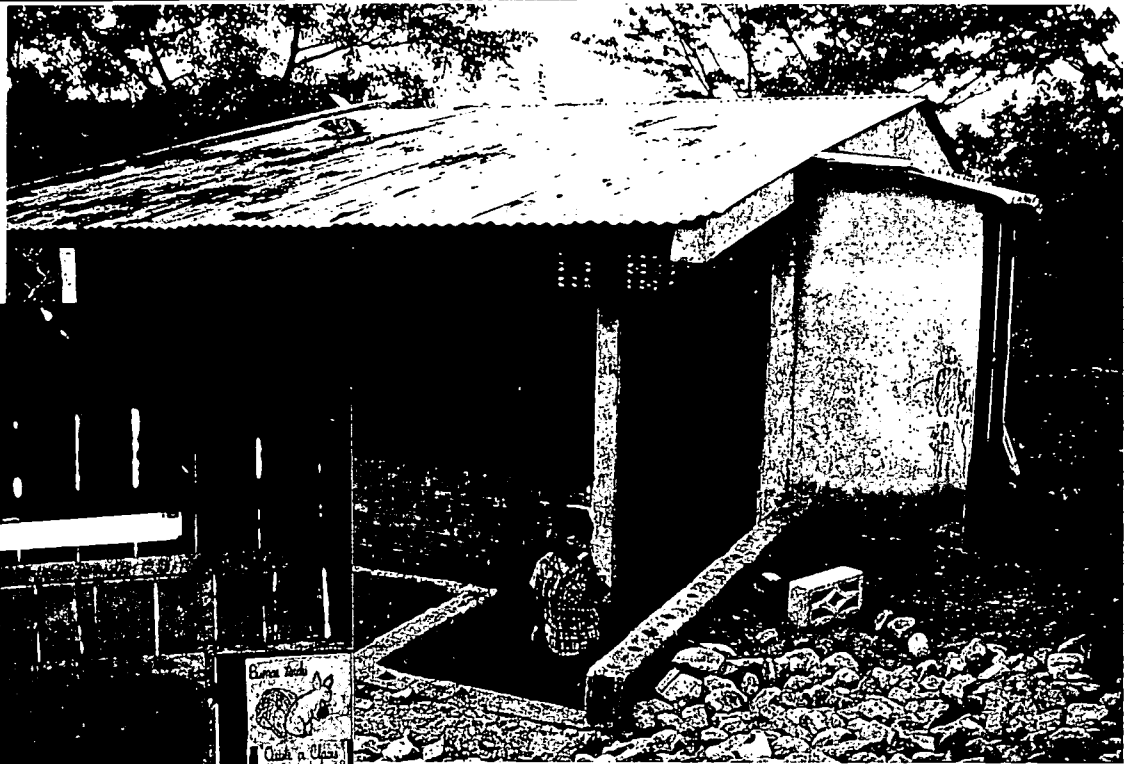
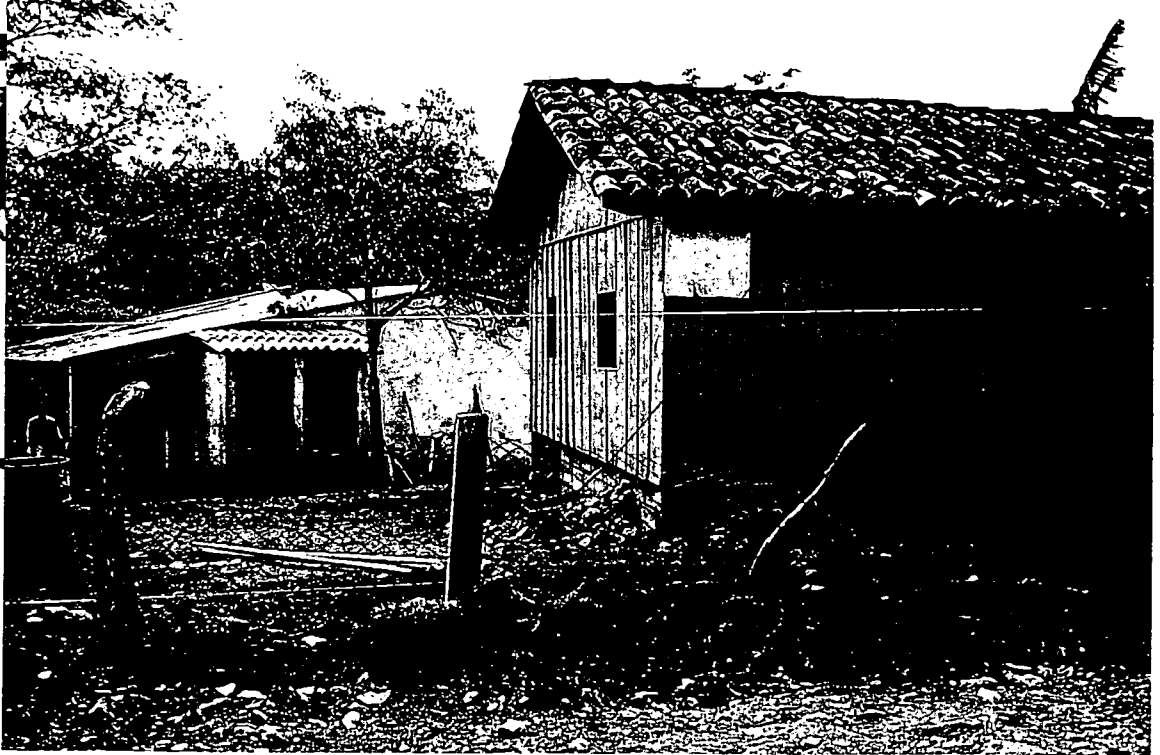
San Isidro Primary Christian School

Access to Building B is down some concrete stairs, at the top of which is a pile of rocks which seem to have been placed there intentionally. Access is hindered by the pile.
