TITLE Crashworthiness of Small Poststandard School Buses: Safety Study.

REPORT NO NTSB-SS-89/02

Crashworthiness of Small Poststandard School Buses: Safety Study

October 11, 1989

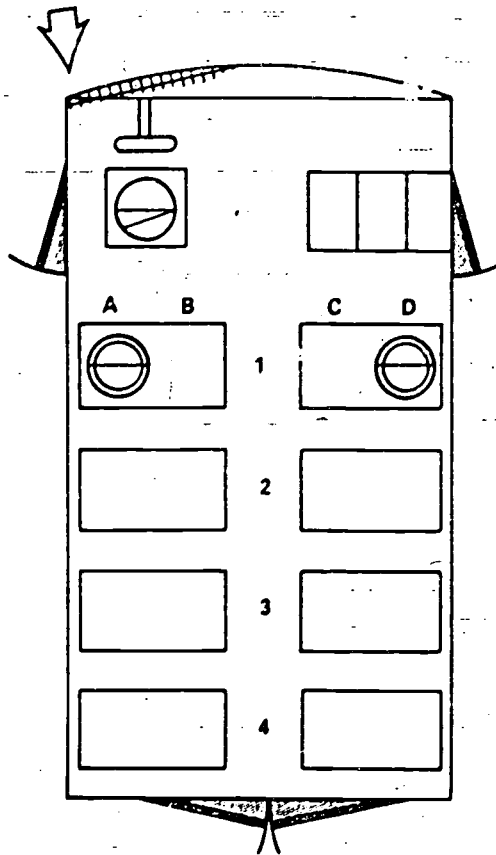
Bedford, New York
Case Number 1

Left Side of Bus
Driver
F-44, MAIS 0
Row 1A
M-7, MAIS 1

Right Side of Bus
Row 1D
M-10, MAIS 1

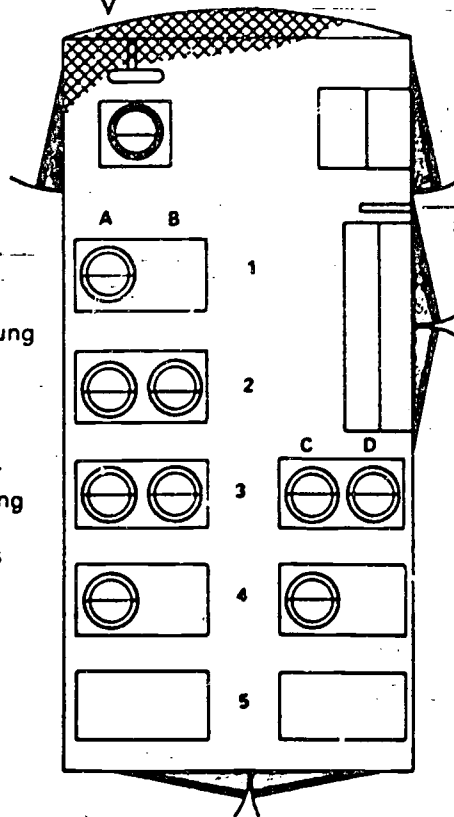
Driver
 M-72, MAIS 5
 Lacerations of left lung with hemothorax
 Cardiac contusion
 Flail chest
 Fracture - sternum
 Fracture - left femur
 Contusion - right lung
 Multiple abrasions
 Multiple lacerations

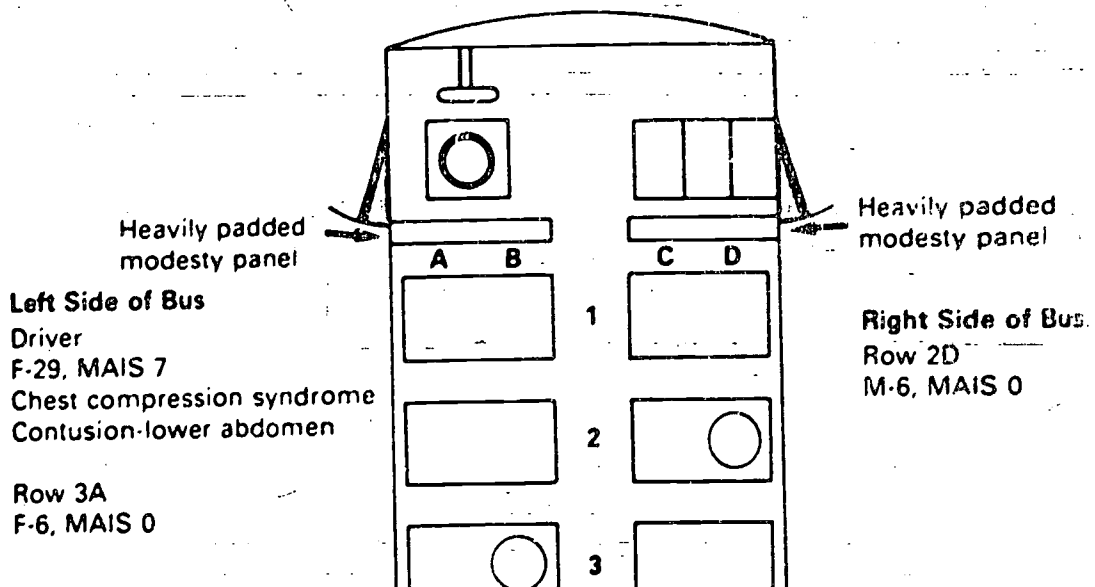
Fort Dodge, Iowa
Case Number 8

Left Side of Bus
 Driver
 F-29, MAIS 7
 Chest compression syndrome
 Contusion-lower abdomen

Row 3A
 F-6, MAIS 0

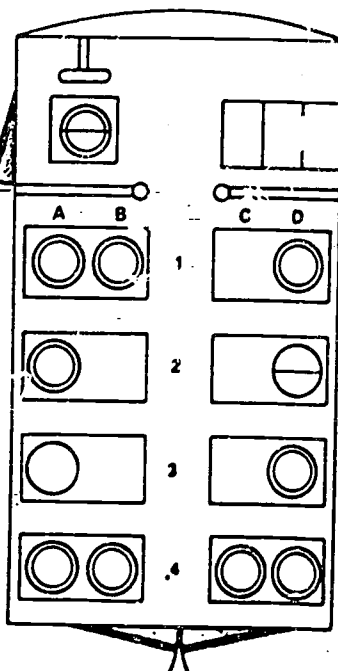
- Driver
- F-38, MAIS 1
- Row 1A
- F-12, MAIS 1
- Row 1B
- F-11, MAIS 2
- Fractured left clavicle
- Contusion on left shoulder
- Row 2A
- F-9, MAIS 1
- Row 3A
- F-12, MAIS 0
- Row 4A
- M-11, MAIS 1
- Row 4B
- M-10, MAIS 1

- Row 1D
- F-26, MAIS 1
- Row 2D
- F-12, MAIS 0
- Row 3D
- M-13, MAIS 1
- Row 4C
- M-11, MAIS 1
- Row 4D
- F-10, MAIS 1

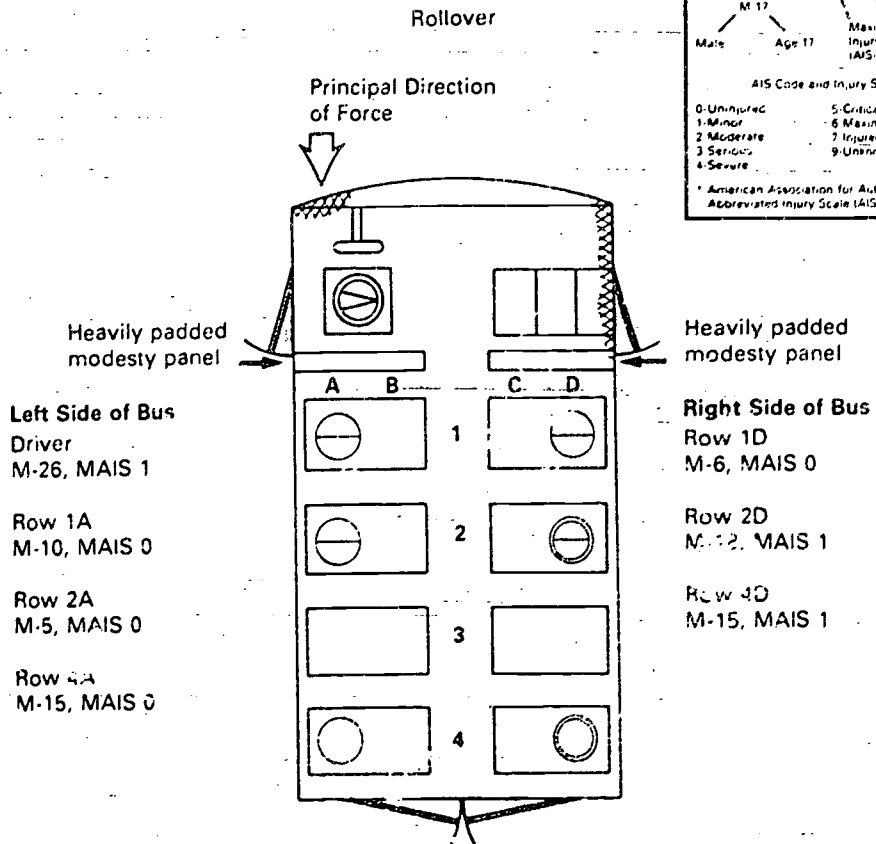
Denville, New Jersey
Case Number 11

It appears that the right side passenger loading door opened during the collision; the door control arm did not have locking mechanism. Although the open door did not result in additional injuries in this accident, it did present a potential hazard by creating an opening through which an occupant could have been ejected. (See case 8, Fort Dodge, Iowa.)

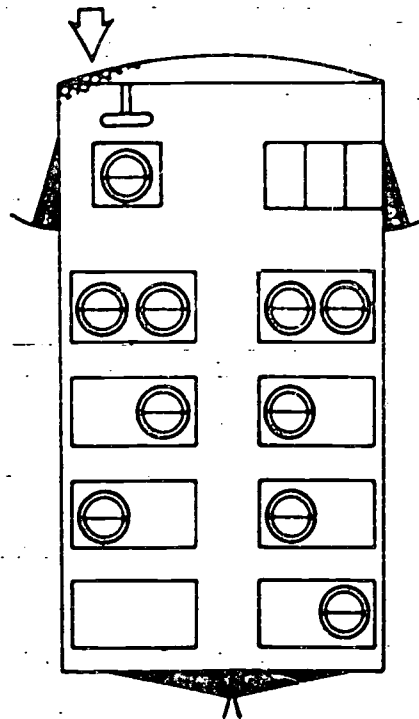
Driver
F-31, MAIS 1

F-14, MAIS 1

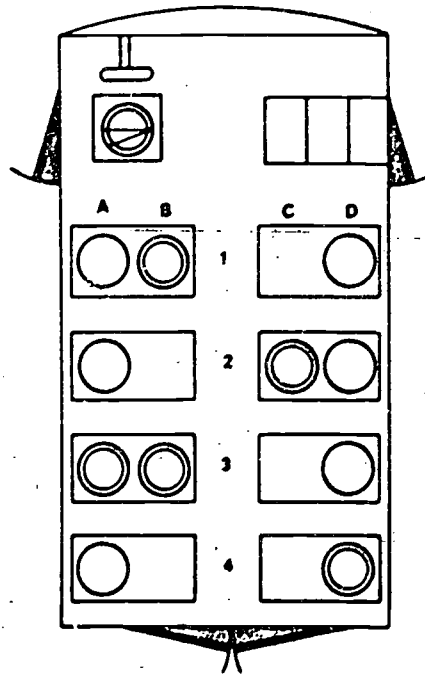
- Driver
- F-35, MAIS 1
- Row 1A
- M-14, MAIS 0
- Row 1B
- M-15, MAIS 2
- Fractured pelvis
- Abrasion on left knee
- Row 2A
- M-16, MAIS 0
- Row 3A
- M-15, MAIS 1
- Row 3B
- M-17, MAIS 1
- Row 4A
- M-17, MAIS 0

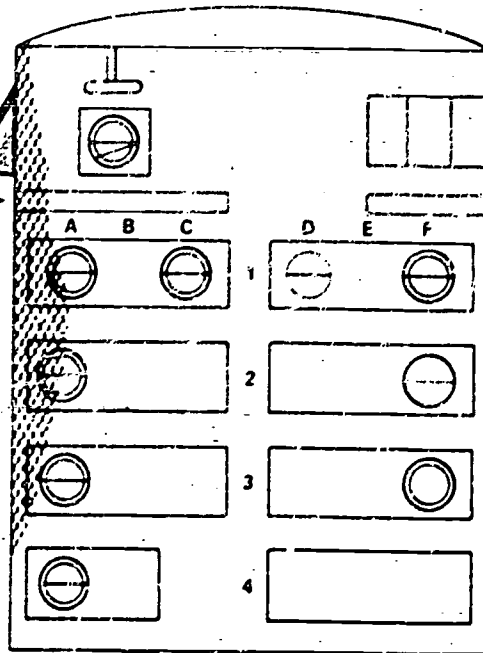
Row 1C
F-17, MAIS 2
Moderate concussion
Abrasions on head

Row 2A
F-18, MAIS 3
Open fracture of right tibia
Open fracture of left tibia
Closed fracture of left femur

Row 3A
M-15, MAIS 3
Closed head injury, unconscious more than 1 hour
Closed fracture of left femur
Contusion on the nose

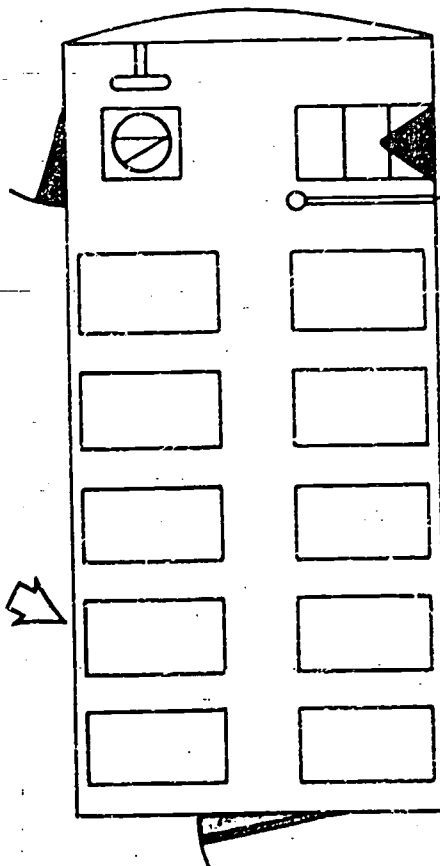
Modesty panel with lightly padded aisle stanchion and cross support; panel was bare metal.

All passengers were wearing lap belts; seating positions unknown. Injury status could be confirmed for only one passenger.

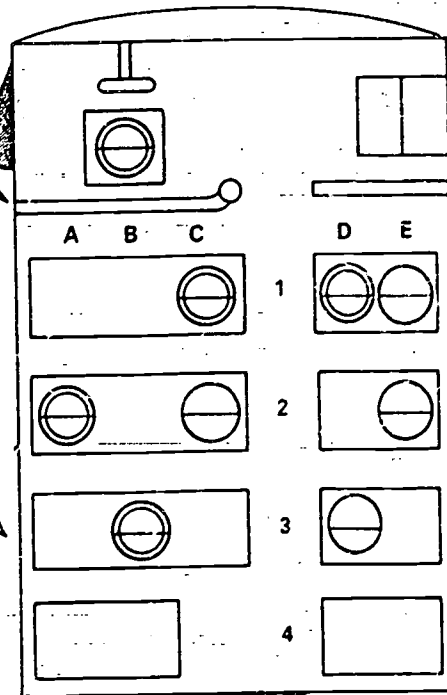
Driver
F-22, MAIS 2
Large facial contusion
Large contusion on abdomen
Contusion on left shoulder
Contusion on left elbow
Abrasion on right lower arm

Modesty panel with lightly padded tubular frame

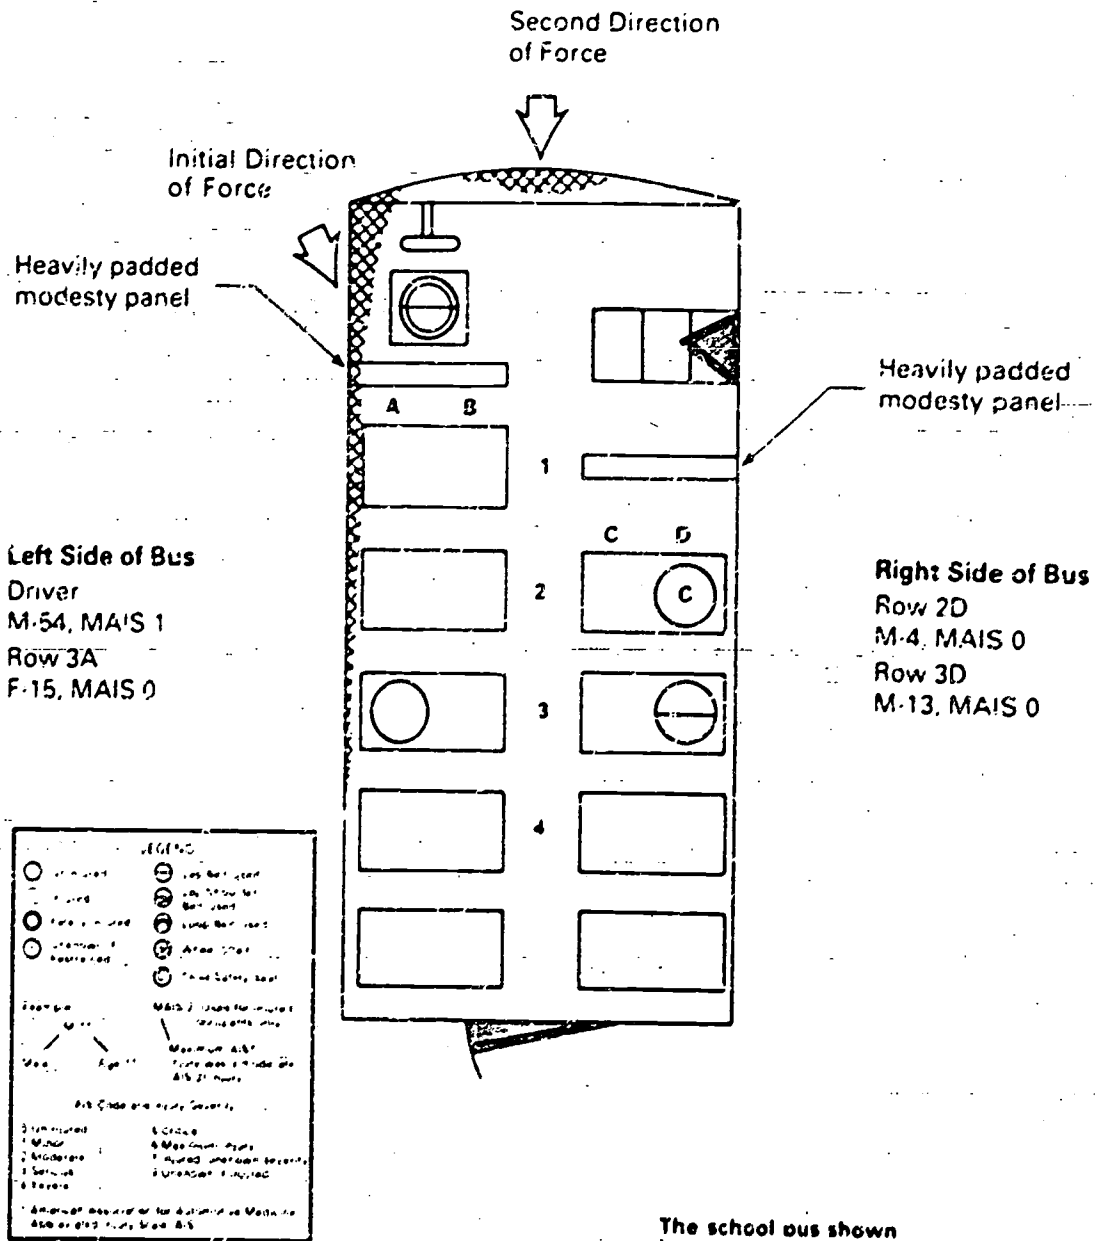
Williston, Vermont
Case Number 21

The lapbelts on this bus were an aftermarket addition by the school district. Safety Board investigators determined that the lapbelt used by the passenger in the second seat on the right side was installed and used improperly. The webbing with the buckle end was anchored to the wheel well instead of the floor. The wheel well was much higher than the floor, adding 9 inches of extra length and preventing the belt from properly fitting the child. To take up the slack, the driver had knotted the belt webbing. Had this collision been more violent, the knot might have caused an injury because the passenger would have "jackknifed" over the belt and the knot. The child safety seat was also secured with a knotted lapbelt.

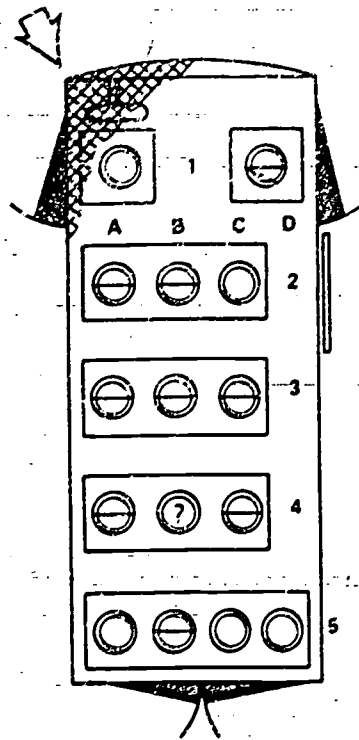
Driver
M-68, MAIS 2
Fracture of left knee
Fracture of five adjacent ribs on left.
Kidney injury, unknown severity
First degree burns on both hands, left forearm, lower back, and left thigh

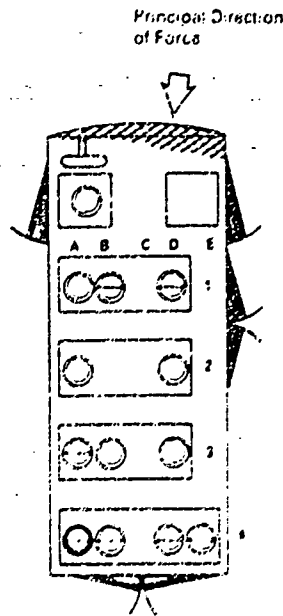
Row 3A
F-6, MAIS 3
Closed head injury
Bladder contusion
Fracture right iliac crest
Contusion - right hip
Contusion - left iliac crest
Abrasions - contusions - lower right leg
Contusions - lower left leg
Contusions - right hand
Contusions - left hand

Row 3B
F-6, MAIS 1
Row 3D
M-6, MAIS 1
Row 4A
F-6, MAIS 5
Cervical axial dislocation
Closed head injury
Laceration - small bowel
Laceration - colon
Subdural hematoma
Torn mesentery
Serosal tear
Subarachnoid hemorrhage
Retroperitoneum hematoma
Bilateral pulmonary contusions
Contusion - 6" x 6" - left hip
Contusion - left cheek
Contusion - lower pelvic area
Contusion - left arm
Contusion - lower left leg
Abrasion - lower right leg
Row 4B
M-6, MAIS 5
Severe brain stem injury
Subarachnoid hemorrhage
Bilateral fracture - iliac crest
Contusion with hematoma to forehead
Contusion - lower left abdomen
Contusion - lower right abdomen
Contusion - right ankle
Abrasion - right tibia area
Abrasion - left tibia area
Row 4D
M-6, MAIS 5
Spinal cord contusion
Perforation of small bowel
Subarachnoid hemorrhage - posterior fossa
Subarachnoid hemorrhage - cranial cervical junction
Contusion with hematoma - cecum
Contusion with hematoma - forehead
Abrasion contusion - lower abdomen

Row 4E
F-7, MAIS 7
Unspecified leg injury
Full depth laceration of tongue
Abrasion - right side of forehead
Abrasion - right side of face
Contusion - right side of pelvis
Contusion - left side of pelvis

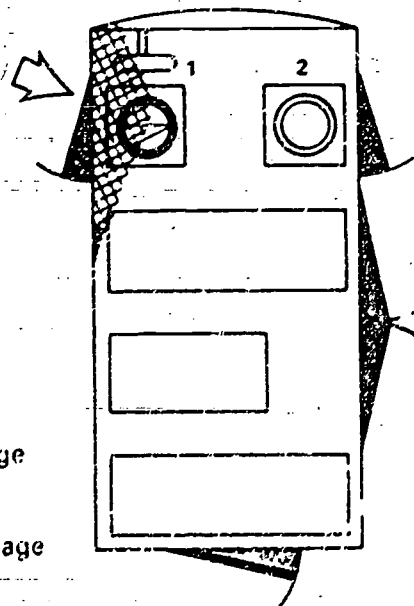
Bedford, New Hampshire
Case Number 27

Left Side of Van
Driver
F-40, MAIS 4
Subdural hematoma
(right cerebral)
Laceration of liver
Laceration of left kidney
Subarachnoid hemorrhage
Laceration of spleen
Collapsed left lung
Retroperitoneal hemorrhage
Fracture of right femur
Skull hairline fracture
(left temporal)
Skull hairline fracture
(right temporal)
Fractured pelvis (left ischium)
Fractured pubis
Fractured left 7th and 8th ribs
Fractured left tibia

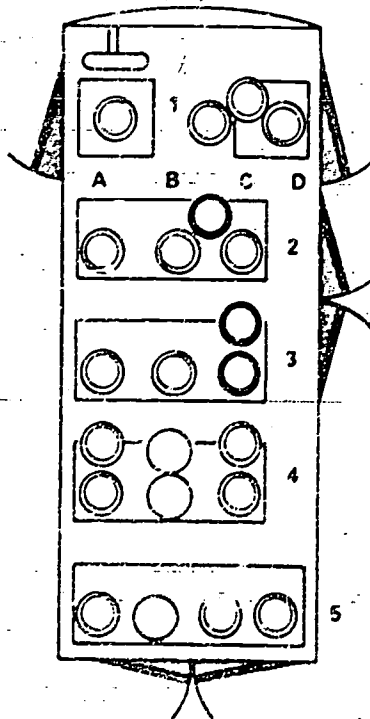
Odessa, Texas
- Case Number 28

- Driver
- M-20, MAIS 7
- Row 1B
- F-16, MAIS 1
- Row 1C
- F-9, MAIS 1
- Row 1D
- F-21, MAIS 1
- Row 2A
- M-18, MAIS 1
- Row 2B
- F-21, MAIS 1
- Row 2C
- M-32, MAIS 1
- Row 2 B C
- F-29, MAIS 7
- Specific injuries unknown
- Row 3A
- M-8, MAIS = 3
- Specific injuries unknown
- Row 3B
- F-11, MAIS = 3
- Specific injuries unknown
- Row 3C
- F-40, MAIS 7

- Row 3CX
- M-2, MAIS 7
- Row 4A
- M-13, MAIS 1
- Row 4B
- M-27, MAIS 0
- Row 4C
- M-11, MAIS 1
- Row 4AX
- M-6, MAIS = 3
- Specific injuries unknown
- Row 4BX
- M-3, MAIS 0
- Row 4CX
- M-4, MAIS 1
- Row 5A
- M-11, MAIS 1
- Row 5B
- M-17, MAIS 0
- Row 5C
- M-14, MAIS = 3
- Specified injuries unknown
- Row 5D
- M-12, MAIS 1
