TITLE A Guidebook to FEMA 154--Rapid Visual Screening of Buildings

for Potential Seismic Hazards. A Handbook for Use in the

Screening of School Buildings.

INSTITUTION Building Technology, Inc., Silver Spring, MD.

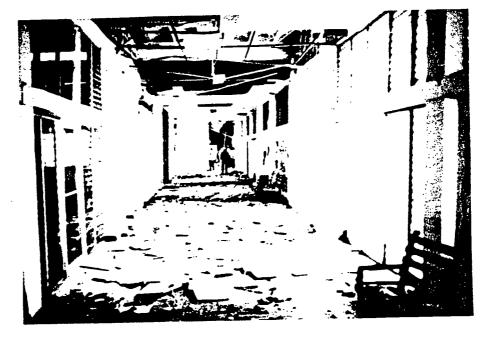
FIGURE 25
Blocked egress
route.

Safe, direct, unobstructed exit routes should be planned so students and teachers can safely exit a school. Lockers, ceiling systems, lighting systems, ventilation systems, and windows that enclose these routes must be designed as critical components and be located so that their failure will not impede egress (Figure 25).
