# Better School Buildings for Less Money:

## A Report of A Survey of 50 Pennsylvania School Buildings

Pennsylvania Department of Education 1973

# Better School Buildings for Less Money

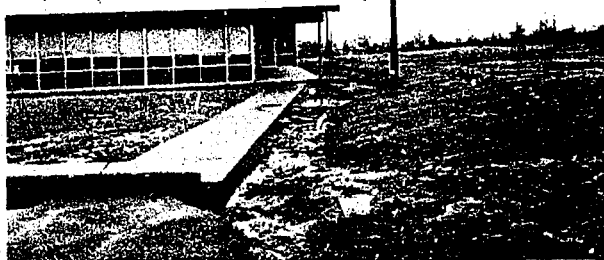
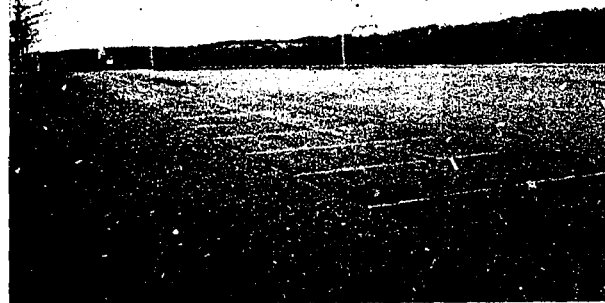
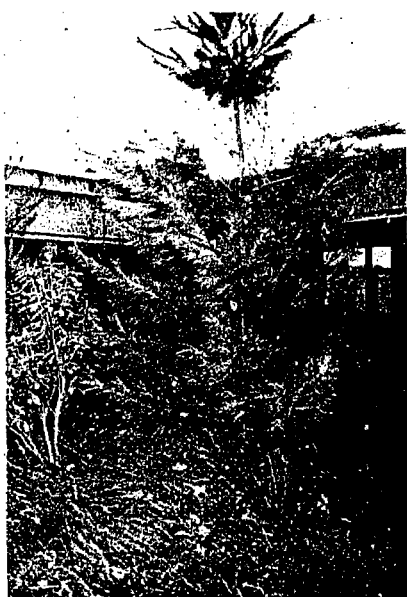
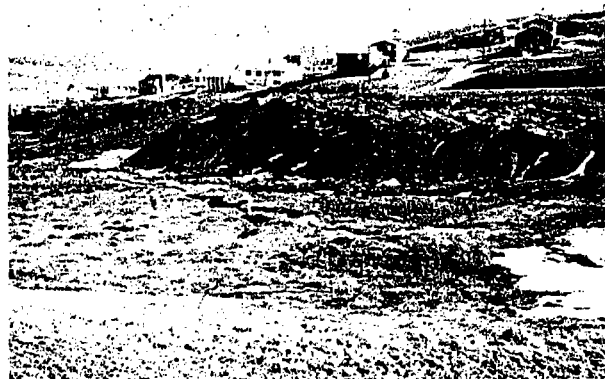
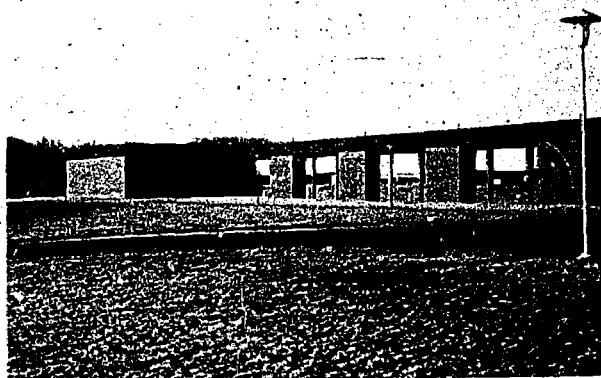
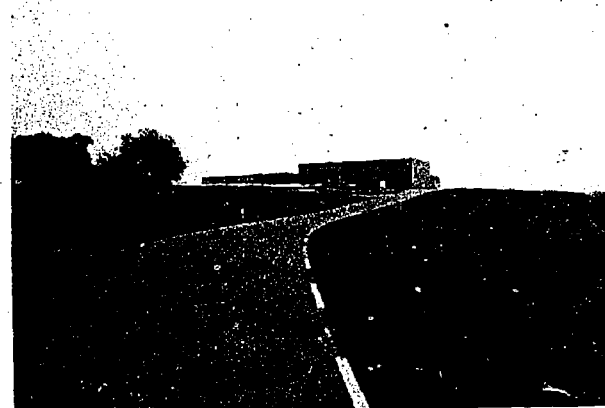
SITE DEVELOPMENT

POOR DRAINAGE, EXCESSIVELY LONG ACCESS ROAD, GENERALLY UNUSED PARKING AREA

**Sites:** A few sites were improperly located or too small. Sloping parking and play areas were less than satisfactory during winter weather. Poor drainage was a problem on some sites, because water was directed toward the building. Delivery trucks and buses crossed play areas in some cases. One school had the play area located across a dangerous highway. (Page 13 illustrates some of these conditions.)

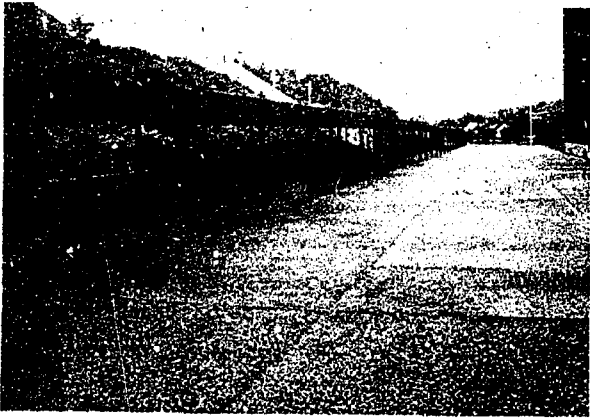
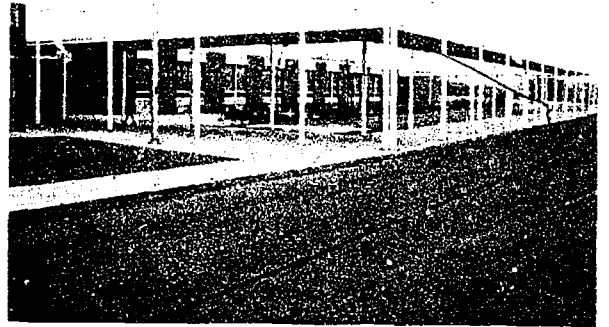
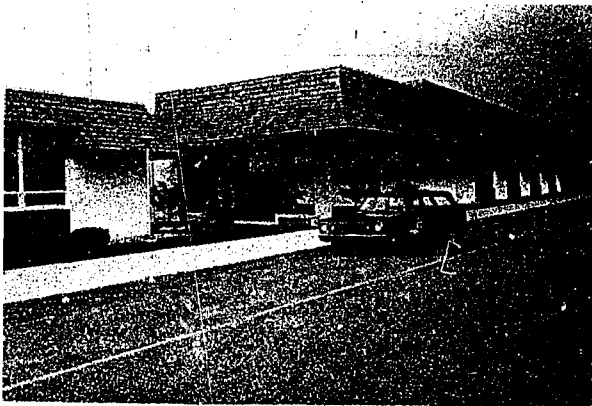
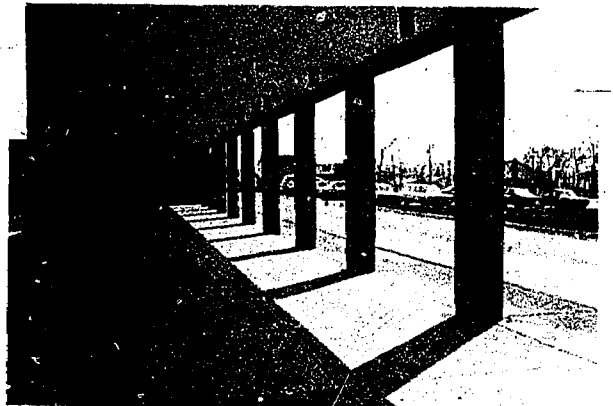
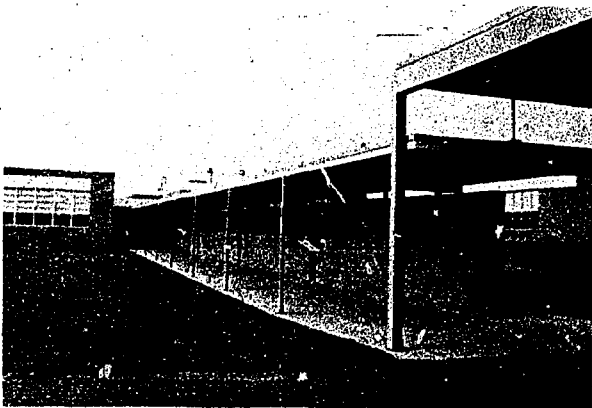
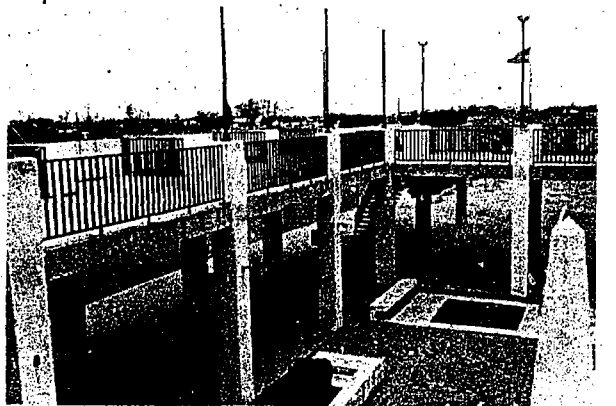
BUS CANOPIES AFFORD INSIGNIFICANT PROTECTION AND POSE AN EXPENSIVE MAINTENANCE PROBLEM.

Bus canopies: Almost without exception, the bus canopies observed during the survey represented unjustified expenditures of money that could have been more usefully expended elsewhere. Too often, it appears that the primary purpose of these appendages is aesthetic enhancement of the building. In many cases, because they are too high or narrow, they actually afford little protection from windblown rain or snow. Further, because their intent is, perhaps, as much aesthetic as functional, bus canopies are constructed in such a way and of such materials that they are perpetual and costly maintenance problems. (page 15)

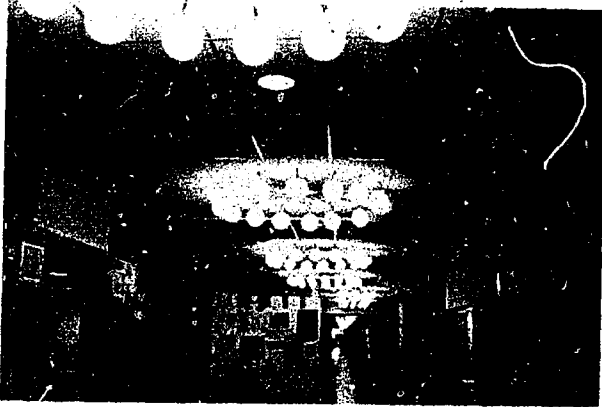
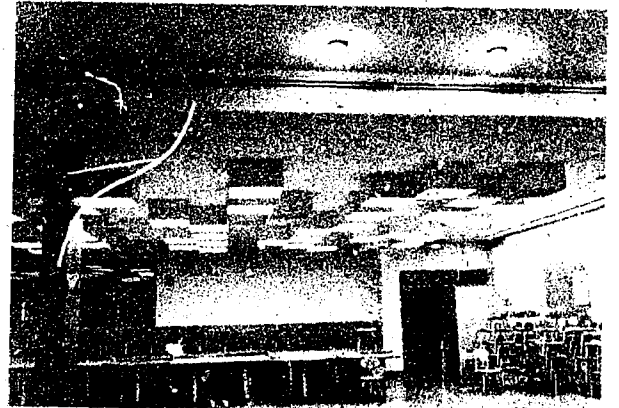
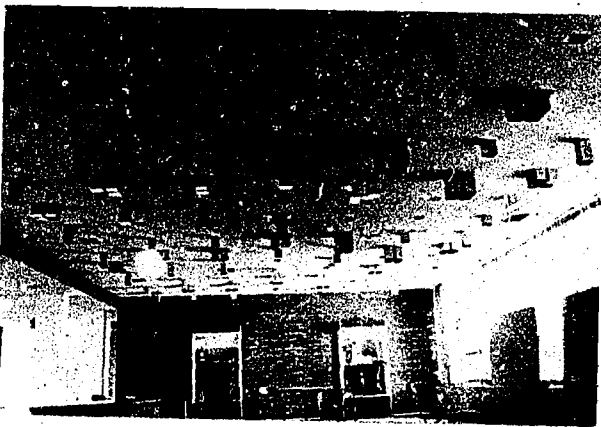
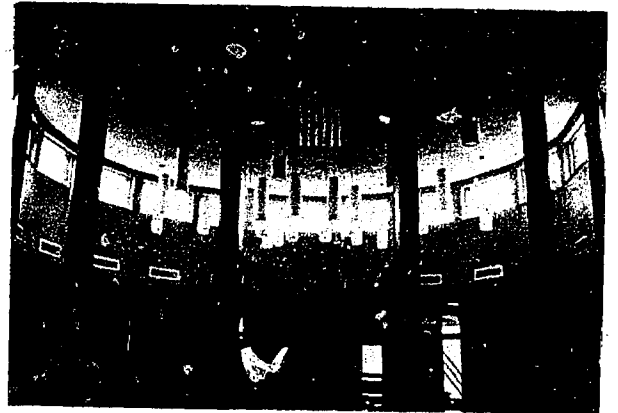
DECORATIVE LIGHTING FIXTURES

ENTRANCEWAY, LOBBY, CAFETERIA, AND LIBRARY

high schools; they are not needed for the types of productions staged in elementary, middle or junior high schools. If included in these types of facilities, such lighting systems are an unwarranted expense. Interior lighting appeared to be more expensive than necessary in several buildings (page 17).

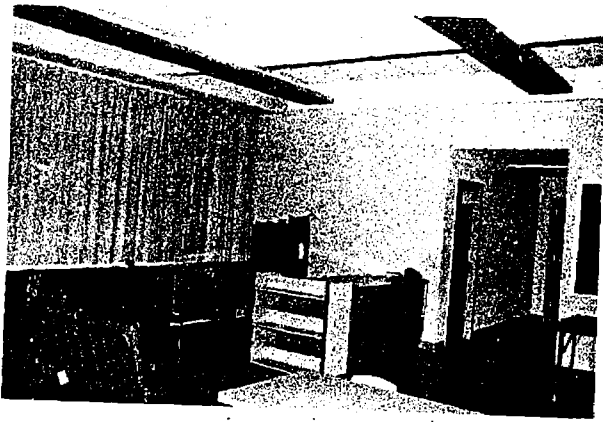
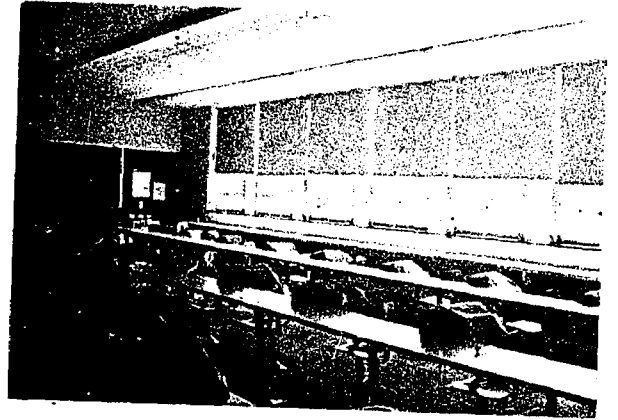
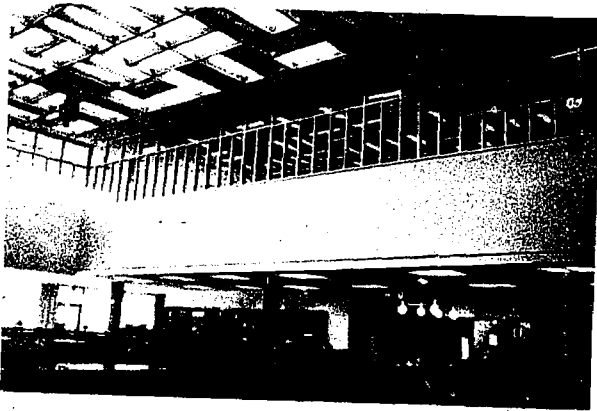
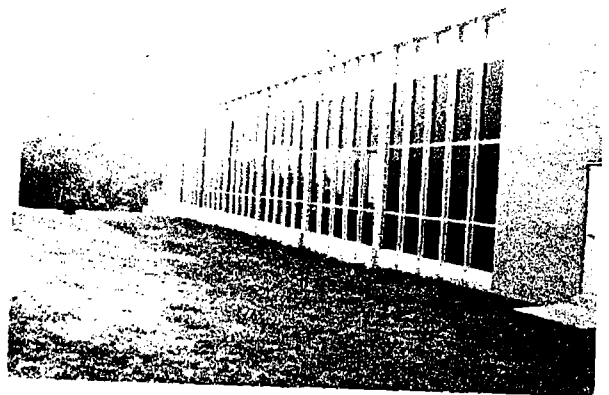
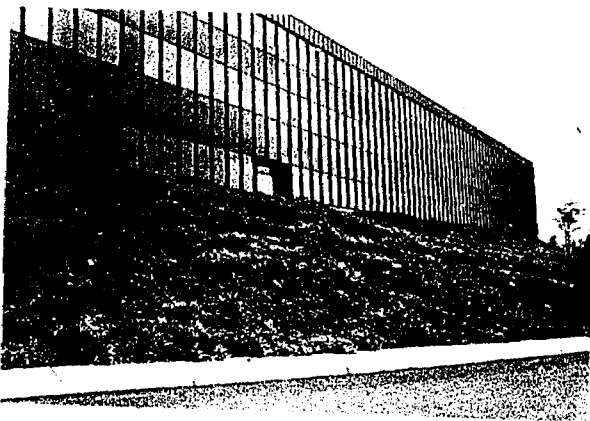
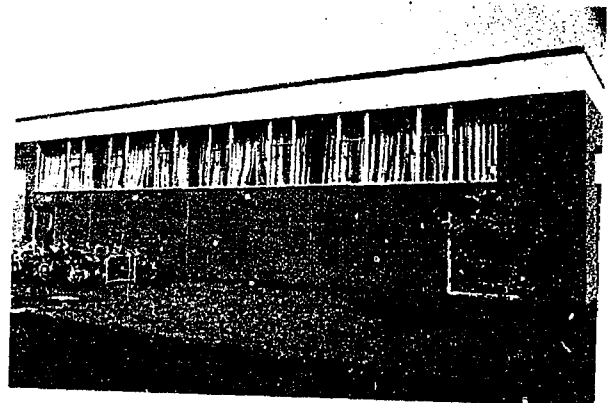
EXCESSIVE WINDOWS

CLOSED SHADES AND DRAPERIES DRAWN TO REDUCE SOLAR HEAT, OPPOSE NATURAL LIGHT AND MAKE ARTIFICIAL LIGHTING NECESSARY

**Excess fenestration:** Modern climate control technology makes it possible to construct buildings with a minimal amount of window space. The results of the survey indicate that this should be done. There were many problems mentioned with respect to excess window space in the buildings observed. A major one was the sometimes severe discomfort caused by solar heat and glare during early fall and late spring. At these times of the year, excess window space makes the creation of an optimum learning environment extremely difficult (page 18).

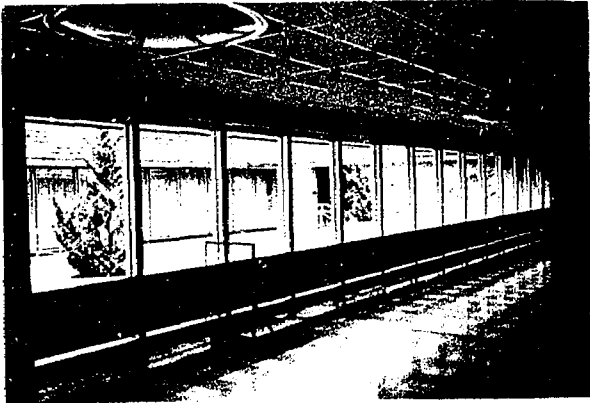
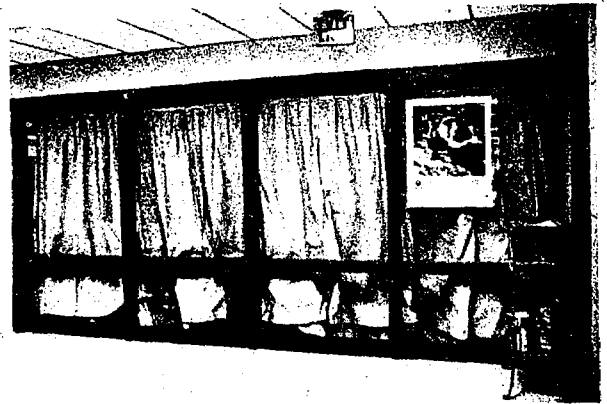
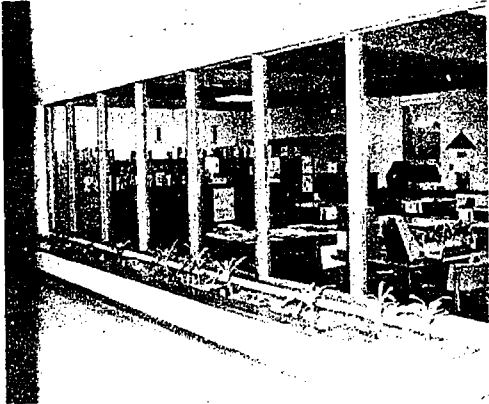
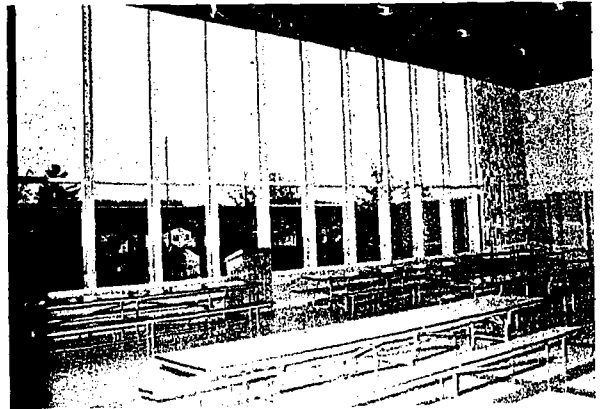
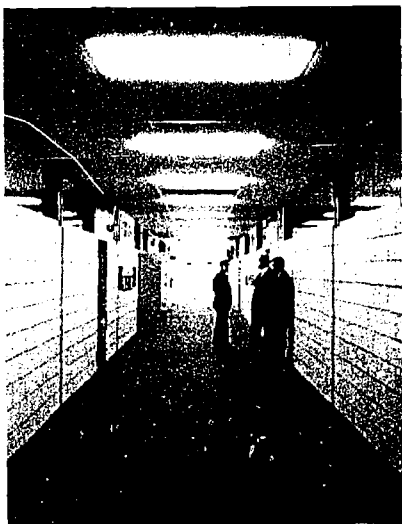
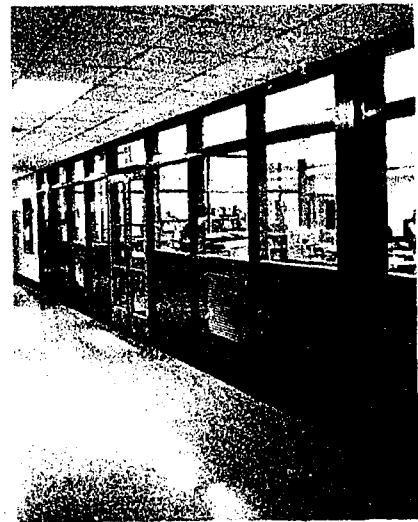
LARGE GLASS AREAS

EXTERIOR AND INTERIOR WALLS

In addition, windows are a natural target of pranks and vandalism and must be cleaned frequently. The cost of replacement and maintenance over the life of the building represents a significant financial outlay. Purchasing window shades and maintaining shades add to the expense (page 19).

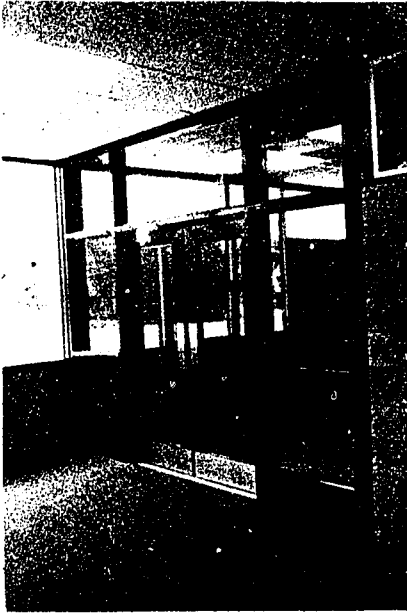
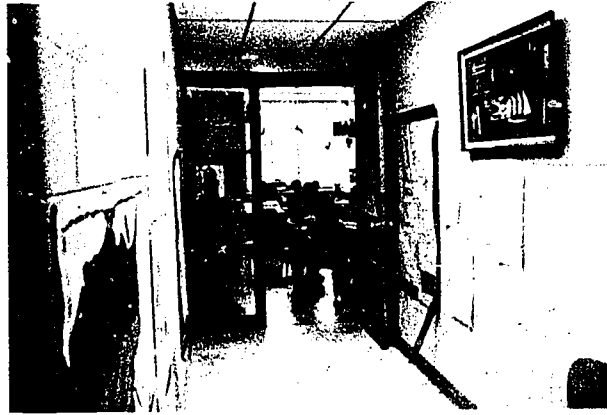
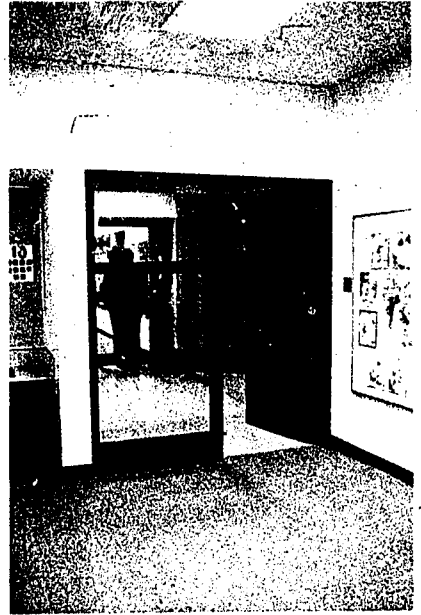
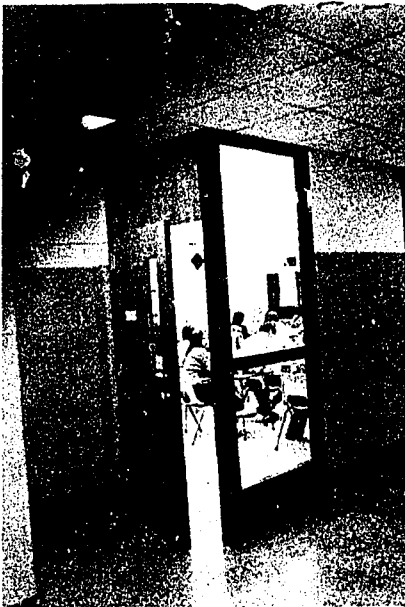
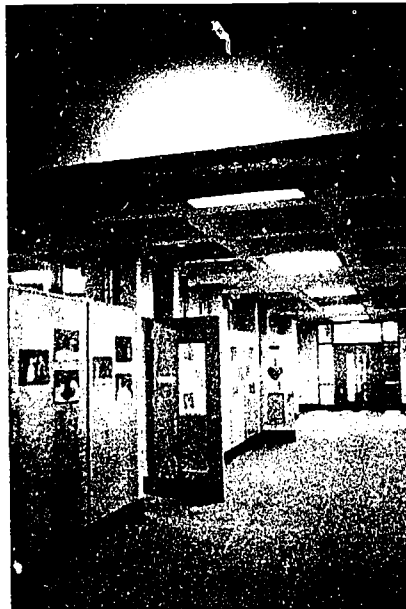
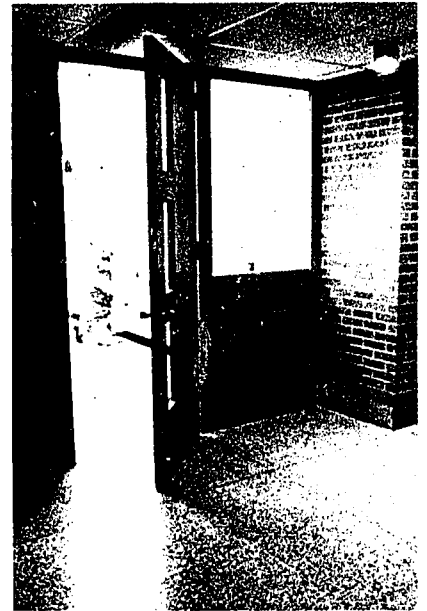
DOOR UNITS WHICH COULD BE ELIMINATED

CLASSROOM AND HALLWAY DOORS

**Classroom doors:** In a majority of the buildings visited, the evaluation team concluded that the doors to classrooms are in many cases unnecessary. In the normal course of instruction in many schools, the classroom doors are not closed. This is particularly true where carpeting is used as a floor covering, but also true in uncarpeted, acoustically efficient buildings. With adequate planning and designing, it would be quite possible to construct a school without classroom doors, except on those rooms where they were needed for security purposes. While the savings per door which would result from this would seem to be insignificant, when multiplied by the number that could be eliminated across the state, it no longer appears so. (Page 21 illustrates doors in various positions.)

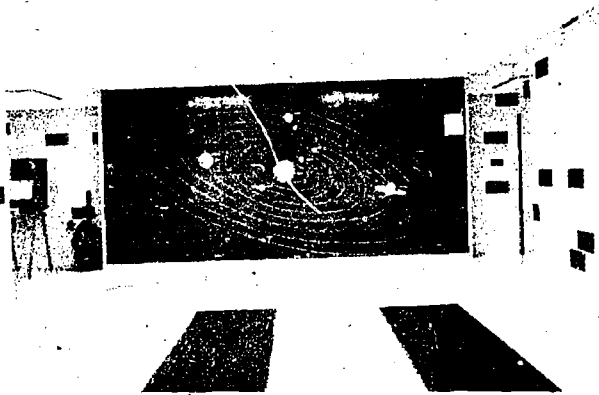
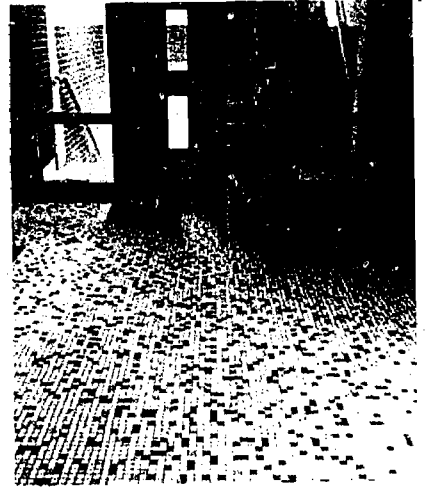
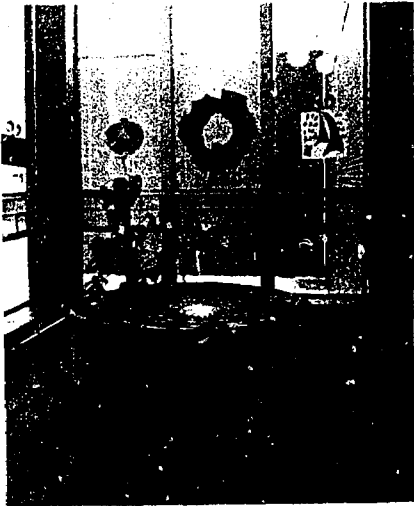
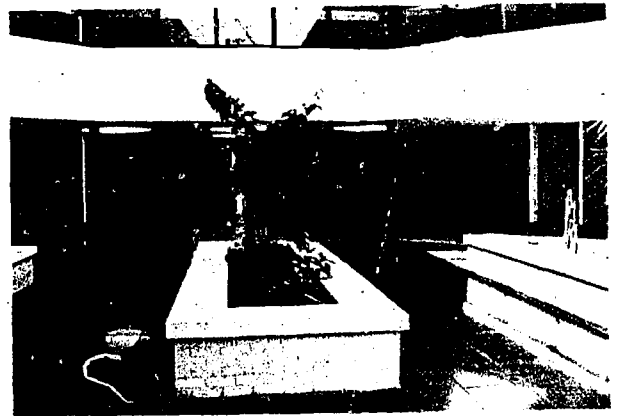
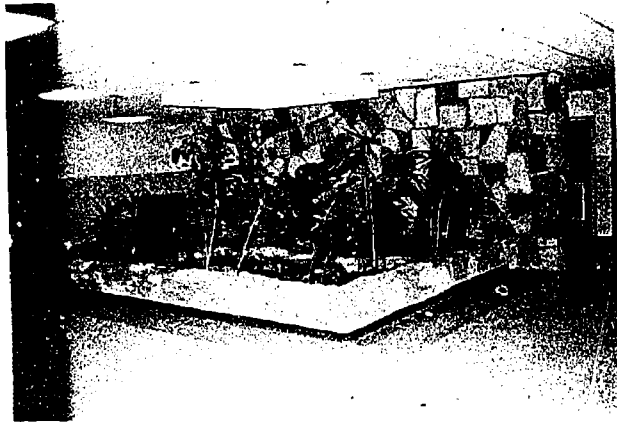
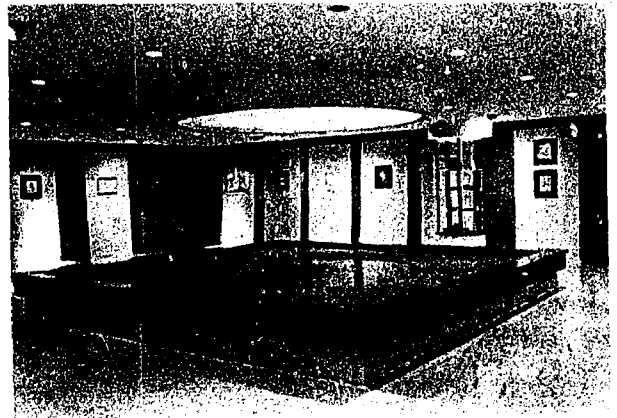
DECORATIVE INTERIOR FEATURES

PLANTERS, FISHPOND, FOUNTAIN, DECORATIVE FLOOR AND WALL DESIGNS

**Excessively elaborate entrance foyers and lobbies:** Aesthetic rather than functional considerations appeared to have been primary in the design of these areas. Fish ponds, spraying fountains, chandeliers, mosaic tile murals, planters and the like were observed in many of the buildings surveyed. The significance of these things to the educational program conducted within the building is certainly questionable. Money

spent for the aesthetic dressing of these areas could have been saved or used in places where a significant contribution to the instructional program was assured. (Page 23 illustrates these features.)

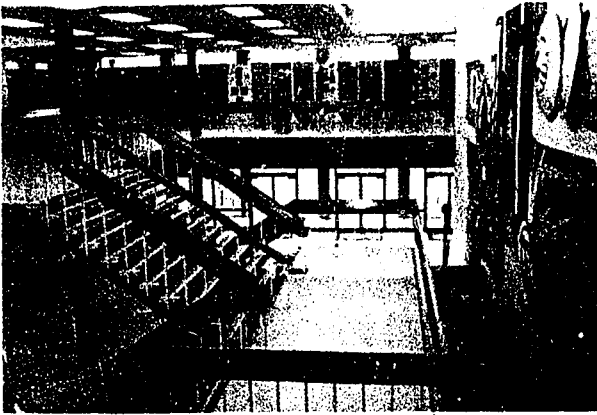
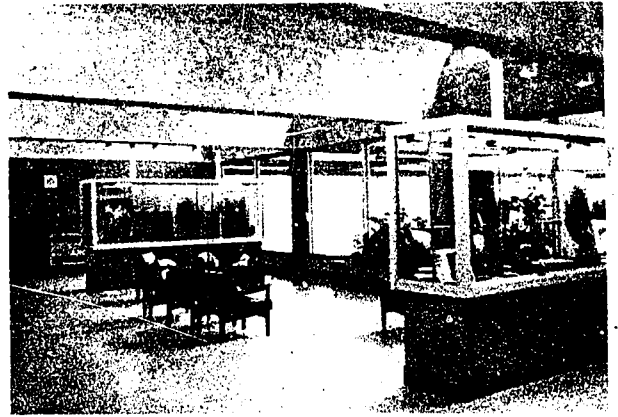
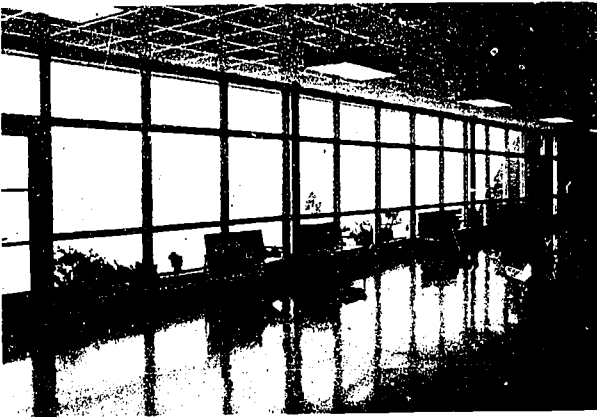
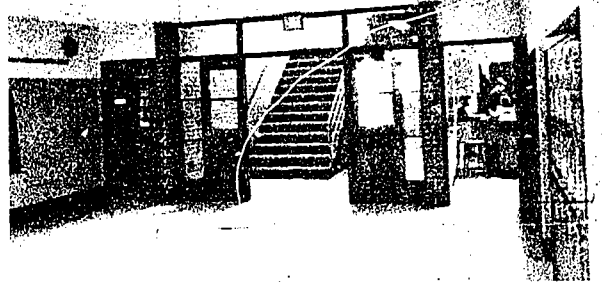
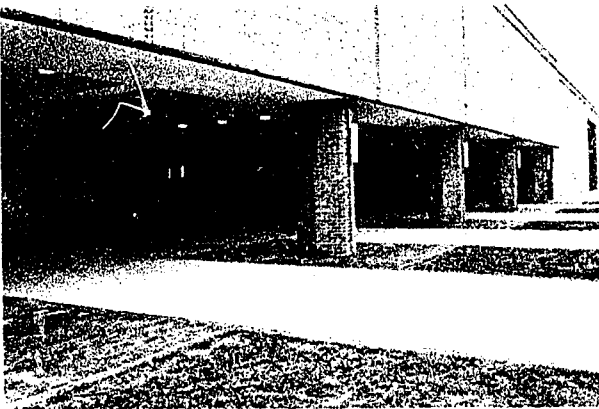
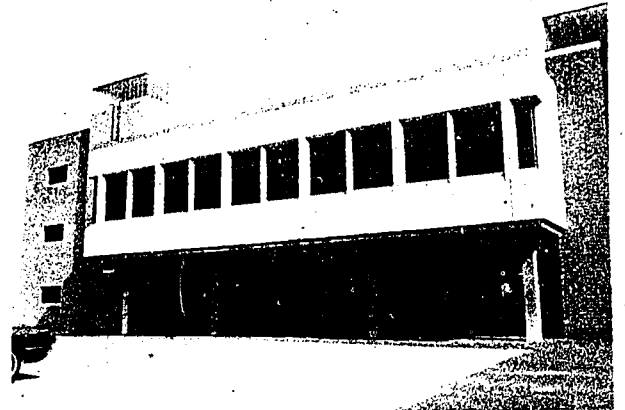
LARGE OPEN SPACES

DEEPLY RECESSED DOORWAYS, OVERSIZED CORRIDORS, STAIRWAYS AND LOBBIES

**Inappropriately sized stairwells and corridors:** In many of the schools surveyed, inappropriately sized stairwells and corridors were observed. If too narrow, these are potential safety hazards and impede efficient traffic flow in the building; if too wide, and this was more often the case, they preempt costly space that could be used for other purposes.

Another observation noted during the survey concerning these areas was that often they were too large and profligate of costly space. In several of the buildings observed, these areas served multiple functions--as entrance lobbies, student commons area, auditorium and gymnasium lobbies. In these buildings the use of the large spaces could be justified. However, in many cases this was not true. The entrance foyers and lobbies were purely that and nothing more. Consequently, many times valuable space was purchased, but not effectively used. (Page 24 illustrates large open spaces found in several schools.)

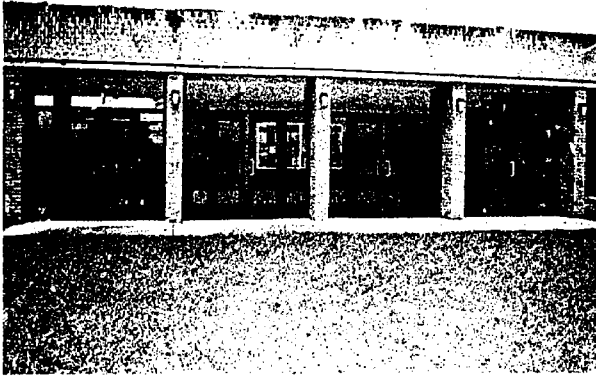
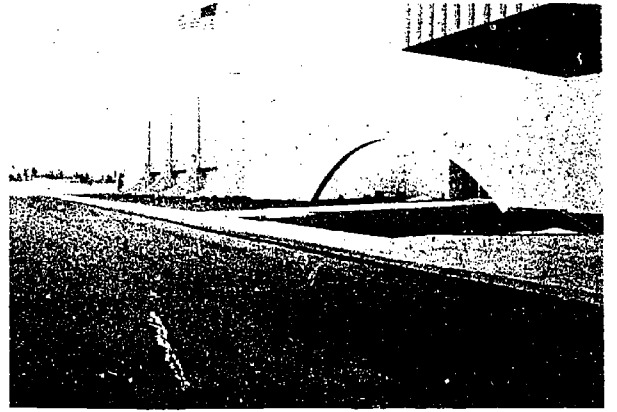
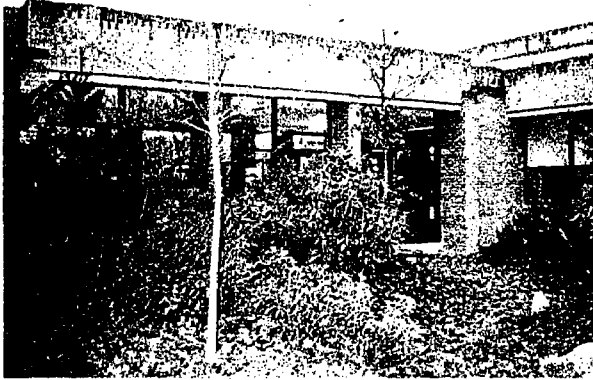
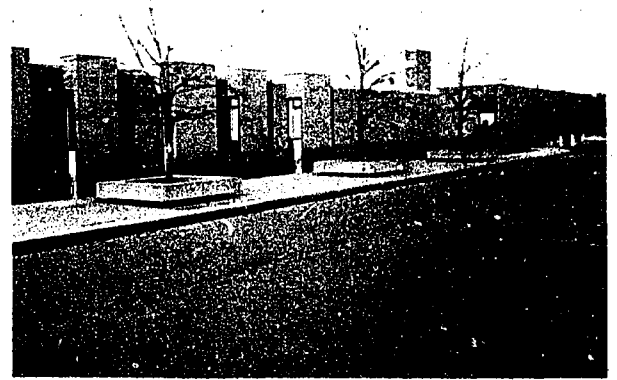
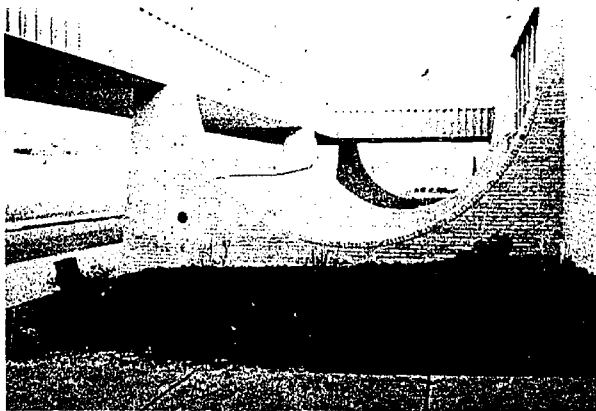
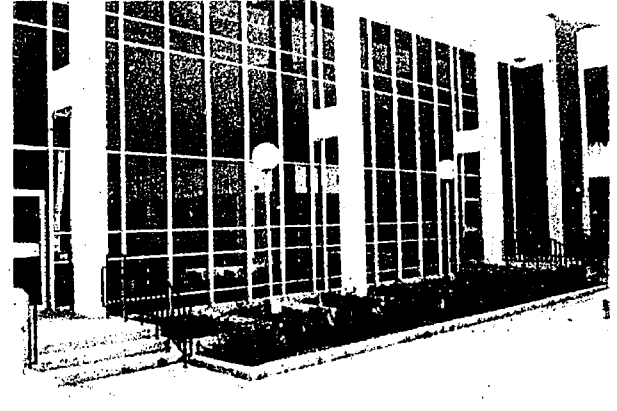
EXAMPLES OF UNUSUAL EXTERIOR DESIGN

EXIT DOORS, ARCHWAY, COURTYARD, WALKWAY, IRREGULAR CONFIGURATIONS

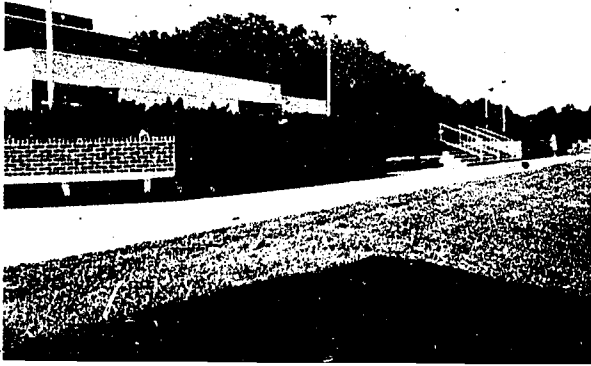
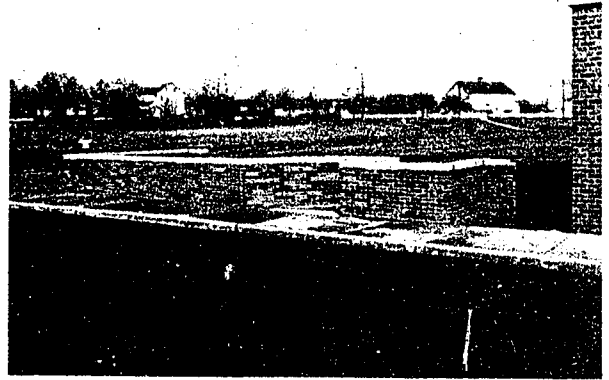
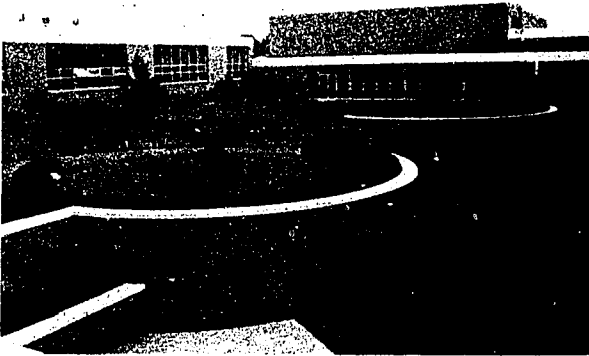
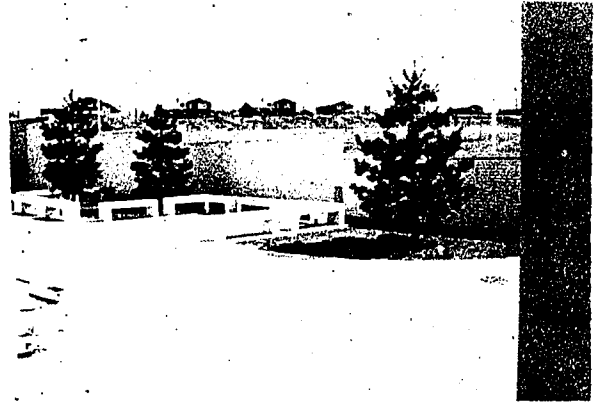
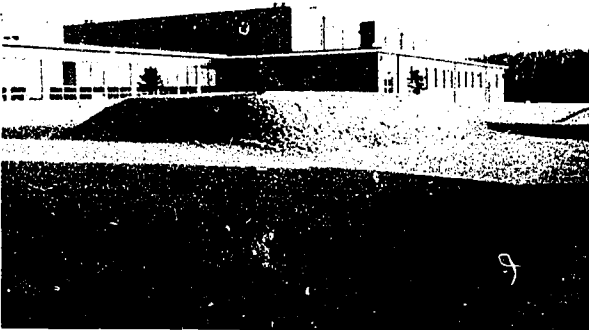
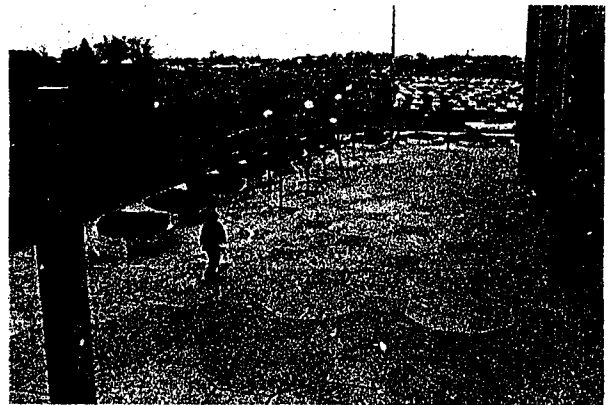
SPECIAL SITE TREATMENTS

MOUNDS, PLANTERS, FREE-STANDING BRICK WALLS AND RETAINING WALLS

The visitation team observed such things as graded, grass-covered mounds in front of buildings, massive precast concrete benches and balconies, free-standing brick walls, terraces, elaborate decorative lighting, decorative cedar shake facades and so on (page 28).

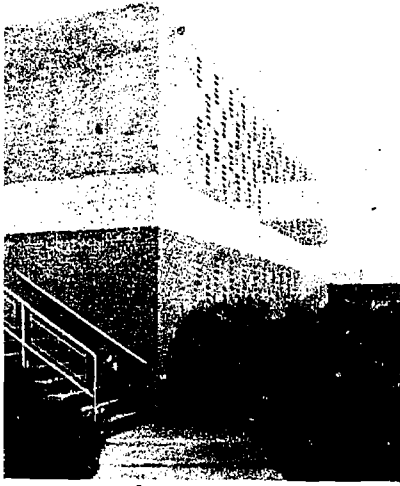
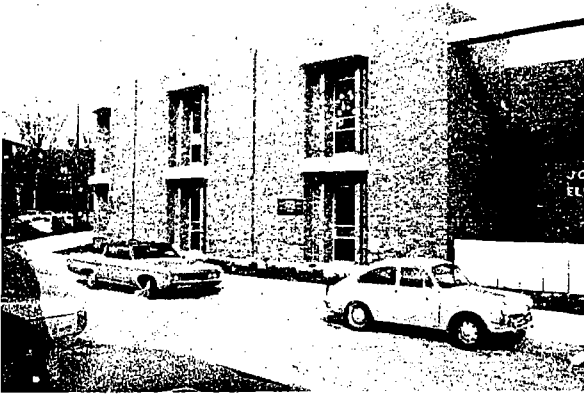
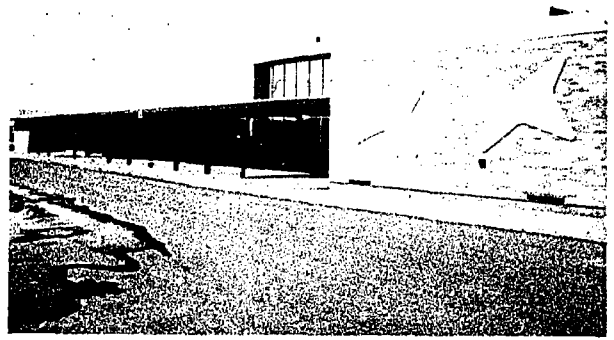
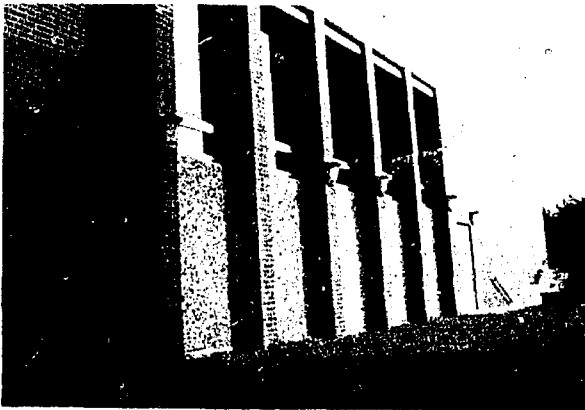
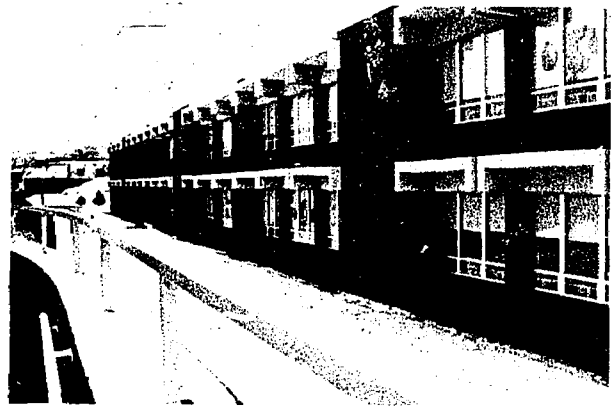
NONESSENTIAL EXTERIOR TREATMENTS

SUN SHADES, WALL DECORATIONS, AND DECORATIVE STRUCTURAL DESIGNS

Sun shades above windows: In most instances where sun shades above the outside of windows were observed during the survey, they were ineffective. It appeared, again, that the purpose of these was more a decorative than functional one since none protruded far enough from the building to shield much of the room inside from the sun's rays. Further, the type of material used in their construction, such as precast concrete, pebble block, cedar shakes, etc., made them a potentially costly maintenance problem (page 30).

If windows are necessary, it would appear to be more economical and much more effective to screen the sun through the use of tinted window glass.

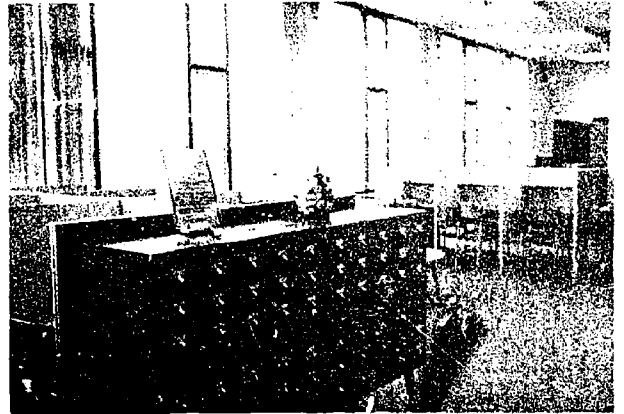
UNUSABLE WALL SPACE IN LIBRARY

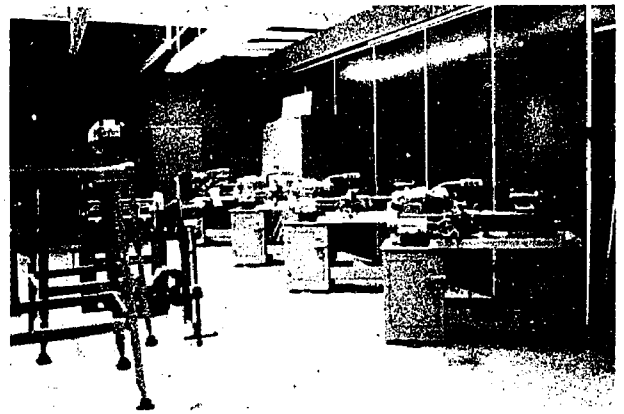
INAPPROPRIATE USE OF FOLDING PARTITION

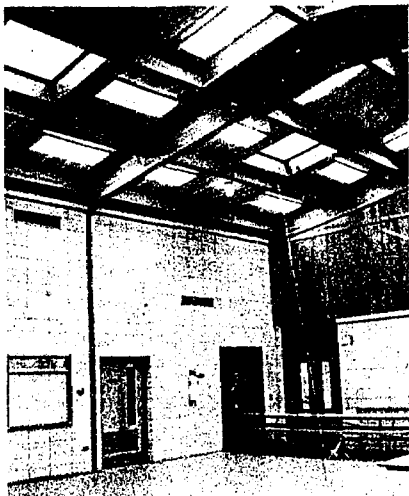
INAPPROPRIATE CEILING AND STRUCTURAL MATERIAL

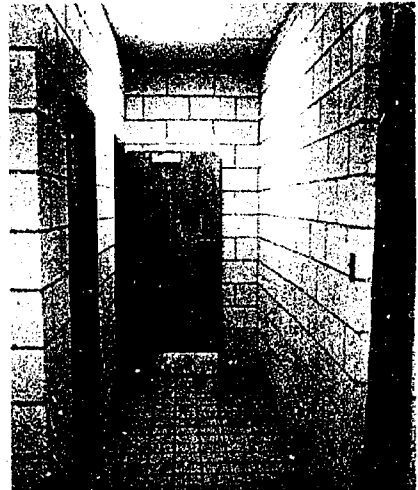
UNNECESSARY DOOR
