Accessible Elementary Schools

A Renovation Planning And Design Manual

By Peoples Center For Housing Change

March, 1981

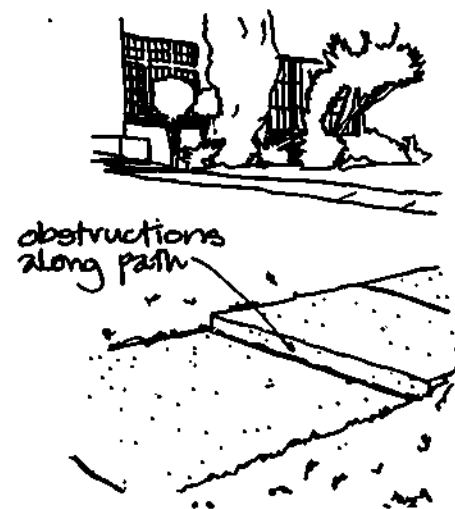
Obstructions on Circulation Paths

Narrow circulation paths are difficult for wheelchairs to use because there may not be enough room for two wheelchairs to pass each other, or to allow turning maneuvers. Circulation paths which have loose or uneven surfaces, such as sand or cobblestone, require wheelchair users to exert a great deal of effort to move across them. Similarly, carpets which have high or loose pile, such as shag carpets, or which have soft cushions underneath are difficult to maneuver in wheelchairs. Finally, paths with abrupt changes in levels are obstructions to wheelchair users.

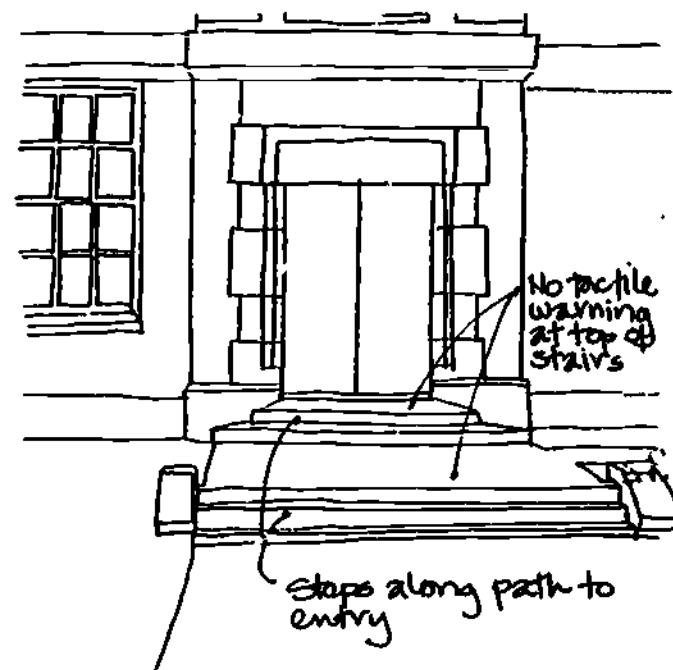
Stairs at Entries

Stairs, either inside or outside of entries may prevent many disabled children from participating in school activities because of the difficulties getting into the school buildings. If the only entries without stairs require that the disabled children have to enter the school through basements, kitchens, or mechanical rooms, then, not only are those children even more likely to be singled out from their classmates but they are also subject to possible injury from hazards in those areas.

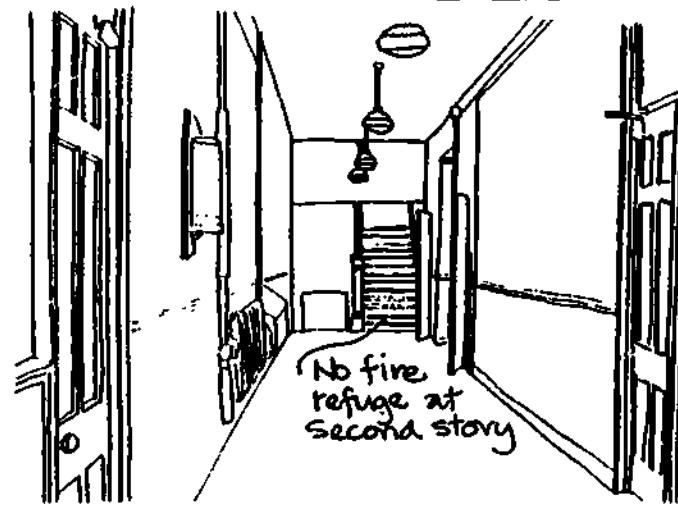
Inadequate Fire Safety Provisions

In multi-story buildings where there are elevators for access to upper floors, there is usually no provision for a fire protected area near the stairway. This is needed since an elevator is not acceptable as an emergency means of egress.

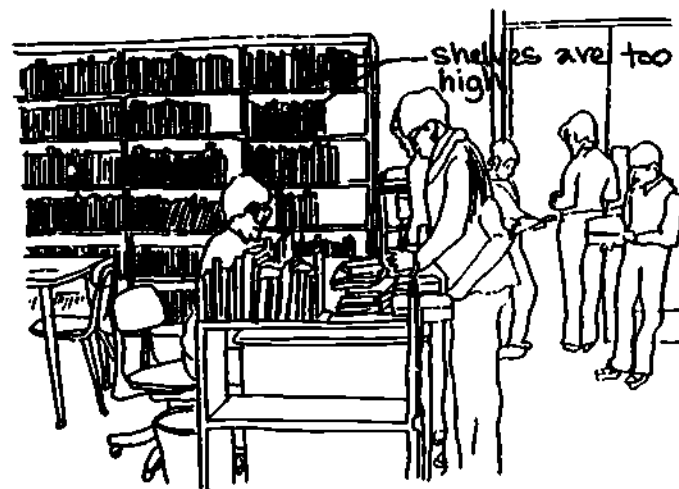
Limited Access in Libraries

Furnishings cause the most significant impediment to disabled children's use of libraries. High bookshelves are not within the reach of almost all elementary school children. Aisles between shelves are sometimes too narrow for wheelchairs to use. When there is no clearance under card catalogs and check-out counters, children in wheelchairs cannot make forward approaches to them.

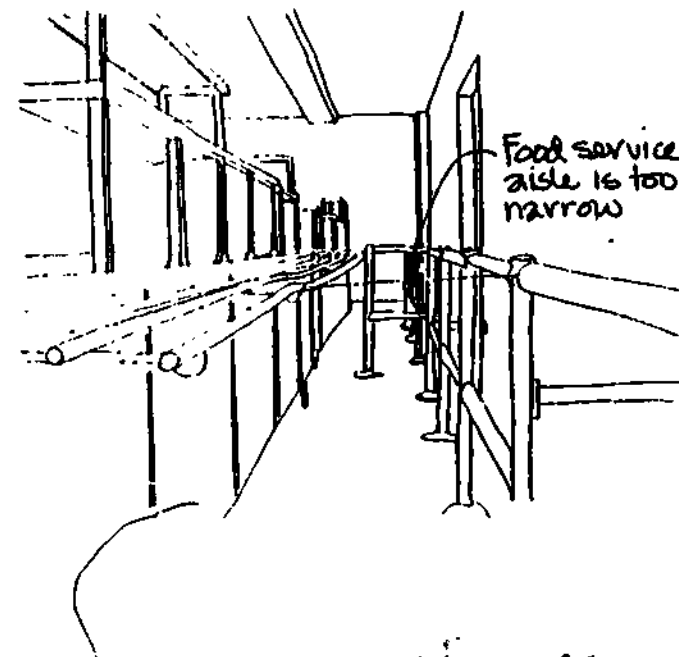
Inconvenient Cafeteria Seating and Lunch Lines

Most cafeteria table seating consists of long benches which are attached to tables. In order to sit at these tables one has to first climb over the bench; a difficult task for most semi-ambulatory children. Lunch lines are usually too narrow for wheelchairs to pass through and the reach for food service can be both too high and too far.

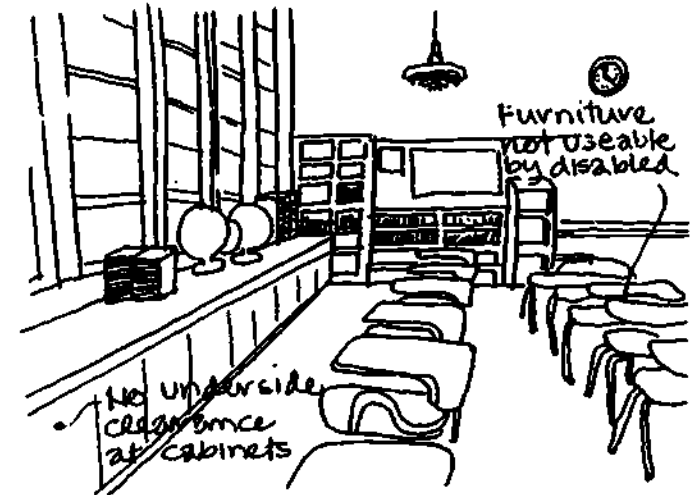
Inadequate Furniture and Cabinetry

A great deal of school furniture is not useable by disabled children. For example, tables and desks with insufficient underside clearance or which have built-in seats. Built-in seating is also difficult to use by some semi-ambulatory children. Lift-up desk tops cannot be used by some children with motor control impairments. Counters in offices and classrooms are often too high and do not have underside clearance.

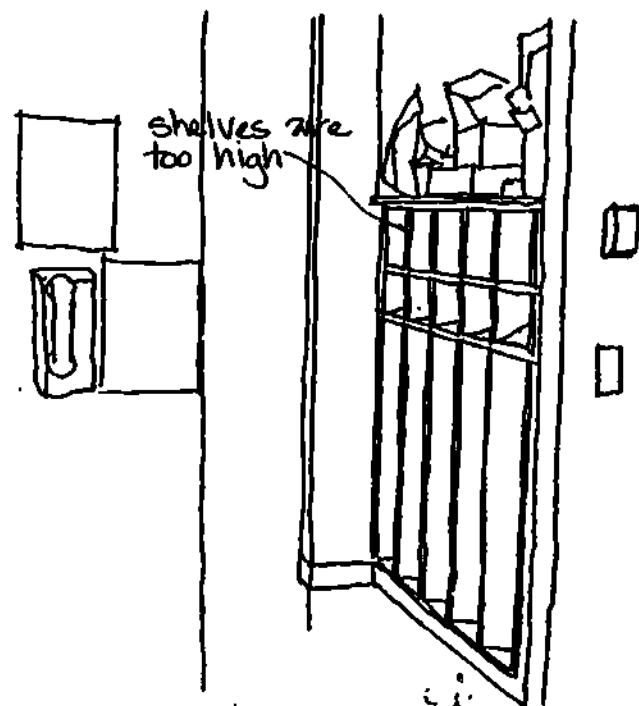
Inadequate Lockers and Locker Room Facilities

Often, locker room facilities are not easily useable by disabled children. Aisles are often too narrow for wheelchairs. Combination locks and thumb-latches on locker doors are difficult for children with motor coordination problems to operate. Locker stalls are usually narrow and, if adjacent ones are being used at the same time, there may not be enough space for disabled children to approach their own lockers. Hooks and shelving are frequently out of reach of disabled children. Toilet facilities are usually not accessible. When there are curbs in front of showers, they are not useable by many semi-ambulatory children and those in wheelchairs.

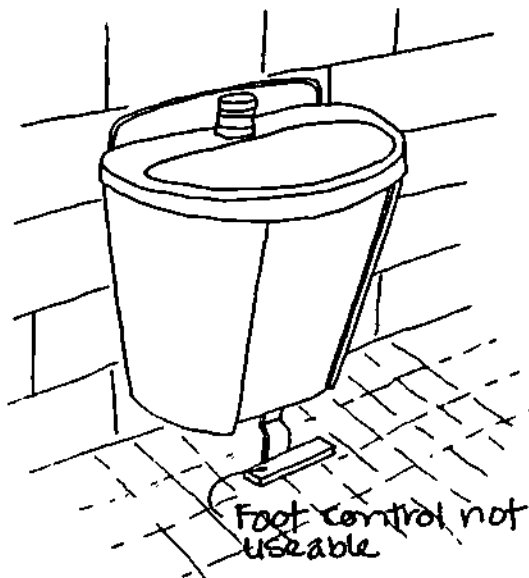
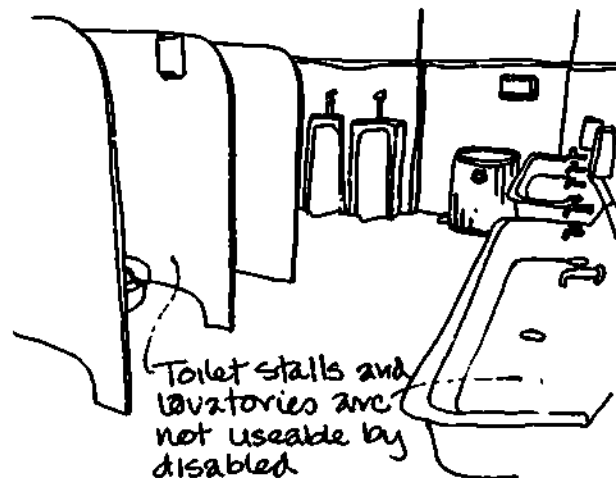
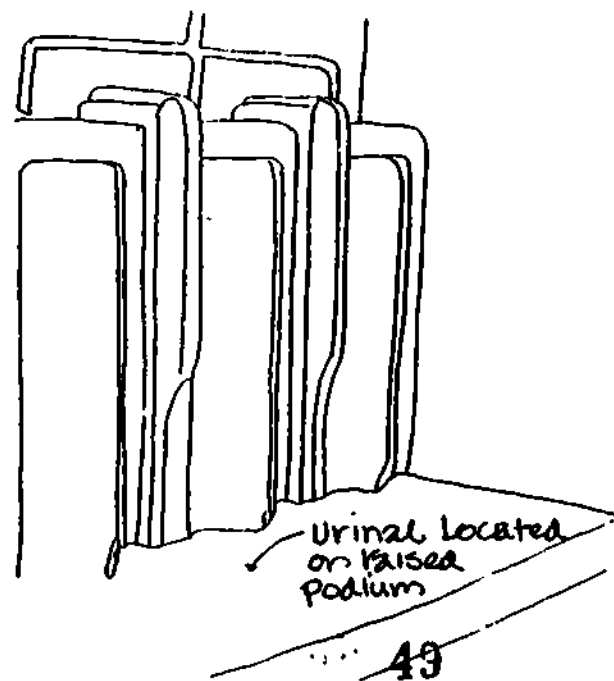
Inadequate Toilet Facilities

In most schools, toilet stalls are not useable by disabled children because the toilet is mounted too high, there are no grab bars and paper dispensers are difficult to use. There usually are no stalls which are large enough for an aide to accompany and assist a child. Traps under lavatories prevent wheelchair users from making a forward approach. Knob-type lavatory controls requiring the twist of the wrist are difficult to use. Mirrors and dispensers which are mounted too high are not easily used by children in wheelchairs. Often, toilet room lights are left off and due to the height of the switch a child in a wheelchair will not be able to turn the lights on. Some fixtures are only operable by foot controls. These are impossible for non-ambulatory and many semi-ambulatory children to use.

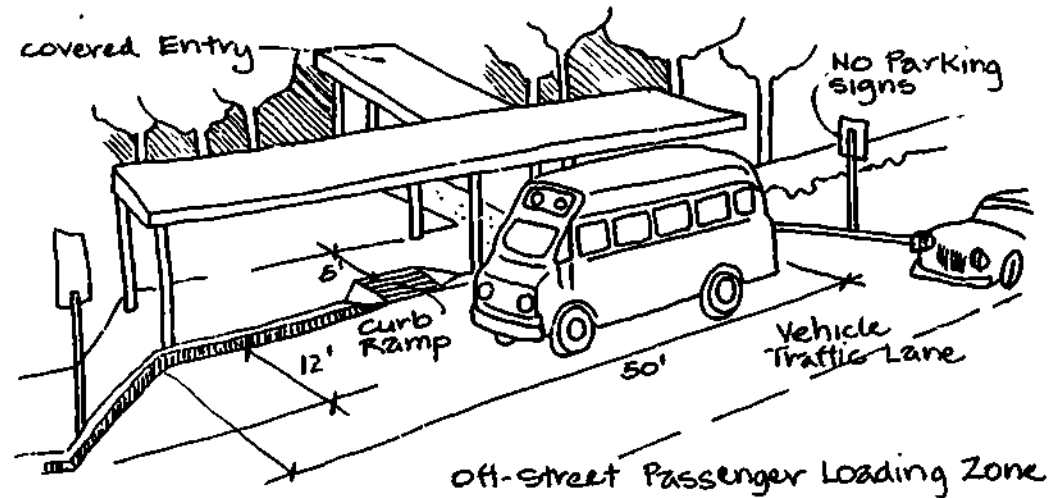
PASSENGER LOADING ZONE

Since most disabled children are brought to school by bus or auto there should be a safe drop-off zone located near the main entrance which has weather protection if necessary.

A passenger loading zone should be at least 12' in depth and no less than 50' in length (this is based on a parallel parking scheme). The cost of a zone is between \$1700 and \$3000 as noted in Action Alternative 1b.

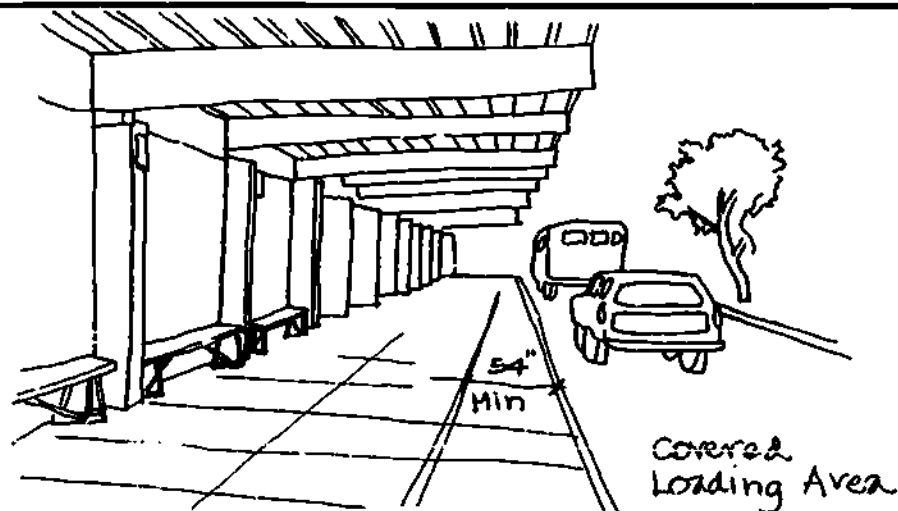
Covered Loading Area

6 If weather protection for the loading zone is required:

The shelter should be of sufficient width to cover the minimum area of 54". Supports should not present a hazard to circulation. The cost for a metal framed canopy with steel supports and built-up roof ranges between \$5-\$8/SF.

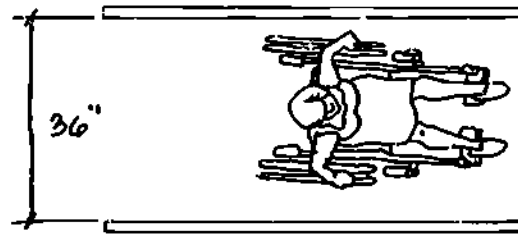
Minimum Path

Accessible paths are essential to provide mobility to disabled children. A path must be sufficiently wide, have a safe surface, and be free of projecting objects that might be dangerous.

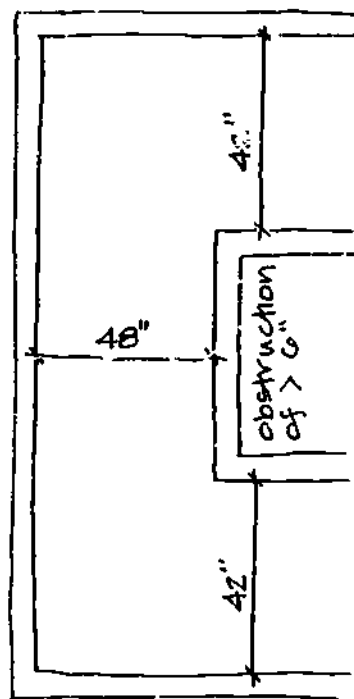
87A Turn Around an Obstruction

9 If there is not sufficient space to permit wheelchairs to complete 180 degree turns on dead end paths:

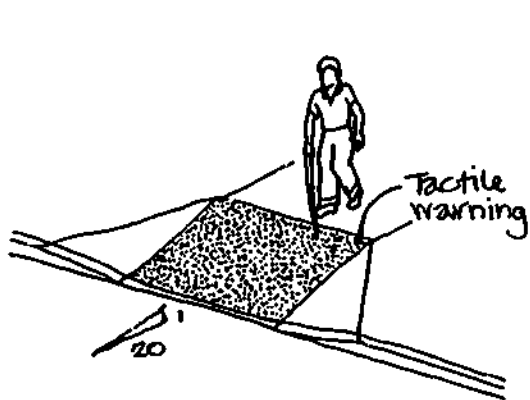
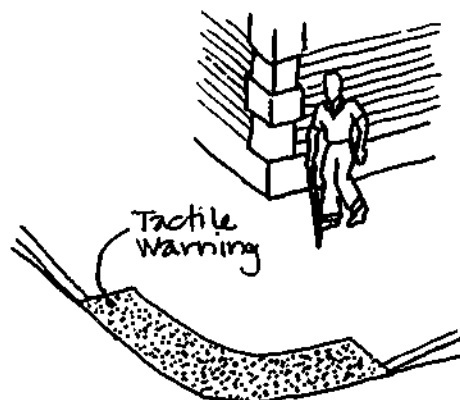
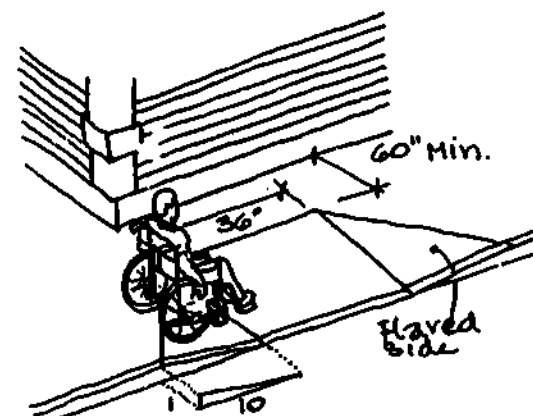
curb Ramp Designs

14 If there is a curb in the middle of a walk that should be accessible:

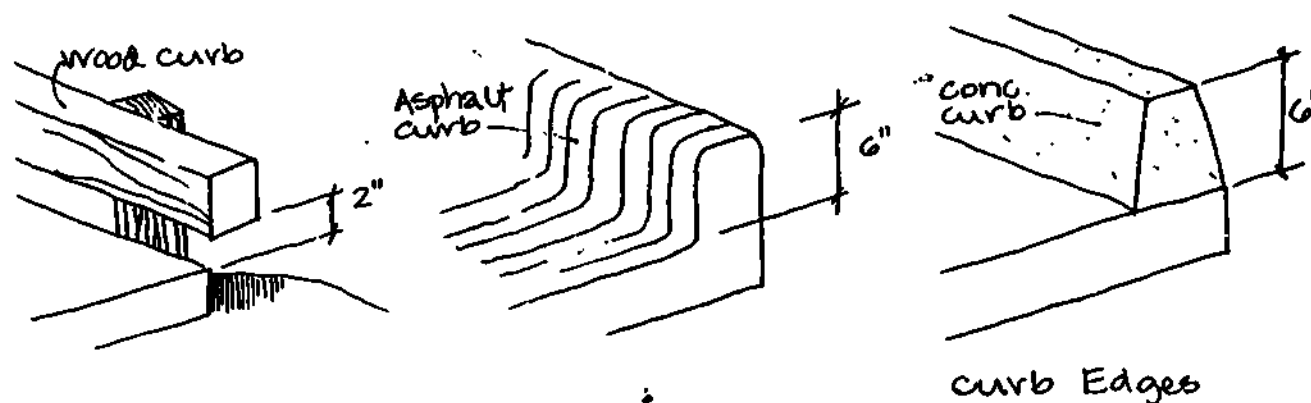
Accessible paths and non-circulation, used as accessible paths, should be free of hazards which might result in injury to disabled children, particularly those with visual impairments. These hazards include edges of drop-offs and projecting objects.

15 If there is a drop-off greater than 6" along side an accessible path of travel:

a Build a raised curb alongside the path.

The cost of a metal guardrail (not including any footing cost) is \$16/LF and the cost of a concrete block wall (also without footing) is \$11/LF. These solutions are assumed to be 32" high. The cost for the block wall does not include footings which will vary depending on the particular site.

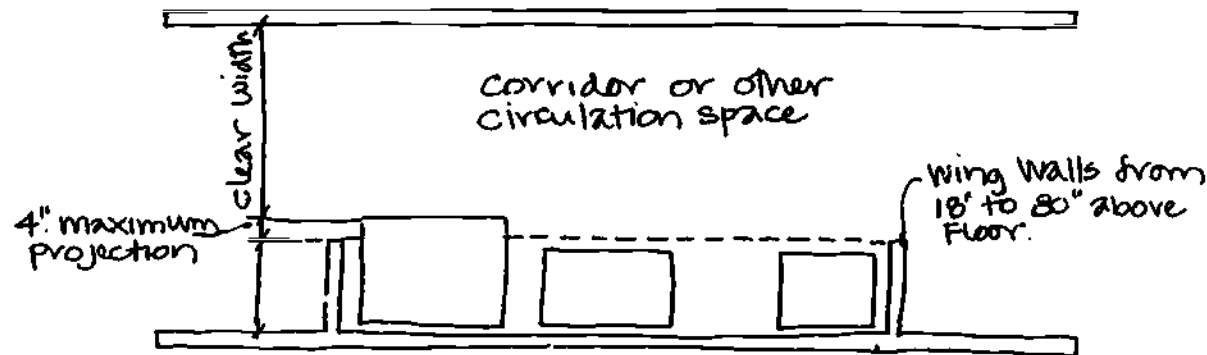
Protection from Projecting Objects

16 If there are dangerous projecting objects:

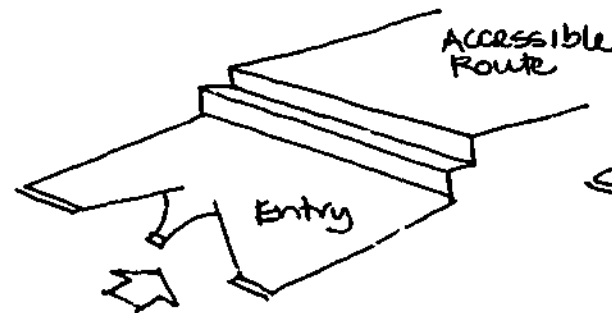
Existing Accessible Entry

A system of accessible entries is the key to providing movement into and throughout the school facilities. At least one entry from the exterior should be accessible and it should be joined to accessible corridors and accessible exterior walks.

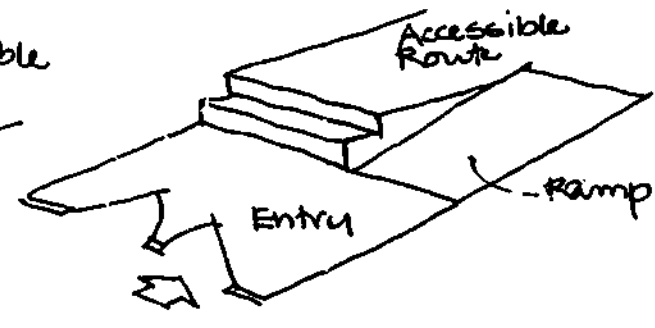
Modified Circulation at Entry

19 If an entry is accessible but does not connect to other accessible routes:

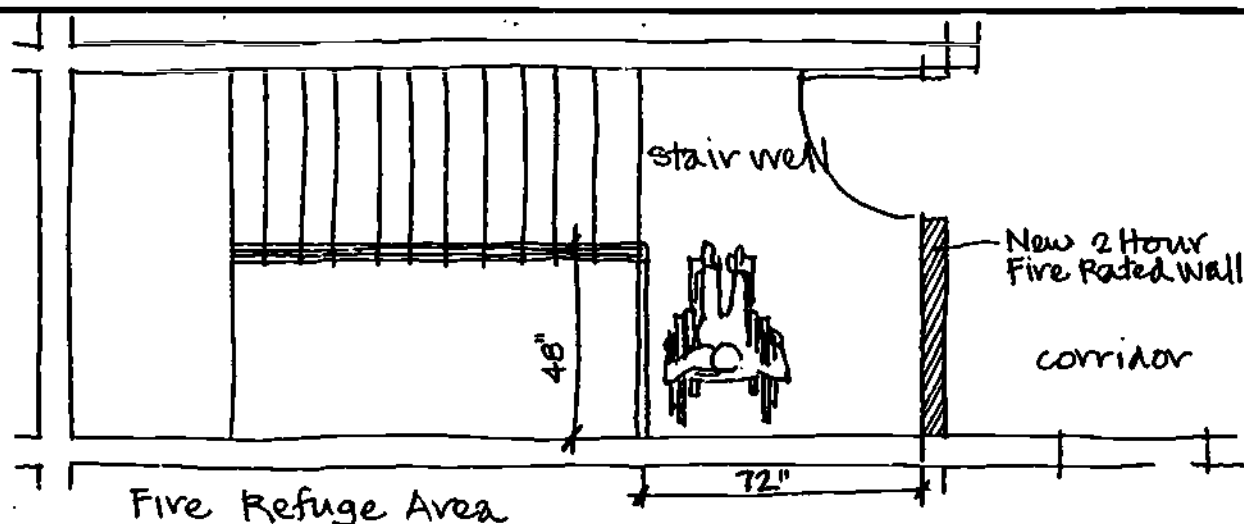
As part of the circulation system there must be provision for exiting or refuge in event of fire, this is particularly important in multi-story buildings. Protection for such exiting should be part of the accessible corridor system.

21 If fire refuge areas are needed:

a Enlarge landings in fire stair towers so that they can accommodate at least two children in wheelchairs.

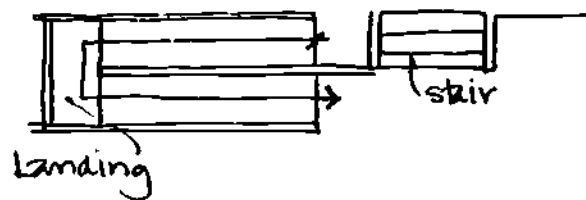
switch-back Ramp

Alternate Ramp Plans

The design criteria and cost for various ramp constructions are found in AA 37.

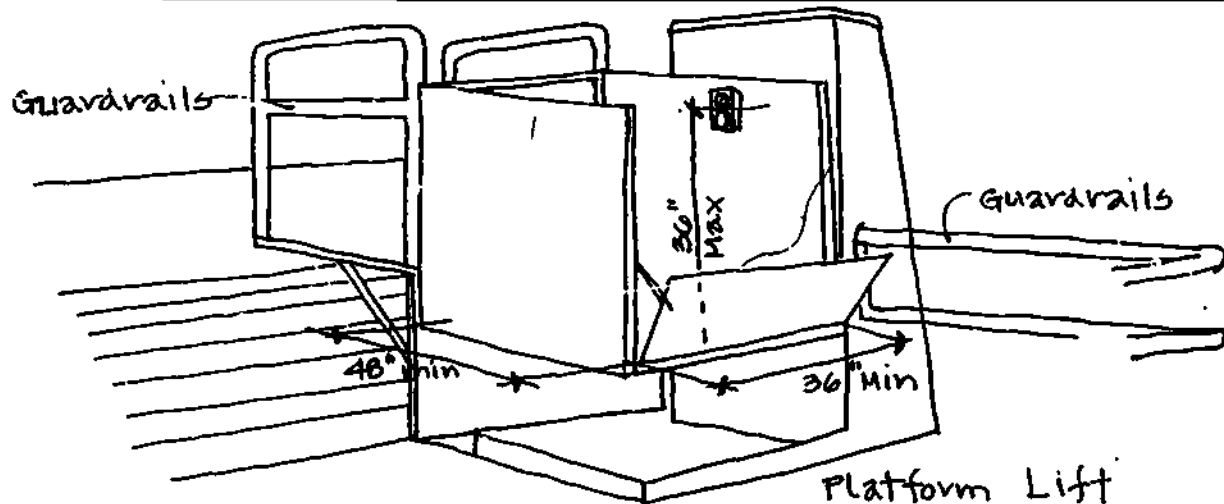
d Install a platform lift.

A platform lift travels vertically, and depending on the manufacturer, can accommodate level changes up to about 8'. 110v. power will be required for the operation. These lifts are made for both interior and exterior use and, in both cases, guardrails will be required for protection at the top and bottom. Local codes may limit the use of these lifts.

Design criteria for the platform lifts are the same as those for the stair elevator in alternative 'c'. The cost of the platform lift varies between \$1,600 and \$2,200. This figure is based on a 60" vertical travel and is for the equipment only. Site modifications will cause the cost of installation to vary depending on the adjacent ground or floor materials and extent of guardrails required. An installation requiring a new landing area of 30 sq ft and guardrails surrounding the upper and lower landings would cost about \$4,500.

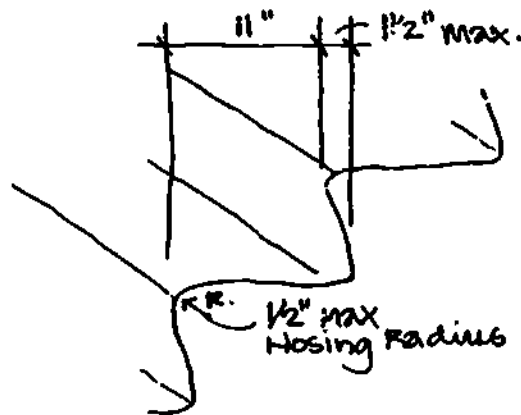
Flush Riser

Stairs can be modified to be safely used by semi-ambulatory children with moderate disabilities. Modifications to handrails, stair treads, and lighting are often necessary. Stairs that are unprotected from below can be hazardous, particularly to children with severe impairments of vision.

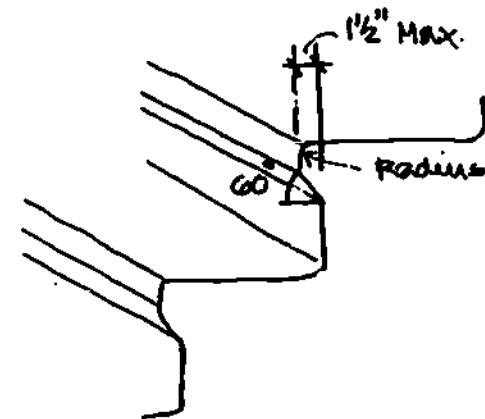
Angled Nosing

24 If existing treads on stairs connecting levels not served by elevators have abrupt nosings:

The nosing can be modified by either installation of a new nosing strip or a new full tread over the existing tread. The existing tread must first be leveled in the worn areas to adequately support the new overlay. If a nosing strip is used, as opposed to a full tread, there is a potential for the rear edge to trip someone. All treads should be replaced or there will be an irregular riser; this is a major cause of stairway accidents.

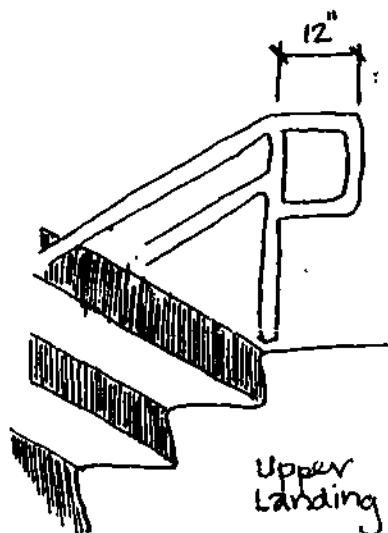
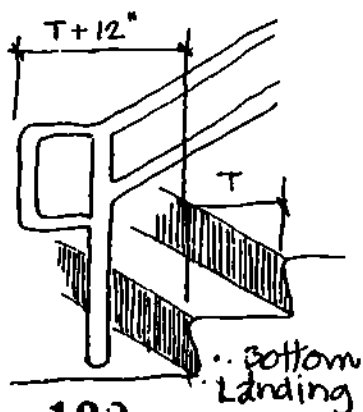
26 If there are existing handrails at appropriate heights which are not continuous or do not have extensions:

a Modify handrails so that they are continuous and have extensions.

To achieve continuity of existing handrails can be difficult at switchbacks where there are newell posts. Extensions should not project into corridors at the top or bottom; if necessary, they can wrap-around the corner.

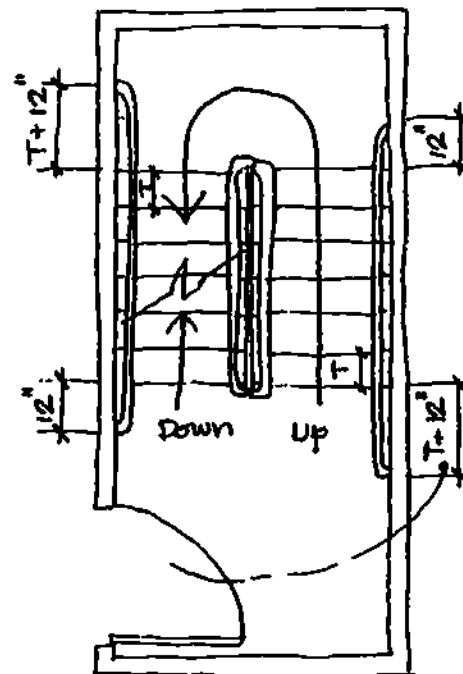
Handrail Plan

The design criteria for handrails are found in AA 25 and 26. The cost for the installation is found in AA 25.

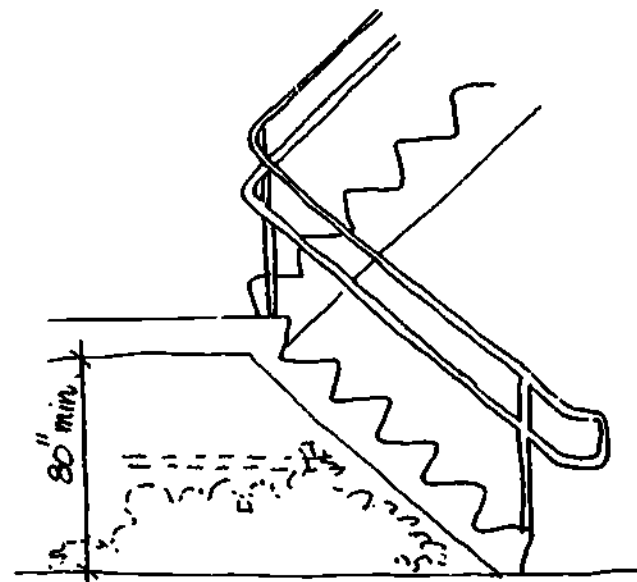
Protected Area Below Stairs w/ No Headroom

The cost would vary based on the particular design and existing conditions.

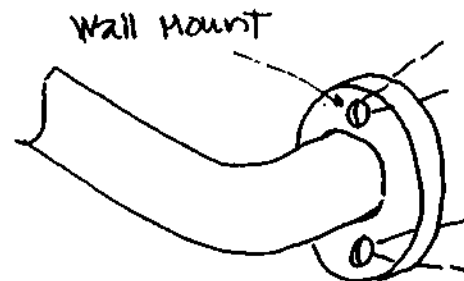
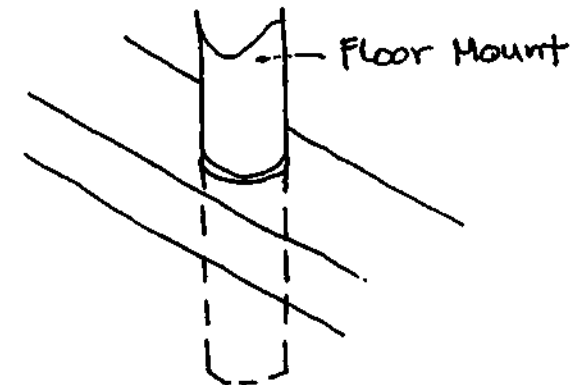
Handrail Mounting

Accessible ramps allow semi-ambulatory children to move between two levels in a school. Most existing ramps are too steep and would require modification; shallower ramps however require the child to travel further and thus become tired. Ramps should have handrails, protective edges, and good light levels.

30 If a ramp does not have handrails:

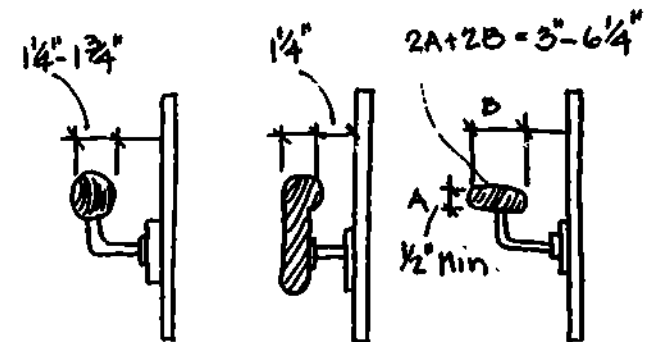
Handrail Shapes

31 If existing handrails are too wide or are mounted too high:

The criteria for the design of the handrails is found in AA 31 and in this section. The cost of the new handrail is noted in AA 25, however this figure does not include the cost of removing the existing railing which can be done in most cases, by school maintenance personnel.

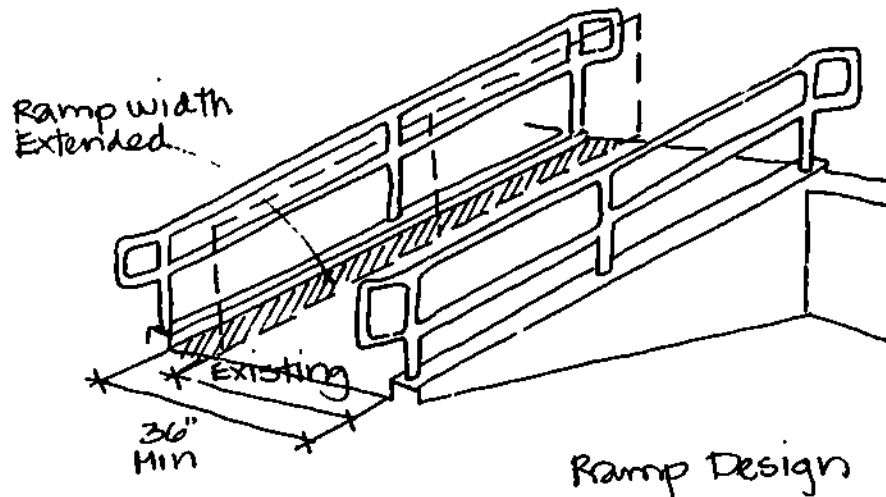
Ramp Design

These figures do not include a cost for a demolition of the handrail and edge condition on the existing ramp.

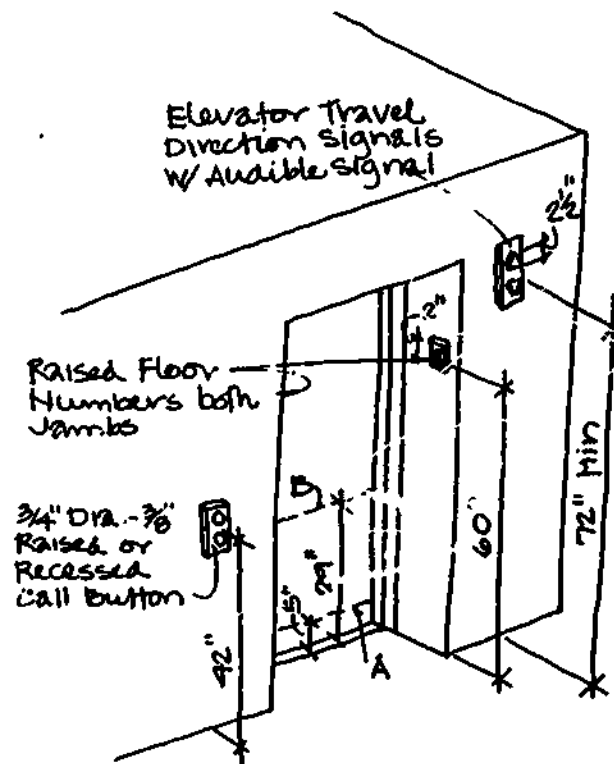
Elevator Controls & Signals

Automatic reopening devices should be installed on the elevator. The cost of this modification is approximately \$950.00 to \$1,350.00 per elevator.

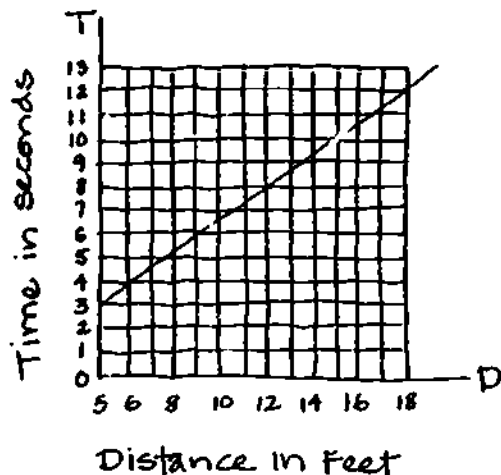
Doors should have a hold open time of 3 seconds minimum. Door timing can usually be adjusted on existing elevators.

Car arrival signals should be both audible and visible. The installation of these signals pose no difficulties. Additionally, there should be an audible signal in the car when it passes each floor. This is not needed in a two-story situation. The sound signal itself is an inexpensive device.

Raised floor numbers should be provided at both jambs of hoistway entrances; they should be at least 2" high and mounted 60" above the floor. The cost of these numbers would be \$8 each and they could be installed by school maintenance personnel.

Cars should be equipped with 2-way communications systems, the highest operable part should be no greater than 36" from the floor. Phones that are not the head-set type are preferable. This modification involves mostly labor with a cost of approximately \$900 to \$1,250.

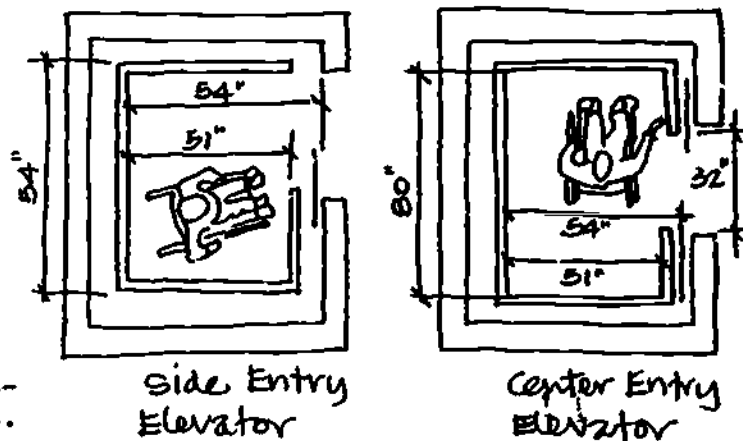
39 If a new elevator is to be added to a building:

a Construct the elevator within the building.

The minimum clear floor space in the cab should be 51" X 54". Criteria for other features required for accessibility are in AA 38 and 40. A basic total cost of \$18,500 for the installation can be used, keeping in mind that this is for a two stop elevator; add \$3,000 for each additional stop. This figure does not reflect specific conditions which could raise the cost such as additional structural work.

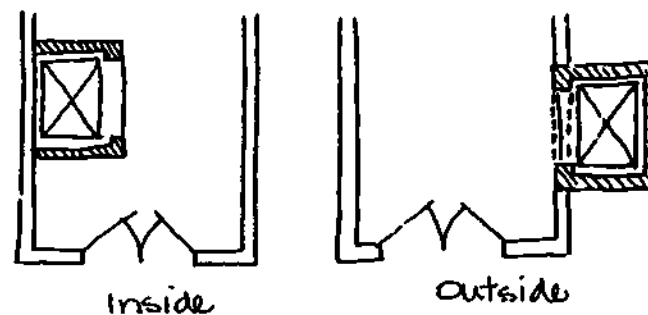
Elevator Locations

Design criteria and costs are as in alternative 'a' with the same qualification that the cost can vary depending upon the particular structural or circulation modifications that might be required.

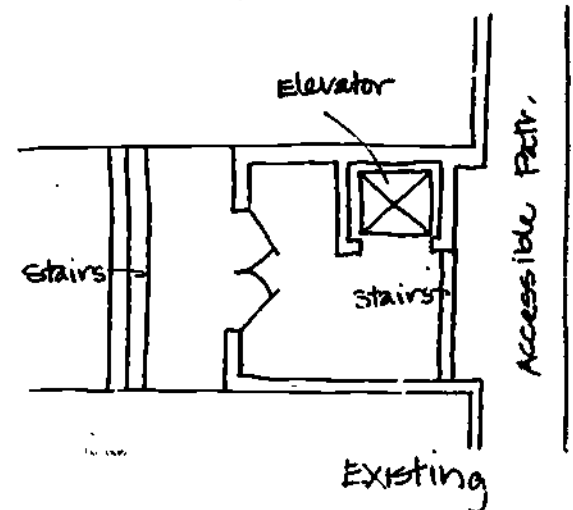
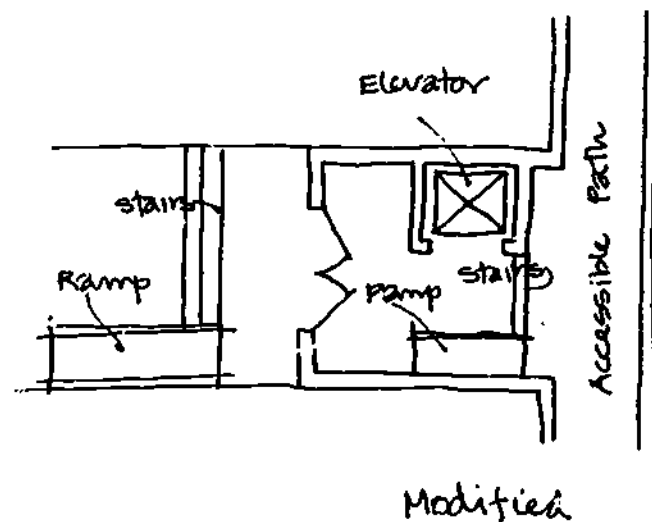
42 If lifts are not located in a secured area: a Issue keys to handicapped children and teachers.

Some method of controlling the use of lifts is necessary. Although the keyed control is often a standard feature with platform lifts, an optional keyed call-send control will probably be required. A call-send set of controls is a switch mounted at the top and bottom of the lift to activate the lift to come to the level where one wants to get on that lift. There could be unauthorized use of keys and also problems due to loss of keys by the children. Lifts should be equipped with pressure sensitive shut-off switches that automatically stop lifts if anyone gets in the way of their movement.

A control should be no higher than 36" if children are to use the lift themselves. The cost for the additional call-send controls is \$212 per set. These could be installed by school maintenance personnel.

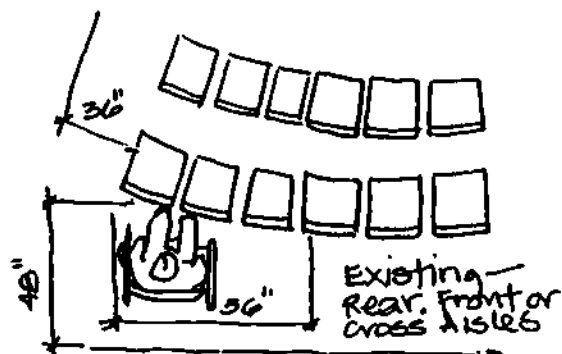
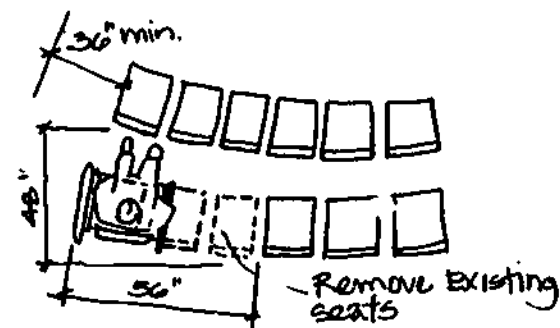
Auditorium Seating

44 If seating space is needed for wheelchair, crutch or leg brace users:

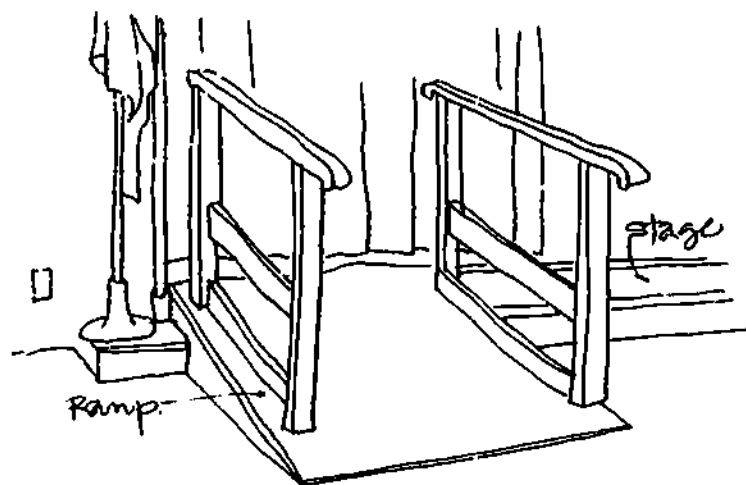
Accessible Raised stage

The criteria for the ramp are found in AA 37. Since most school stages are about 20" high, one could anticipate that the cost of a wood ramp is approximately \$2,500. This does not include demolition of existing platforms.

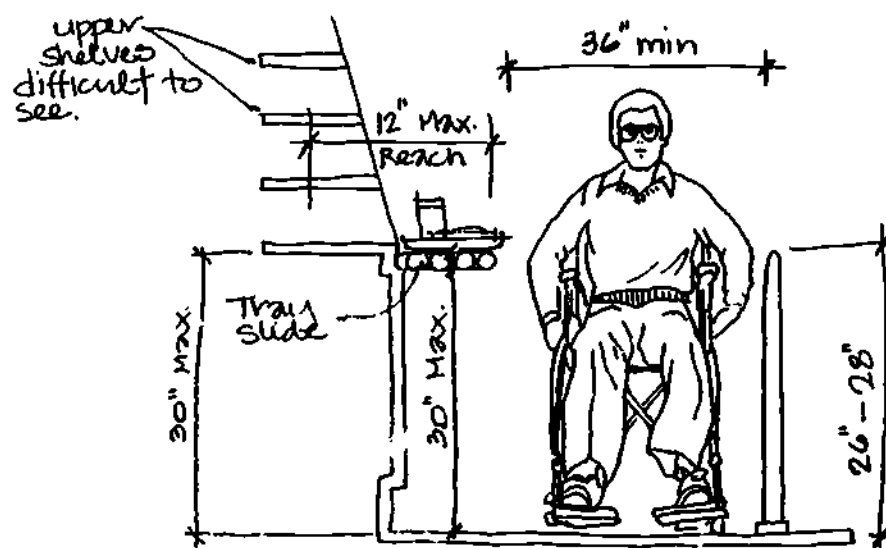
serving line

The tray slide should be mounted no higher than 30". All food counters should be no higher than 30" above the floor and forward reach for food should be no more than 12". The cost to lower the slide would depend on the particular method of attachment and the length of the slide.

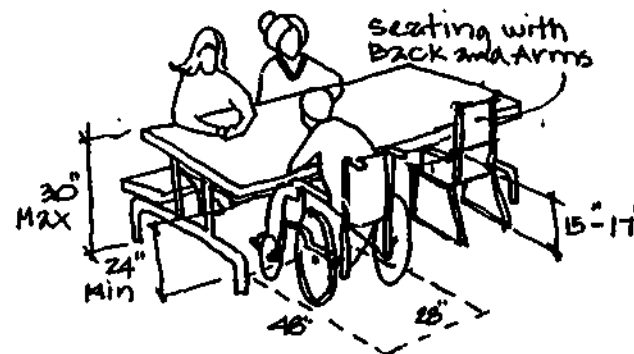
Accessible Seating

The criteria for these furnishings are in alternatives 'a' and 'b'. The cost of chairs is \$10 each in lots of 10 and \$8.50 in lots of 25.

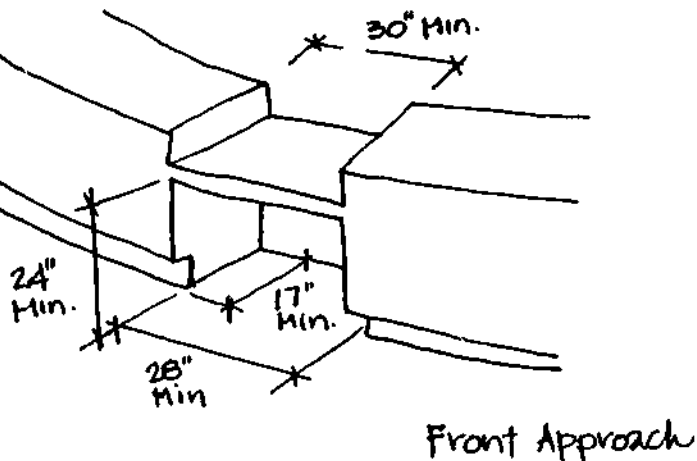
Side Approach

The top of any counter should be no higher than 30; the minimum counter width should be 30". The labor and material costs are about \$150 to modify a counter.

c Provide clear floor space to allow a side approach to counter.

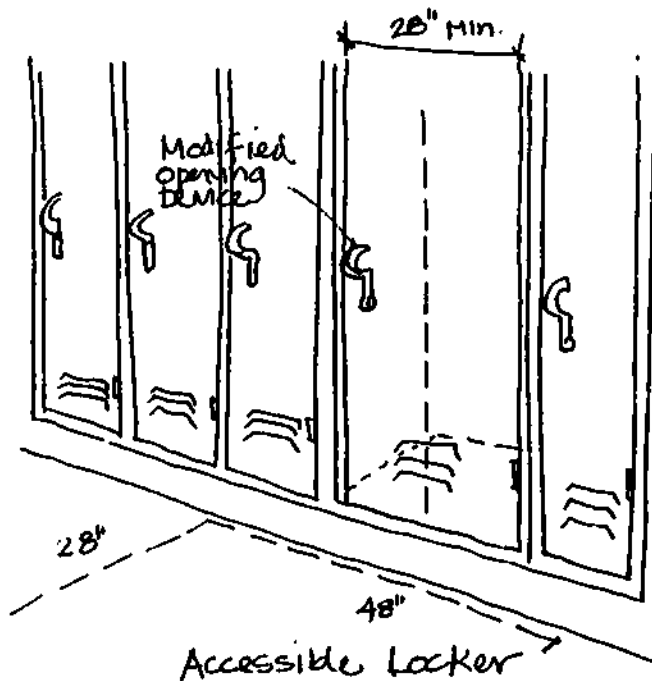
b Make a wide locker from two narrow ones by removing a side partition and replacing existing doors with a wider one.

Lockers come in varying widths, usually from 9" to 18". Two or more lockers can be combined. This will of course result in the loss of some lockers. The wider door might also require modification or movement of some adjacent seating to accommodate the larger door swing.

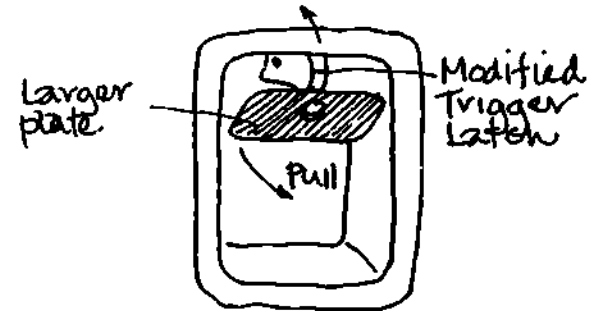
Recessed Type

There doesn't seem to be any particular device made specifically for lockers that solves this problem. Perhaps a standard lever door handle most closely matches the handle requirements; installation of such a handle would be the best solution. Another possibility is the addition of a loop pull handle in conjunction with modification of the latch catch mechanism.

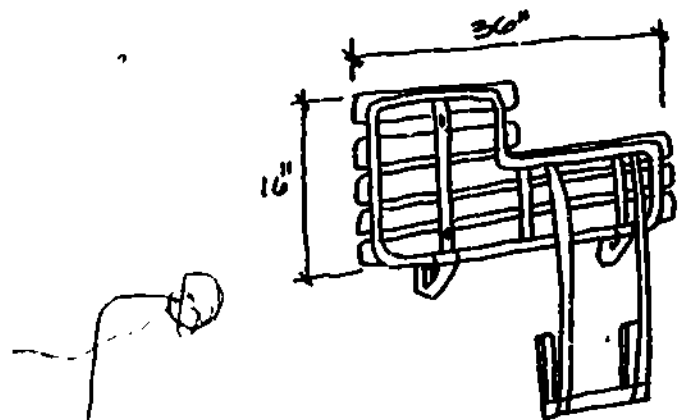
Fold down Shower Seat

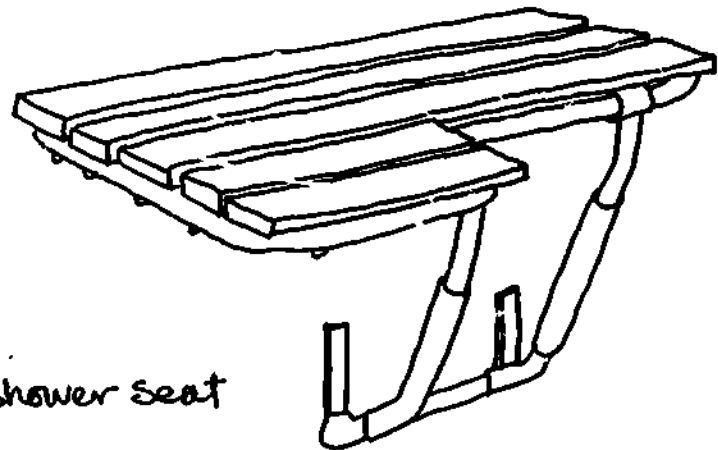
64 If showers are not accessible, modify any of the following deficiencies for at least one individual shower stall or at least one shower in a gang shower room.

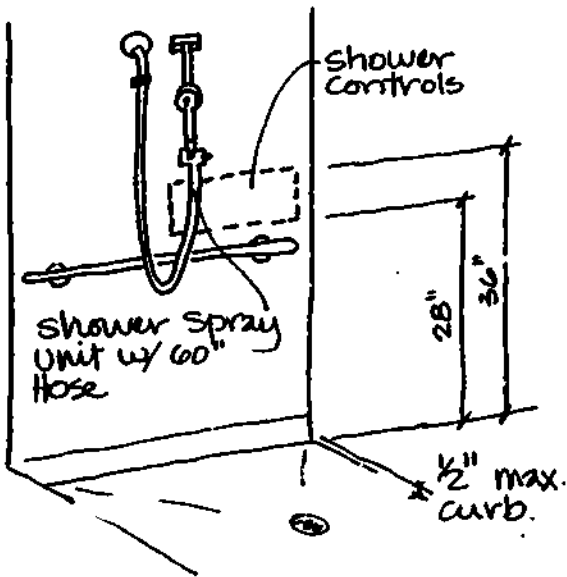
Controls should be operable with one hand and easy to activate without twisting of the wrist or tight grasping. The cost to make this change is:

shower controls

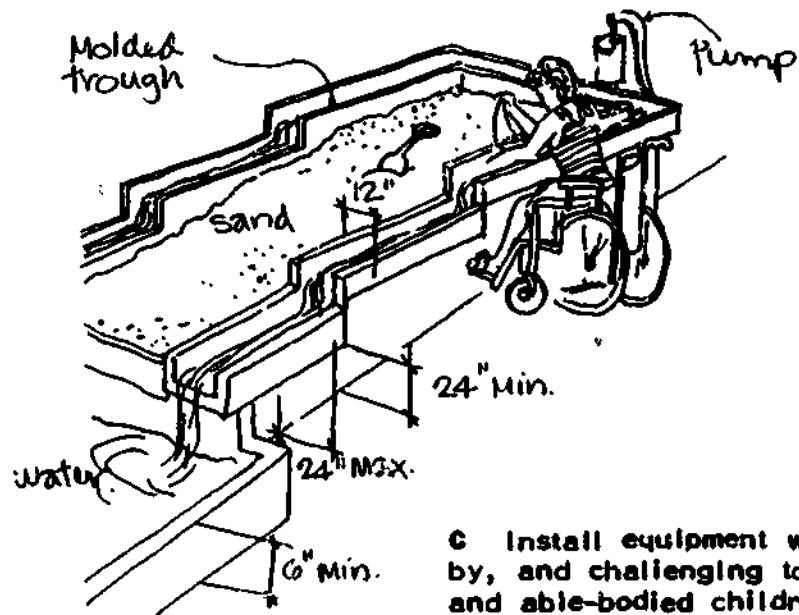
challenging Equipment

c Install equipment which is useable by, and challenging to both disabled and able-bodied children.

Challenging accessible play equipment may have to be custom designed. These designs should pose no problems in construction. Equipment for both able-bodied and disabled will promote socialization yet does require adequate supervision to see that rough play won't endanger disabled children.

Accessible play equipment should have raised manipulative play surfaces, incorporate sloping circulation surfaces, soft ground materials or provide several levels of challenge. Lowered basketball backstops and raised sandboxes are examples of these pieces. Cost for these solutions will vary depending on the particular design and size of the units.

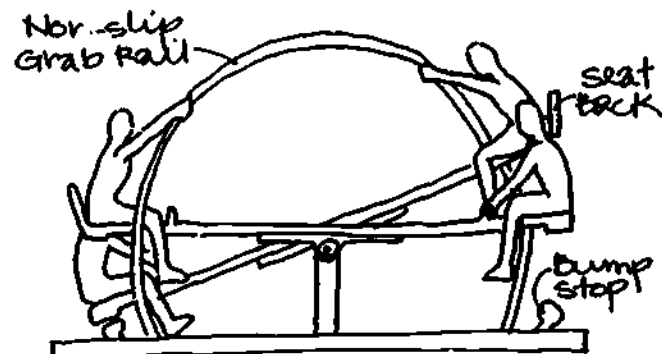
Modified Equipment

d Modify some existing play equipment so that it is useable by, and challenging to disabled and able-bodied children.

An example of this approach would be the addition of free-standing arched rails on either side of a see-saw to serve as handrails. A bumper below the point of impact would also be needed. This option has the same advantages and disadvantages as noted in alternative 'c'.

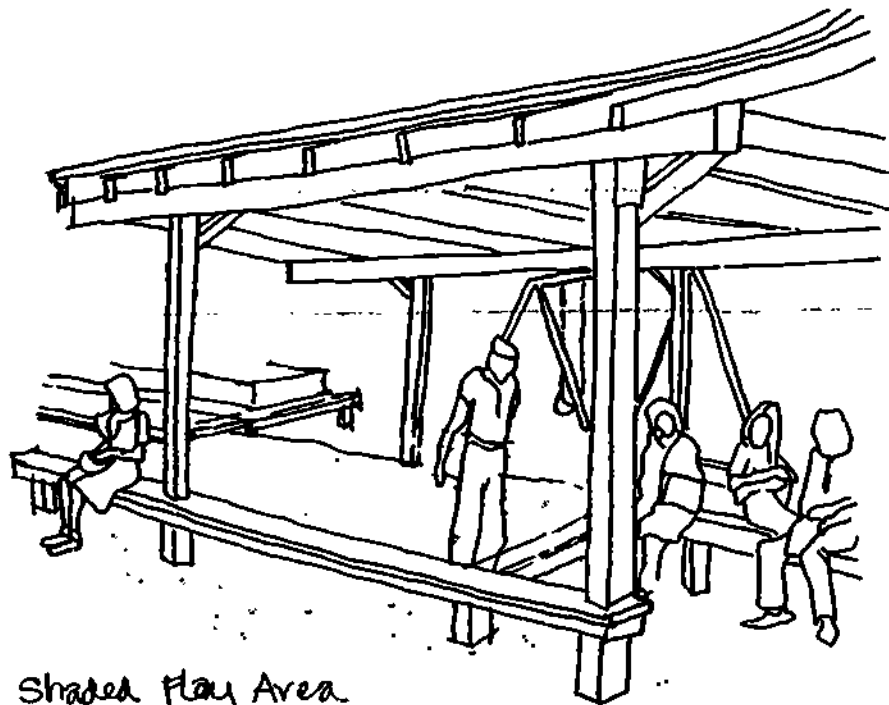
Shaded Play Area
