Accessible Elementary Schools

A Renovation Planning And Design Manual

By Peoples Center For Housing Change

March, 1981

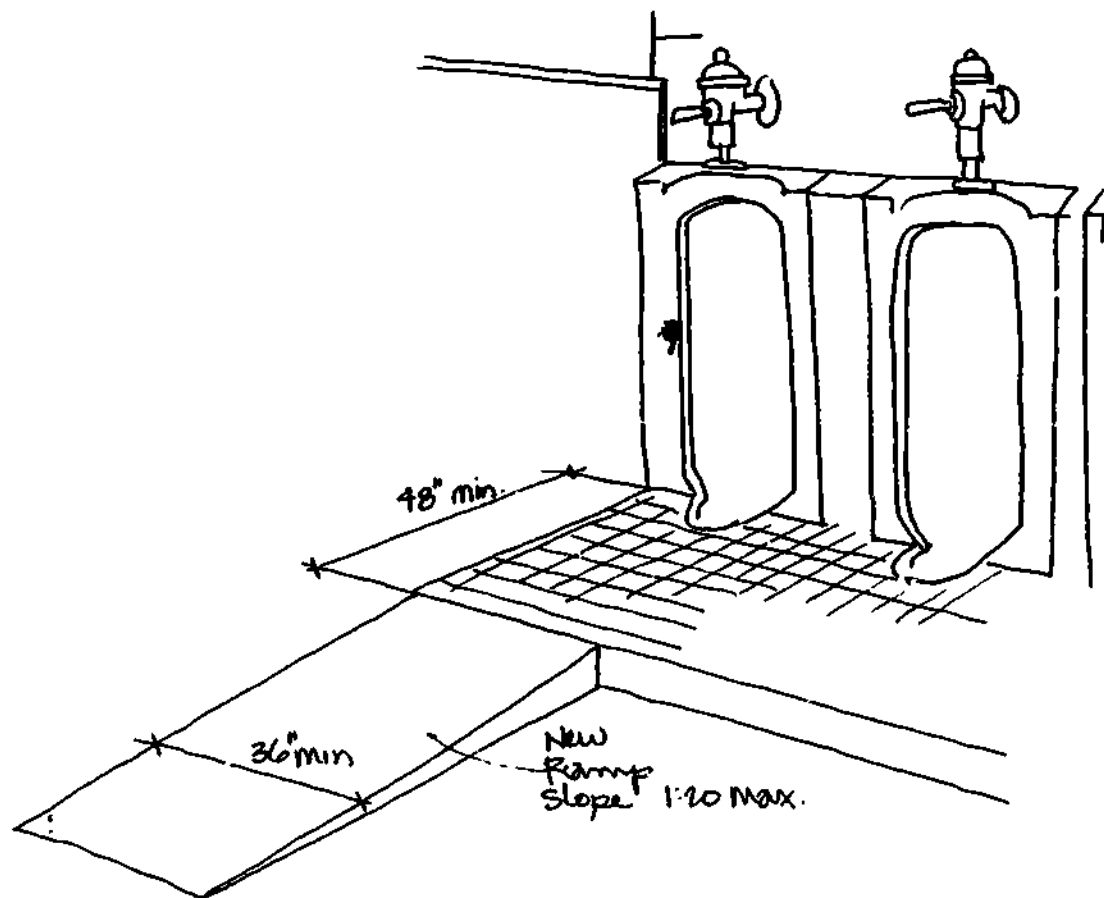
8 Build a ramp to the podium and, if necessary, enlarge the podium so that it can accommodate wheelchairs.

These podiums are rarely greater than 6" high, in which case a ramp of 6' would be required. Having the space necessary to build a ramp that size will be the limiting factor. Other circulation must not be obstructed by the ramp.

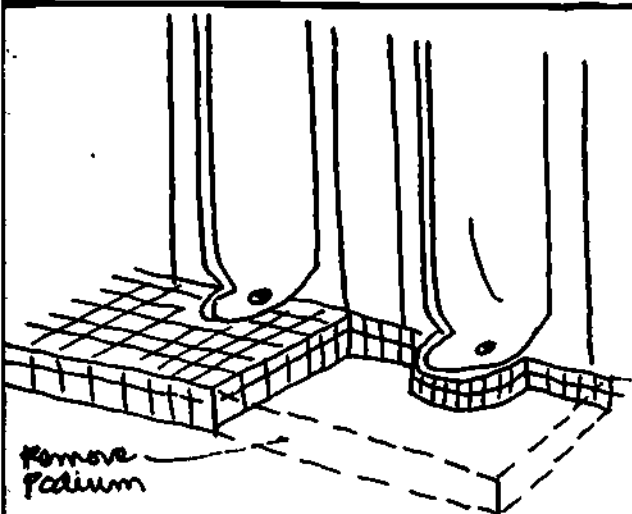
B Remove the podium and lower equipment to appropriate heights.

Such a podium is usually constructed with a slope for drainage either to a drain in the podium itself or sometimes towards floor mounted urinals. If there is a floor drain, the success of this approach depends on the flexibility available to lower the drain and trap within the floor or below it. Covered urinals would also require a new drainage scheme.

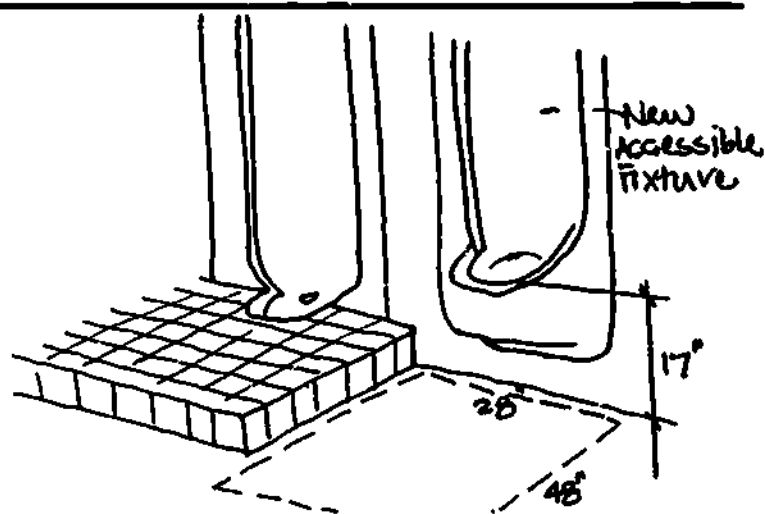
C Install additional facilities in accessible locations within the toilet room.

Typically there would be adequate capacity for additional fixtures but two items should be evaluated to establish the feasibility of this option: the size of existing waste lines and the pitch of those lines. Both of these can have bearing on this alternative.

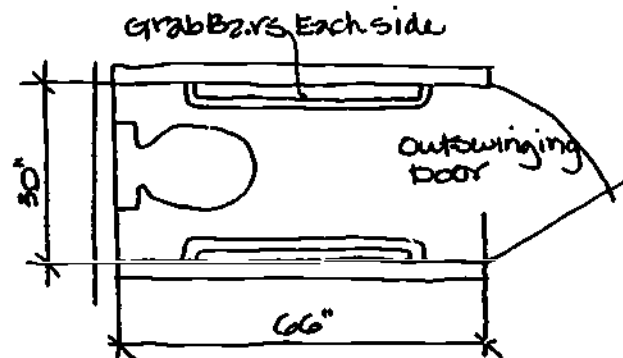
Non-assisted stall

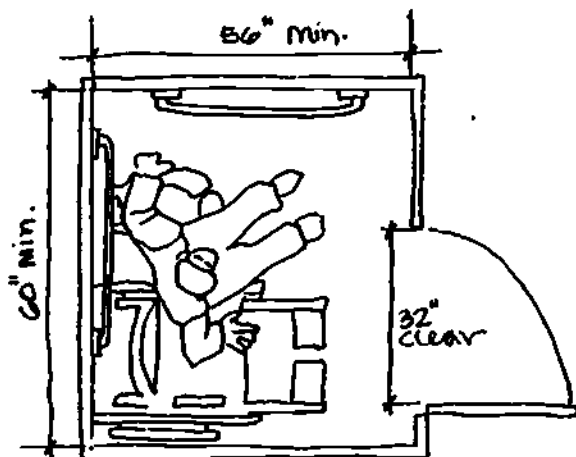
Assisted/Non-assisted stall

b Among a row of stalls, remove a side partition and the toilet from the adjacent stall in order to combine two standard stalls into one wide stall.

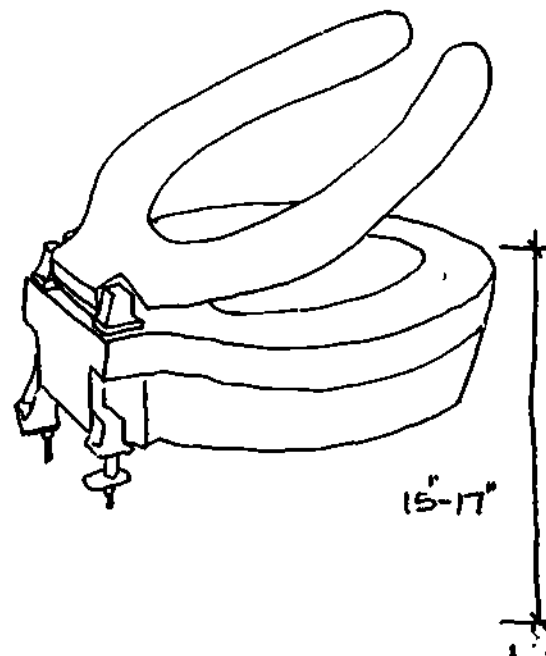
seat spacer

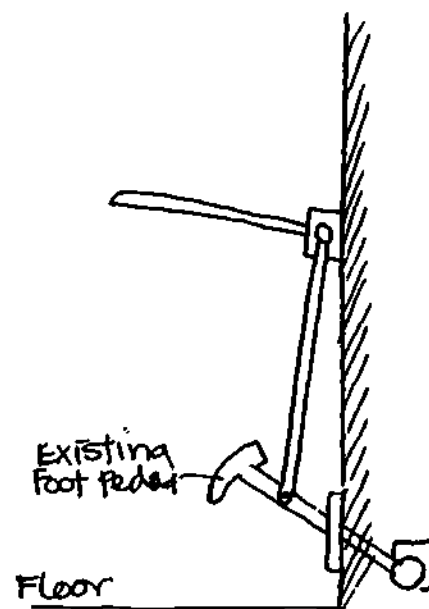
Modified Foot Flush control
240

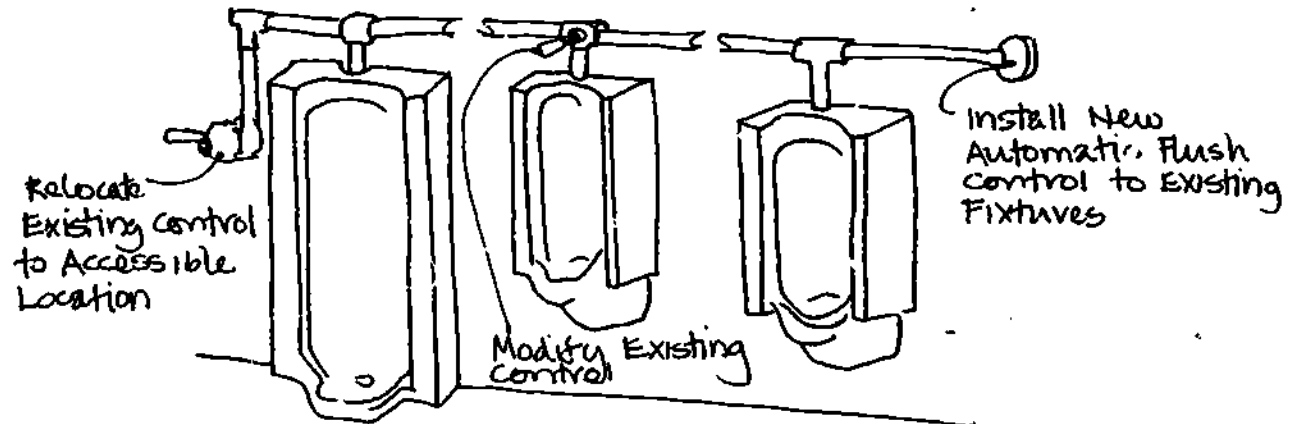
Accessible Flush Controls

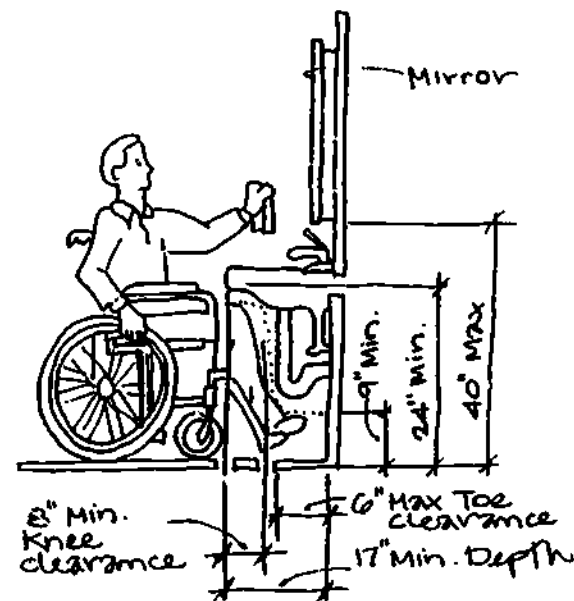
Lavatory Mounting

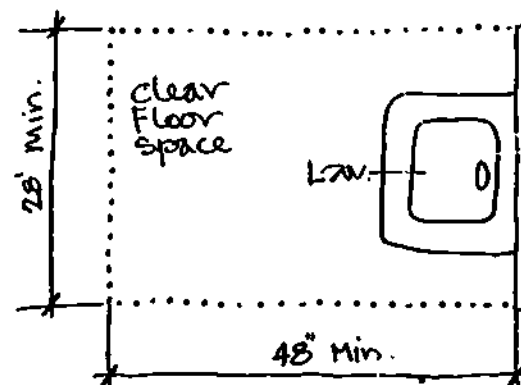
Lavatory Manuvering

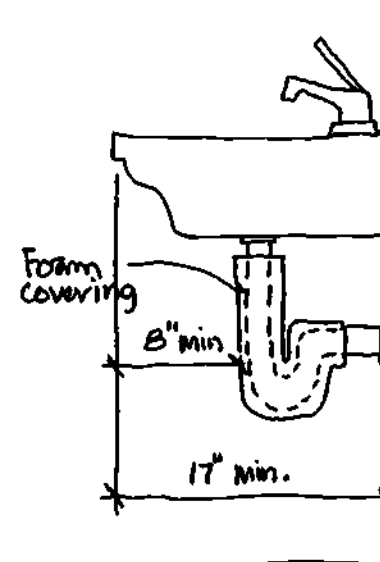
Knee Protection

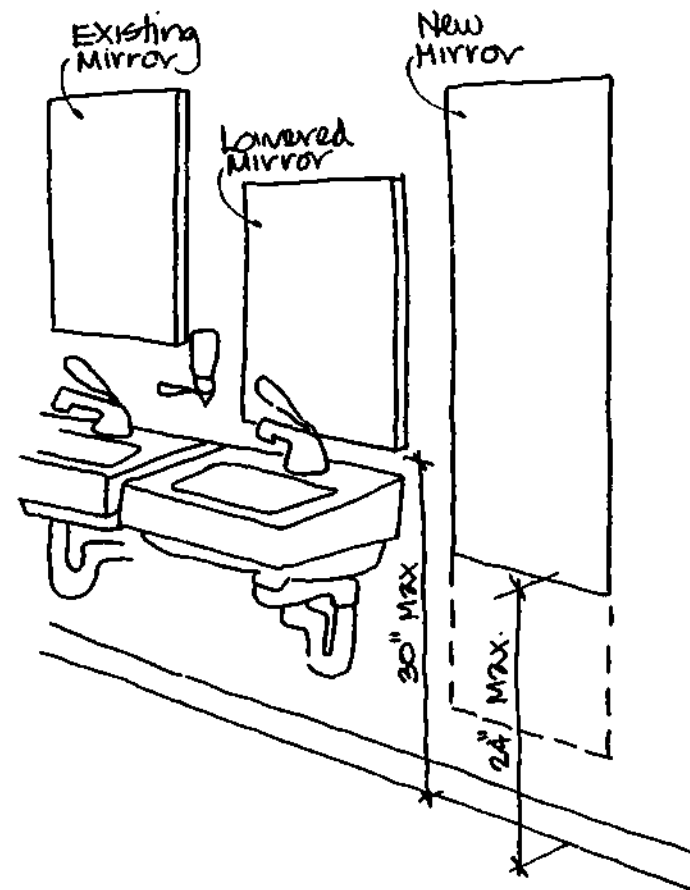
Mirror Mounting

The comments and criteria in alternative 'a' and 'b' are applicable here. The cost for a 16" X 20" mirror is approximately \$20.

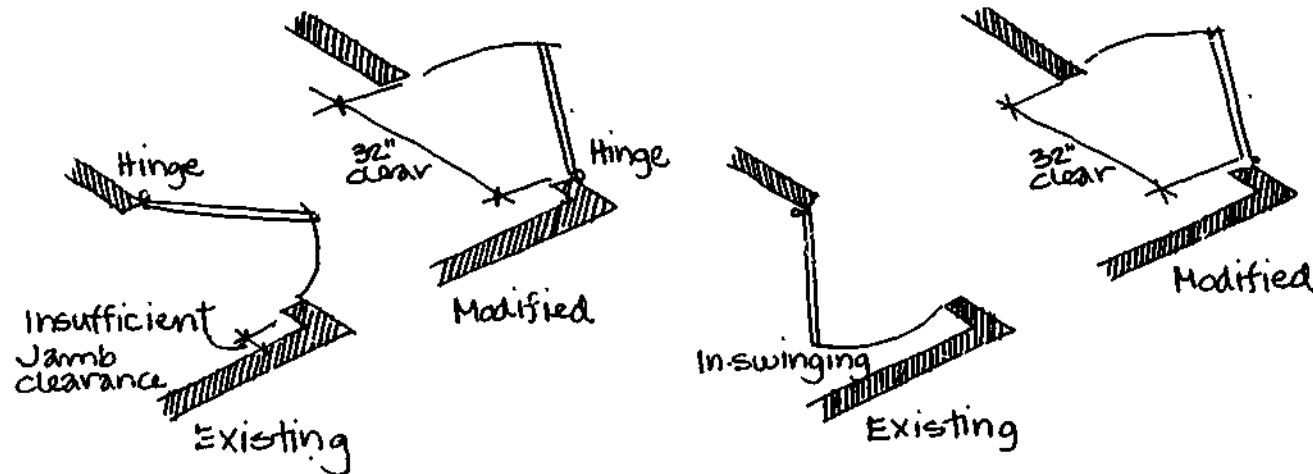
93 If there is not sufficient maneuvering space at a doorway*:

In addition to the approach standards illustrated, the maneuvering clearance area should be level at the interior and have no more than a 1:50 slope at the exterior. The costs of installation of various interior door constructions are:

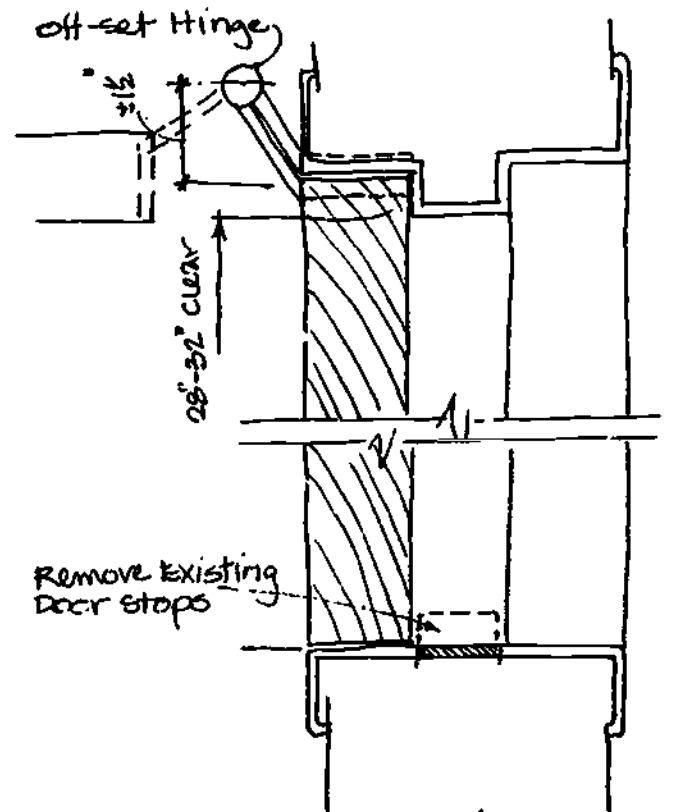
Doorway Modifications for Clearance

If this approach is taken, the costs are approximately \$50.00 less than the totals listed for a new doorway in AA 93c.

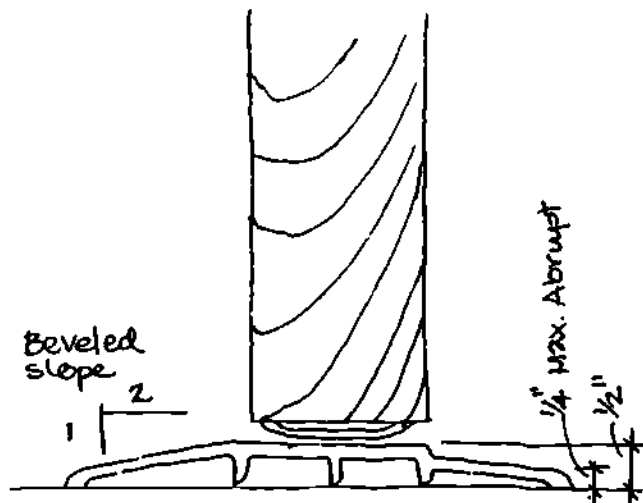
Doorway Thresholds

Thresholds up to $\frac{1}{4}$ " may be abrupt but between $\frac{1}{4}$ " and $\frac{1}{2}$ " will require a bevel with a slope no greater than 1:2. The typical threshold could be removed by school personnel.

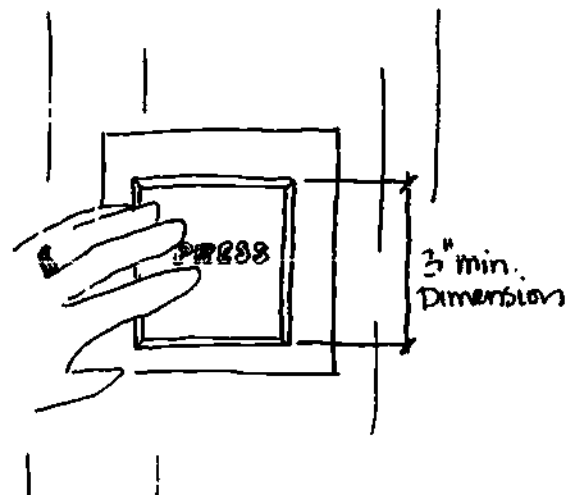
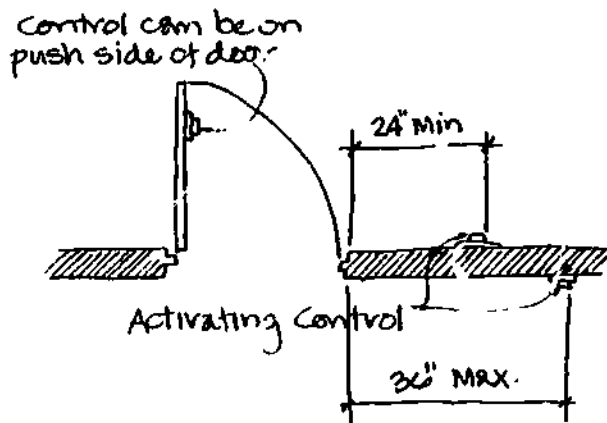
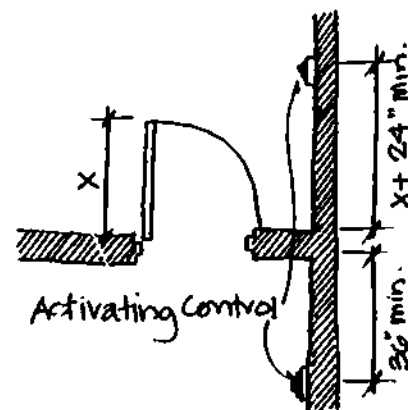
Automatic Door Activating Devices

The push type activator should operate within the maximum pressure of 3 lbs. A push plate should be 3" in the smallest dimension; it should be mounted no higher than 36" above the floor. Controls are best if door mounted. Illustrations of criteria for the location of wall mounted devices are shown. If the wall control is located further than the minimum dimension, add one second to the hold open time for each foot beyond that recommended dimension.

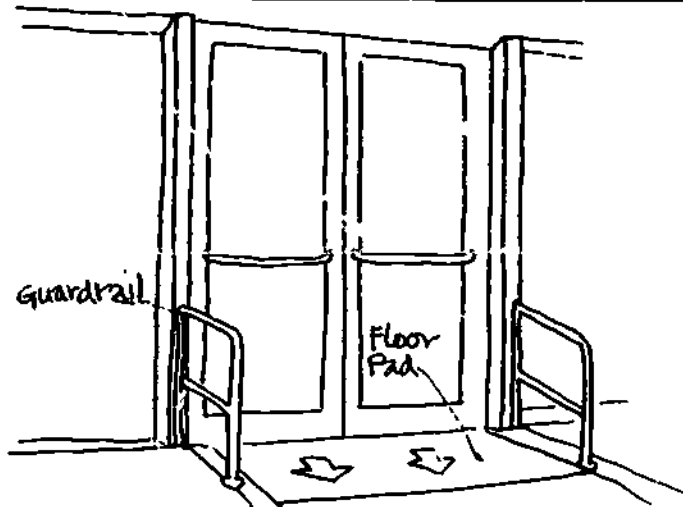
b Floor pressure pad.

It is preferred that such a pad be recessed; this can present problems in some locations.

If a floor mat is installed with swinging doors, guardrails should also be set up; this will prevent the possibility of a child being hit by the door as it opens. The mat edge should meet the threshold criteria in AA 96.

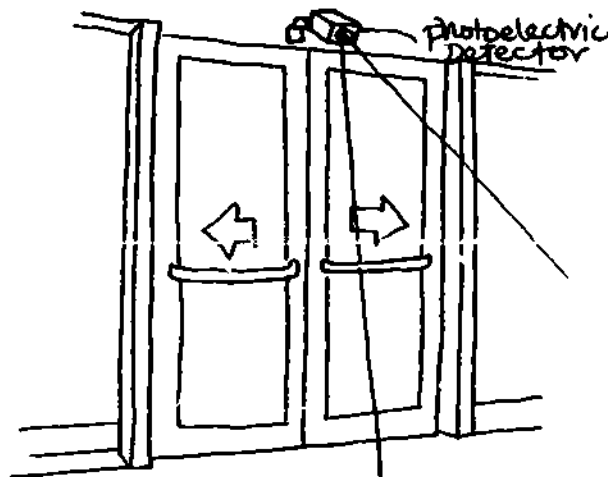
c Photoelectric cell or motion detector.

This would be the most desirable method. These devices can be either mounted above the doors or on posts near the doors. The motion detector can only be used in conjunction with sliding doors. A source of electricity will be required.

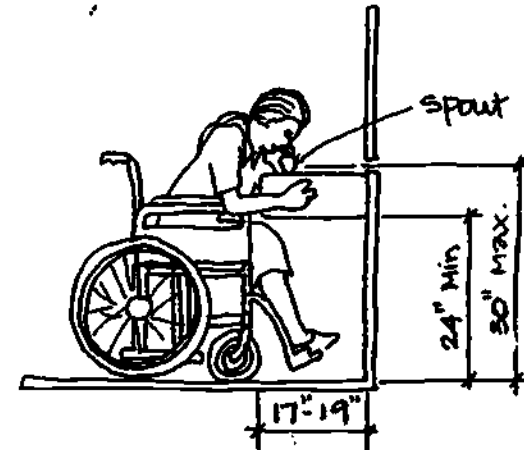
Drinking Fountain Mounting

113 If the fountain is mounted too high:

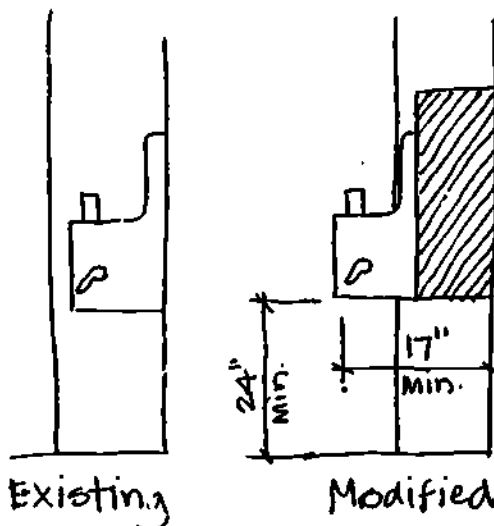
c Modify traps under fountains.

It is possible to provide a shallower trap. The amount of clearance gained will depend on the depth of the existing trap.

The clear height needed is 24" and, as in lavatories there should be protection over the plumbing to prevent injuring a disabled child. Ideally, as in new models, a cover plate would suit this purpose. The cost to replace the existing trap is:

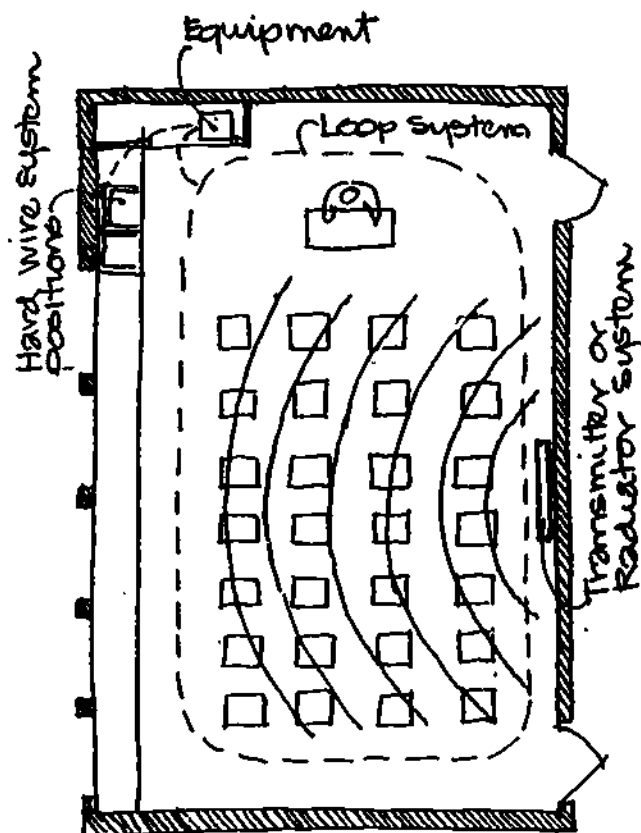
classroom Listening Systems

The infra-red system uses infra-red light to transmit signals to people who are wearing special receivers which convert the light signals to electrical signals which then are converted to sound by head phones or hearing aids.

Infra-red radiators should be located in positions where their signal would not be inadvertently blocked. A sufficient number of radiators would be installed in each room where the system is used to insure signal coverage throughout the entire room.

The basic cost for this type system is about \$1,500 for a radiator/transmitter which would be capable of serving an average classroom. Receiving head sets or receivers for those with hearing aids cost about \$135 each.

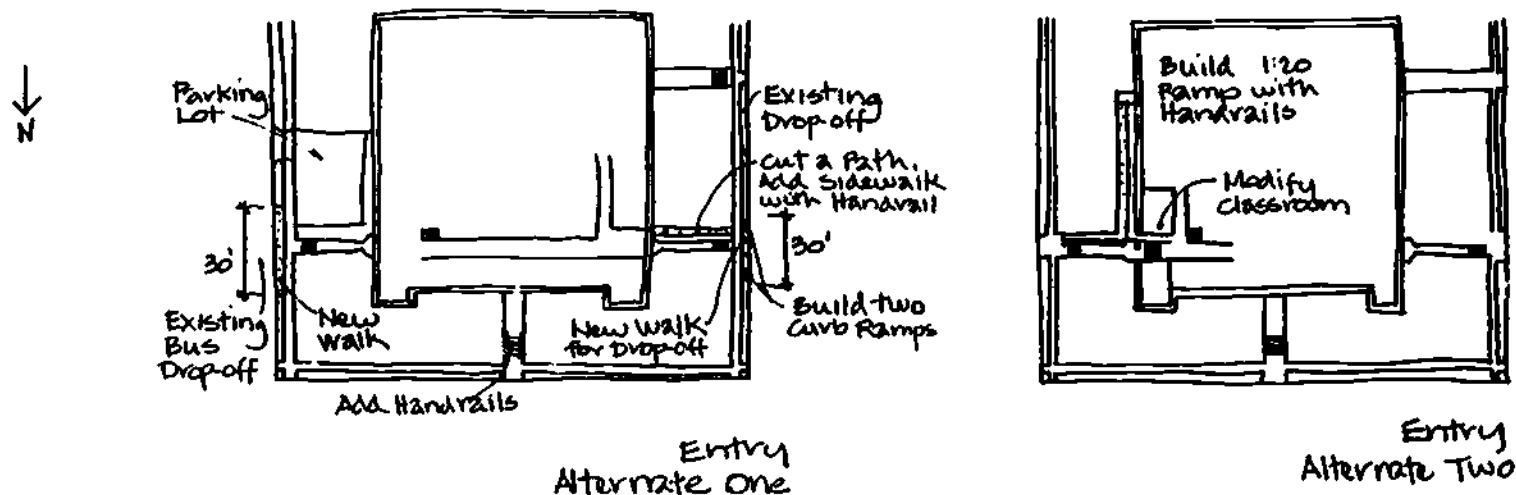
Passenger Loading Zone

- 1 At the existing bus drop-off area build a new portion of sidewalk for unloading/loading of students and designate the zone with signs and striping. Create a new drop-off on the west side of the building as an auto drop-off area. This would require new walk surface. See AA 1.
- 2 Build four curb ramps with two at each drop-off. See AA 14.

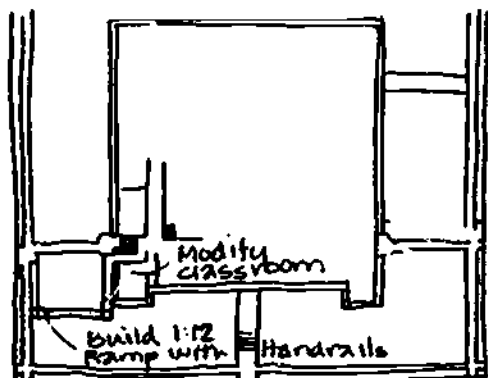
Entry
Alternate Three

Alternate Three Construct a moderately sloped ramp, 1:12, at the east side of the building to the first floor. Since the ramp is steeper than the one in Alternate Two it can be sited so that it runs on the opposite side of the entry and therefore doesn't impinge on the parking lot. This ramp will be of such a slope that it cannot be used independently by many disabled children. This solution will entail the movement of one classroom wall and change its entry. This solution has the advantage of bringing all children to the same entry point.

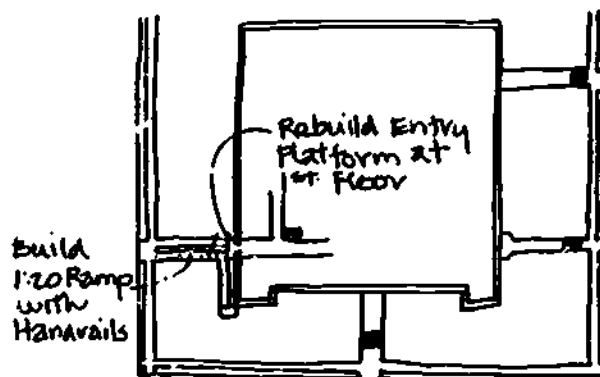
Entry
Alternate Four

Alternate Four This alternate, as in the first one, will bring the disabled children to the basement floor and therefore has the same disadvantage as that option. A ramp slope of 1:20 would be cut to the basement floor on the east side of the building. The landing of the entry at the first floor would require reconstruction. A new doorway would be cut below it and one stair wall moved. The drop-off would be common for all children. See the Action Alternatives for Walks and Corridors, Accessible Entries and Ramps.

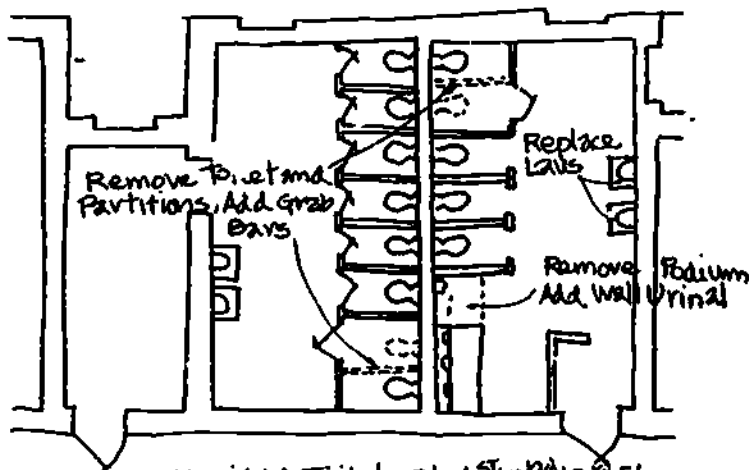
Modified Toilets at 1st, 2nd & 3rd Floor

24 In all the toilet rooms do the following changes:

- Adjust the closing force of the entry door.
- Remove one lavatory and replace it with a wall-hung one which allows for proper knee clearance.
- Change the spring-loaded lav controls to stay-open by adding a self-closing valve.
- Join two existing stalls to make one wide stall for assisted use. Add grab bars.
- Lower one mirror.
- At the first, second, and third floor boys toilet room, add one new wall mounted urinal.
- In the basement, remove part of the existing podium, remove the urinal and replace with a new one.

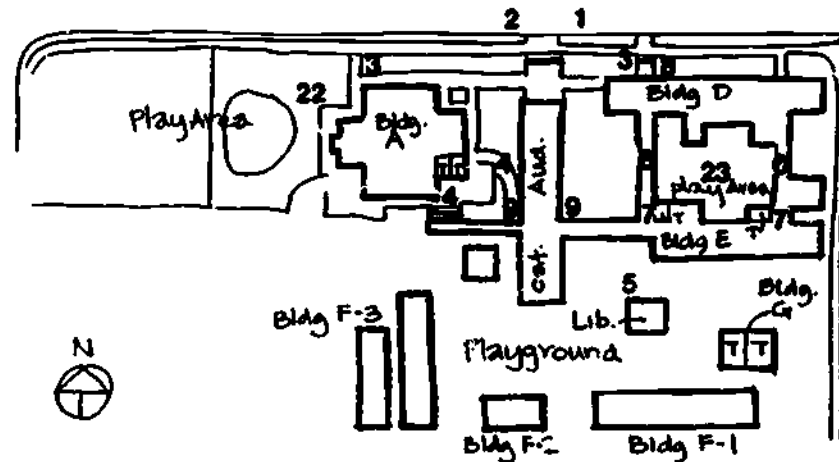
Passenger Loading Zone

1 Presently the drop-off of children is along the curb in the parking lane of a main street fronting the school. It is unmarked.

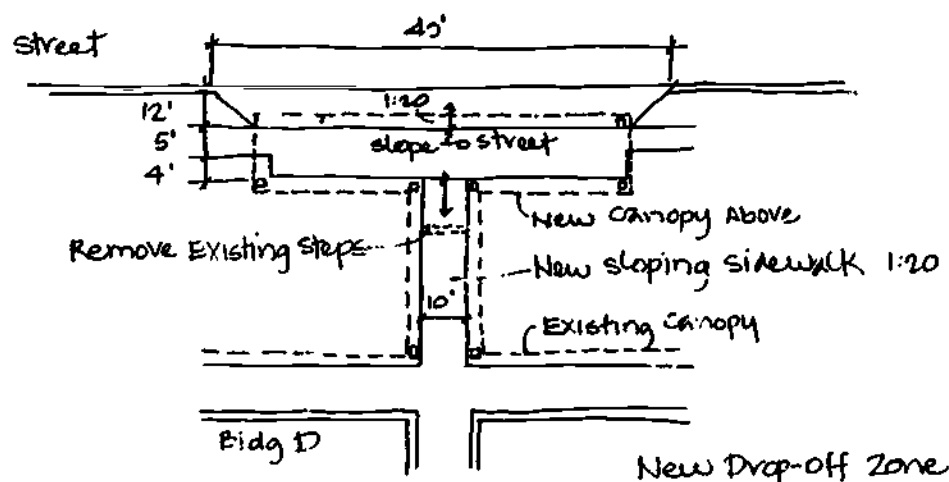
Passenger Loading Zone

1 Construct a drop-off for autos and 2 buses at the west end of Building D which has curb ramps. This location was selected due to its proximity to the mildest sloped path to the common facilities and its closeness to a covered path. This would be an essential improvement. See AA 1 and 5.

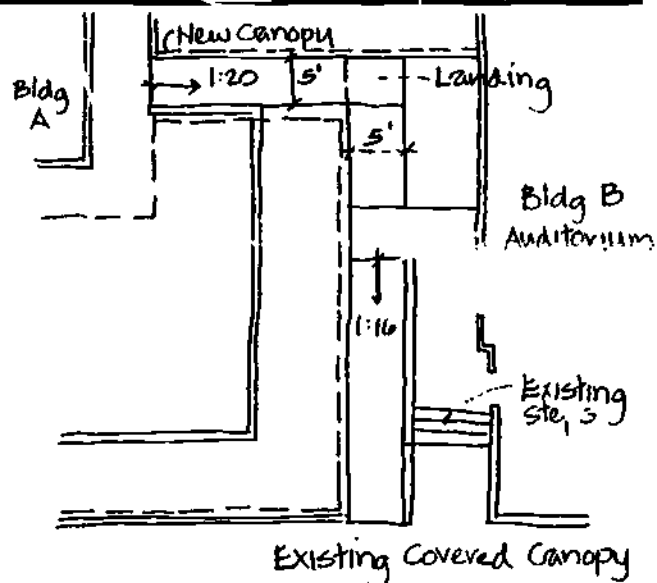
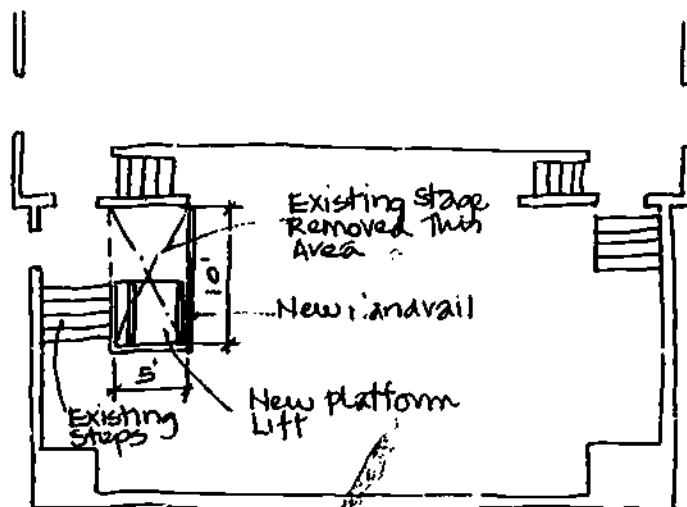
Modified stage Area

12 Install a platform lift at the west side of the stage. This solution was chosen over a ramp due to the configuration of the stage; a ramp would have needed to be approximately 36' long. The lift is proposed for the western side since the accessible ramp proposed in Solution 8 and 9 will serve this side of the auditorium. See AA 46.

12 There is an elevated stage which can only be reached by steps with 5 risers of 7" each.

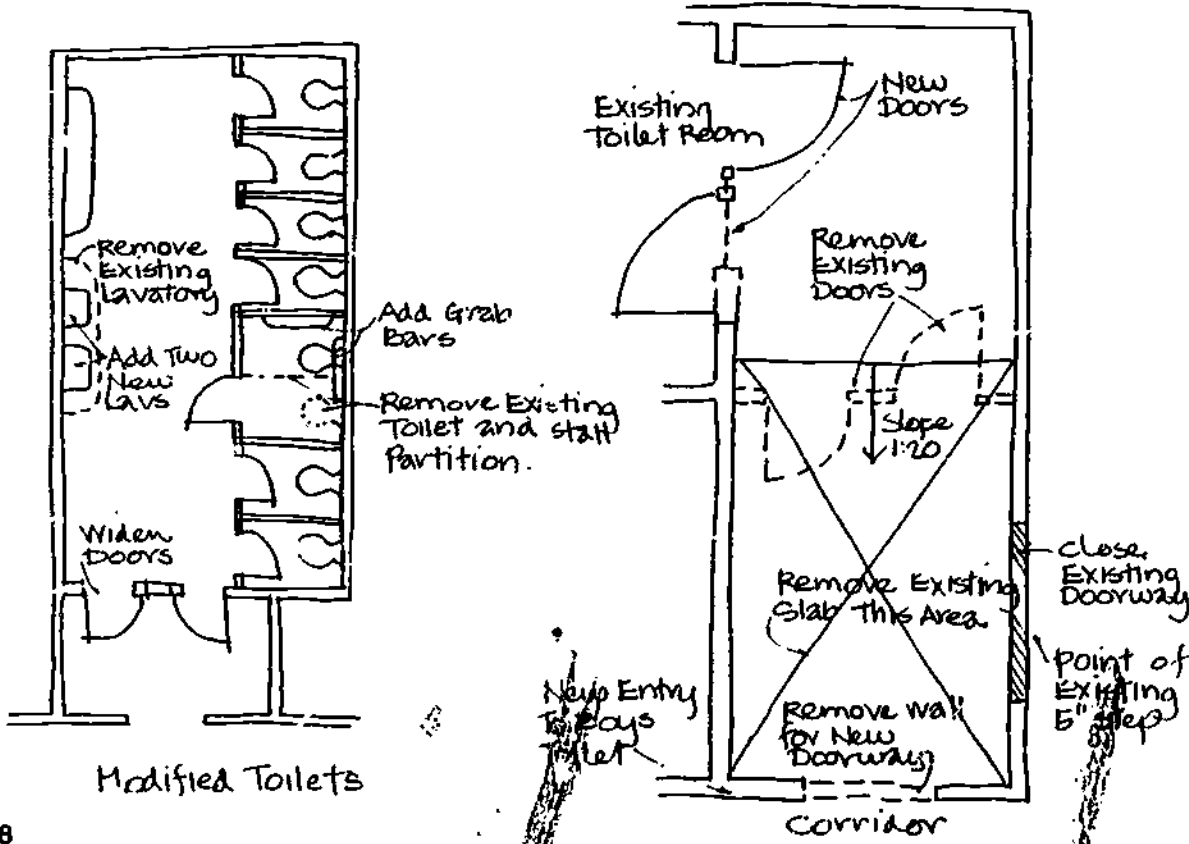
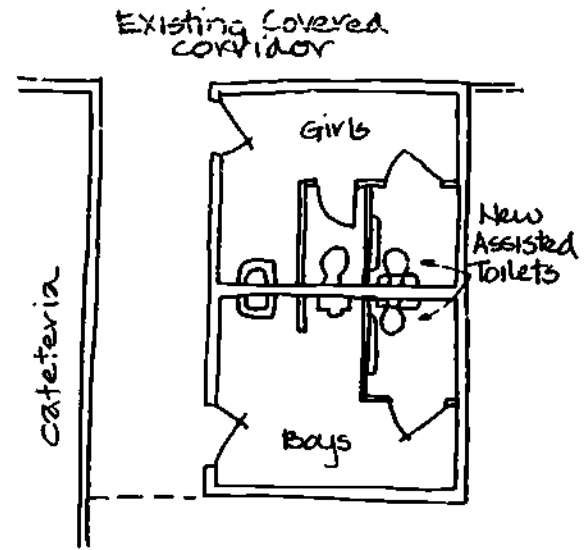
Modified Toilets

Additionally, the Boy's and Girl's toilets at Building E should be modified. The changes at Building E toilets would be to widen doors, add accessible lavatories, join two existing toilet stalls to form an assisted one, and a new lower mirror. Additionally, modifications illustrated are required to solve for a 5" step at the entry to the Boy's toilet. Any solution must change conditions inside the vestibule since a ramp outside would interfere with circulation in the corridor.

Second, to meet a preferred level of accessibility and to avoid a longer trip from the cafeteria and playgrounds, a new toilet could be constructed at the west end of the cafeteria. These toilets would include two lavatories, two toilets for the girls, and one toilet with a urinal for the Boy's. See AA 74 - 92.

25 Boy's toilets at Building E have a step at the entry, narrow entry doors, inaccessible lavatories, and mirrors mounted too high. There are no stalls suitable for assisted use.

26 Girl's toilets at Building E have the same problems as those of the Boy's.

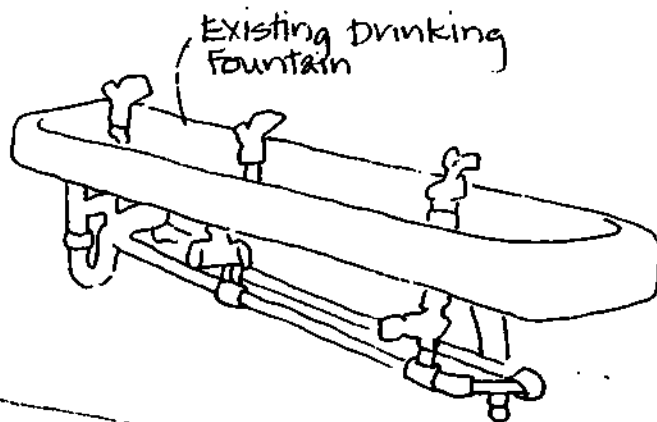
30 Replace the drinking fountains at the cafeteria and in the corridor of Building E. The fountain in Building A has controls which are adequate and although necessary clearance is not available below the fountain, there is a lowered fountain with the required space for a side approach and use.

Add
New Accessible
Drinking Fountain
