AUTHOR Quivik, Fredric
 TITLE Major Energy Conservation Retrofits: A Planning Guide for Northern Climates.
 INSTITUTION National Center for Appropriate Technology, Butte, Mont.
 SPONS AGENCY Department of Energy, Washington, DC. Appropriate Technology Program.
 REPORT NO DOE/CE/15095-11
 PUB DATE Mar 84
 CONTRACT DE-AC01-82CE15095
 NOTE 76p.
 AVAILABLE FROM Superintendent of Documents, U.S. Government Printing Office, Washington, DC 20402.
 PUB TYPE Reference Materials - General (130) -- Reports - General (140)
 EDRS PRICE MF01 Plus Postage. PC Not Available from EDRS.
 DESCRIPTORS *Climate Control; *Energy Conservation; *Facility Improvement; Heating; Housing Needs; *Structural Elements (Construction); Technological Advancement; *Technology; Ventilation
 IDENTIFIERS *Appropriate Technology; Insulation; *Retrofitting

MAJOR ENERGY CONSERVATION RETROFITS

A Planning Guide For Northern Climates

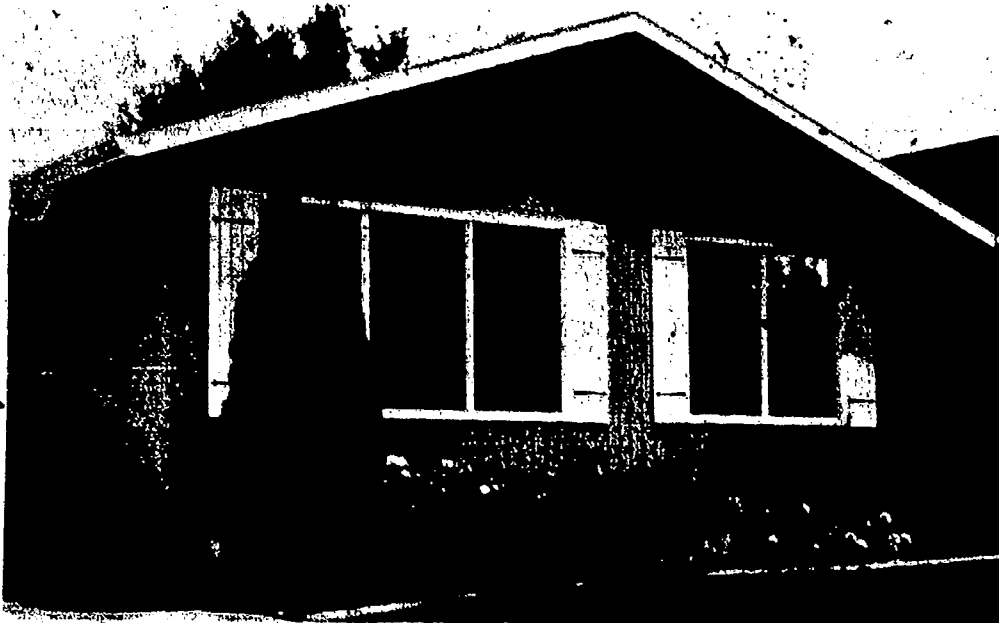
Before the Retrofit: R-8 walls Double glazing
R-15 ceilings Yearly electrical usage: 40,062 kWh

After the Retrofit: R-48 walls Triple glazing
R-55 ceilings Yearly electrical usage: 7,057 kWh

There is a wide range of options available for retrofitting a house to make it more energy efficient. They begin with filling any available space in the attic (except vents) with insulation, and completing standard weatherization steps, like caulking air leaks and adding storm windows. Such an option might cost approximately \$2,000 for an average-sized house. On the other end of the spectrum is a superinsulation retrofit which requires major reconstruction work beyond filling existing wall and attic cavities. This option requires a sizable investment—in some cases, as much as \$20,000 (Figure 1.1).

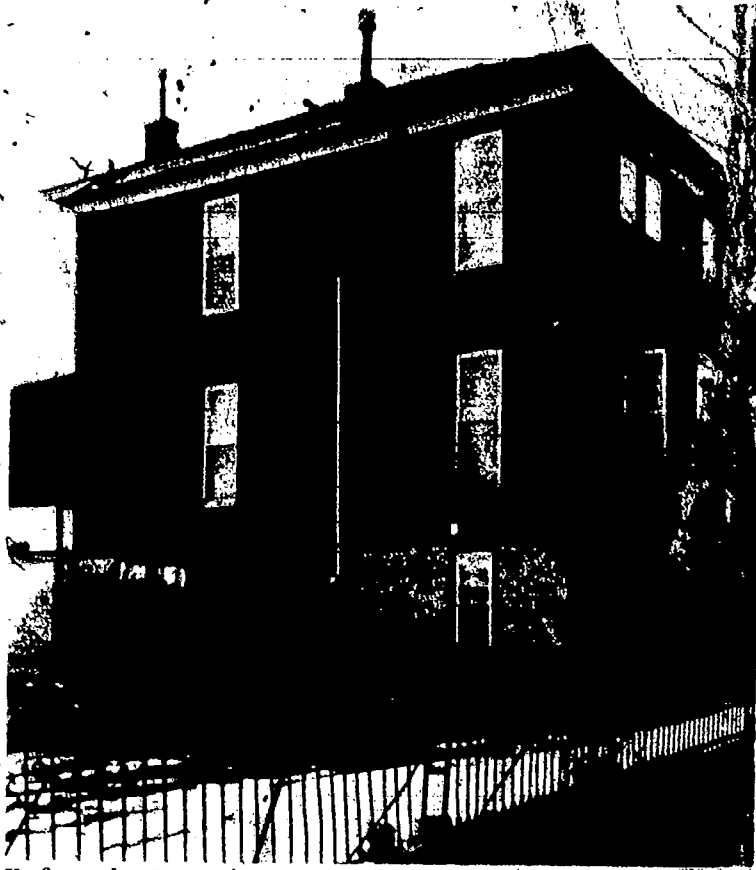
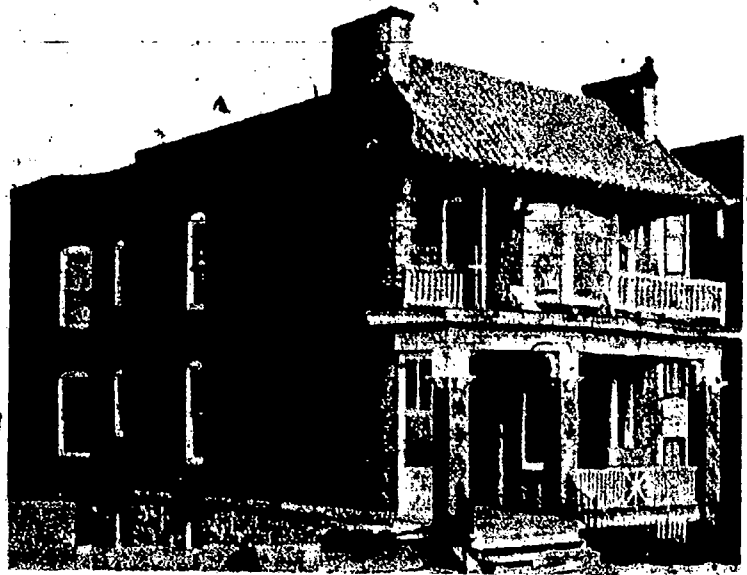
Before the Retrofit:

After the Retrofit:

This passive solar/conservation retrofit by a DOE grantee in Montana demonstrated the value of investing in a conservation retrofit rather than in a passive solar retrofit.

Built in 1905, the apartment is part of a National Historic Landmark District. The building had been vacant for several years when it was purchased by the current owner. It was structurally sound and had significant architectural character, but was in need of major interior rehabilitation. Historic energy consumption figures updated to current prices showed that the uninsulated building, if occupied, would have cost about \$5,000 a year to heat. (Butte has 9,700

heating degree days.) It had leaky doors and windows, no insulation, and an inefficient boiler converted from coal to gas.

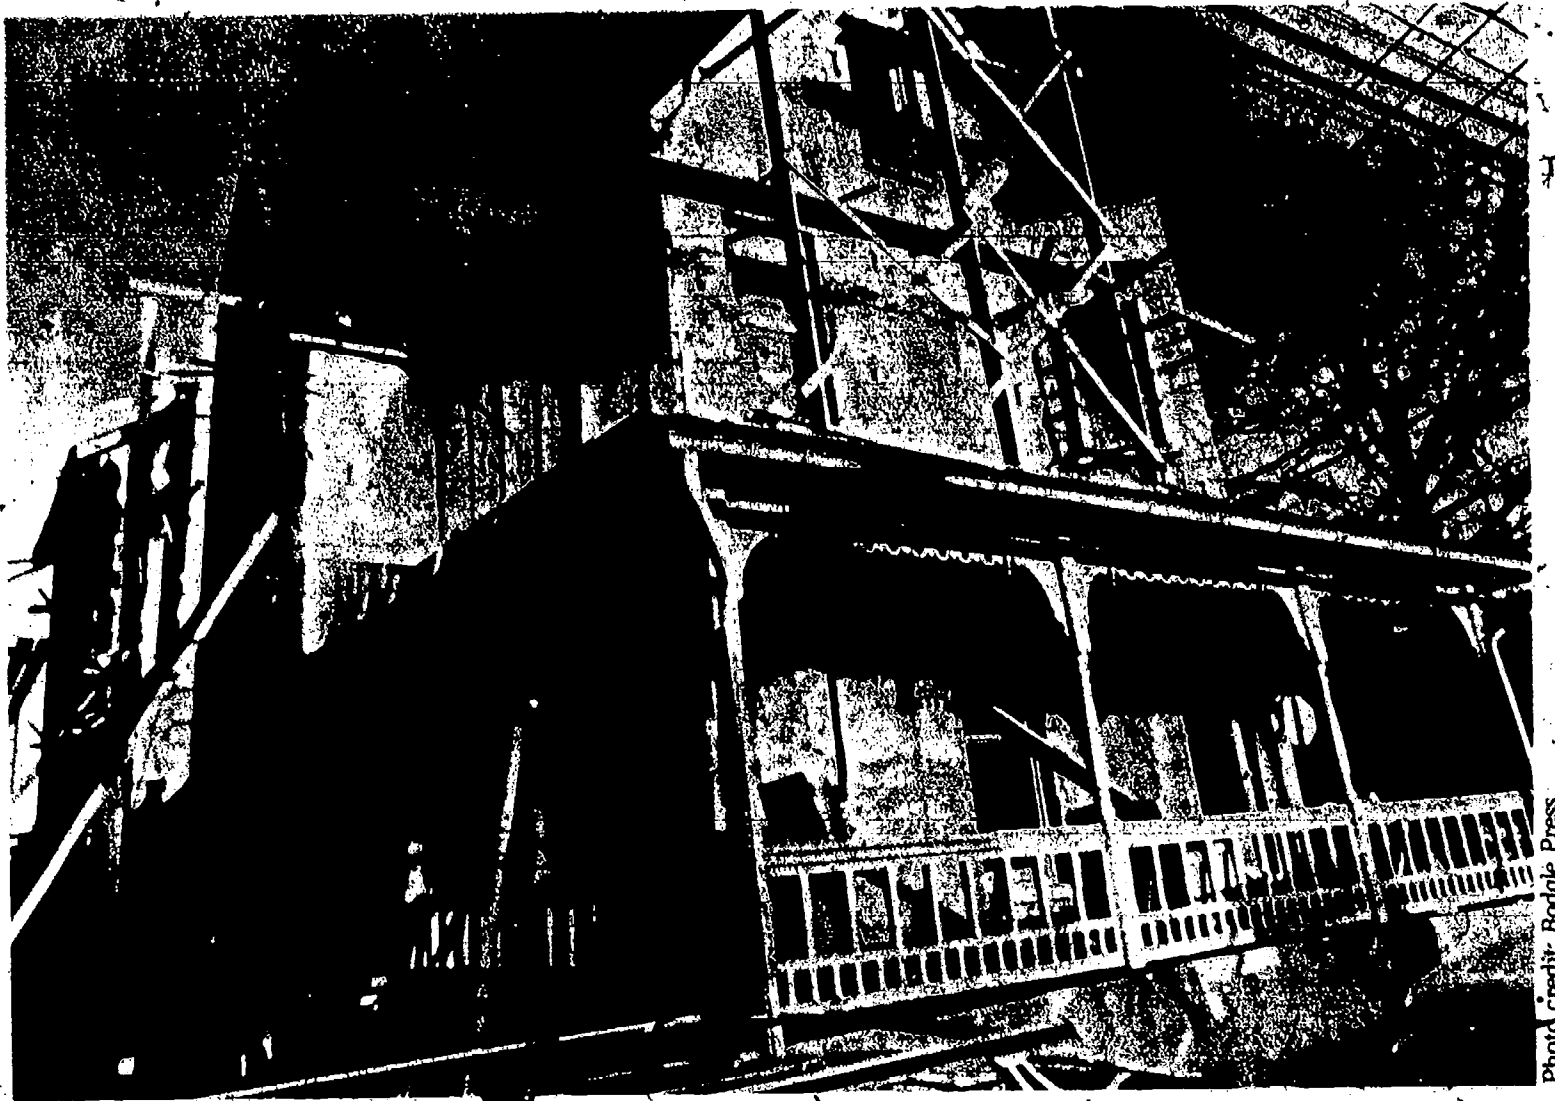
FIGURE 2.2 A grantee in Pennsylvania worked on an exterior retrofit of this historic structure so that the building tenants could remain in the house during construction. Photo credit: Rodale Press.

Another important consideration is whether the house will be occupied during the retrofit. There should be little inconvenience to the occupants with an exterior retrofit, whereas an interior retrofit involves demolition and construction that would be difficult with the building occupied. It might be possible to work on one room at a time, but this technique is generally more costly and the construction mess is still unavoidable (Figure 2.2).
