Guidelines for Retrofitting Bleachers

U.S. Consumer Product
Safety Commission
Washington, DC 20207

Pub. No. 330
000011

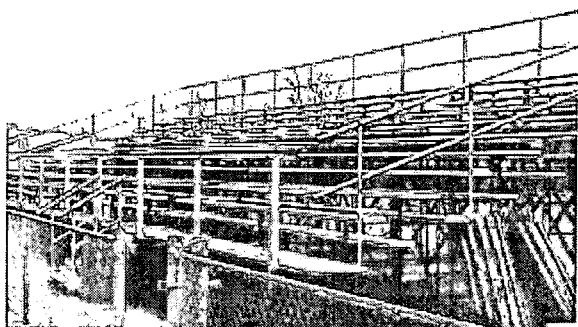
Figure 1: Permanent bleachers

Bleachers are structures that provide tiered or stepped seating, generally without backrests, that come in various configurations and sizes. They generally fit into one of four categories: permanent/stationary, portable/movable, telescopic/folding, and temporary. Figures 1, 2, and 3 are photos of permanent, portable, and telescopic bleachers, respectively. Temporary bleachers are typically stored in pieces and are intended for use only during specific events, such as circuses, golf tournaments, and parades. These guidelines apply to all four categories of bleachers.

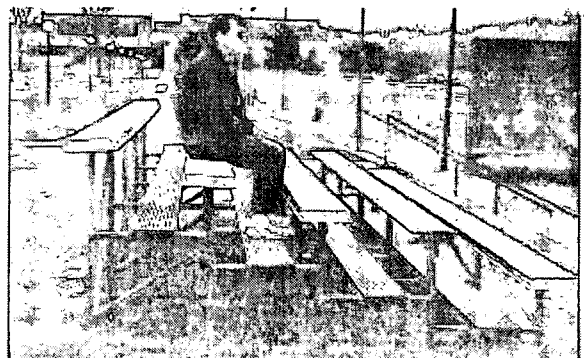
Figure 2: Portable bleachers

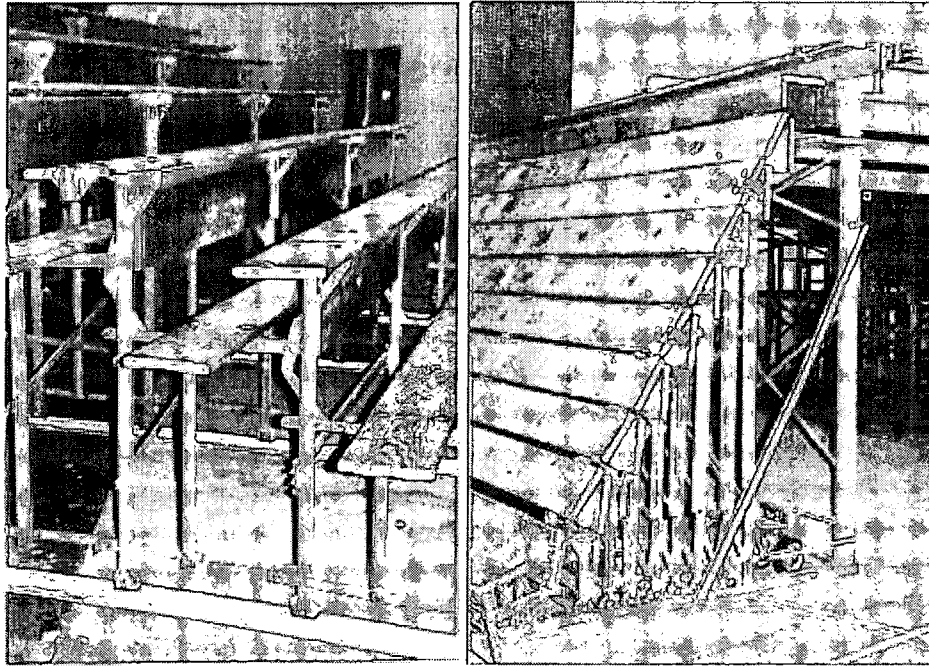
Figure 3: Telescopic bleachers (open and closed positions)

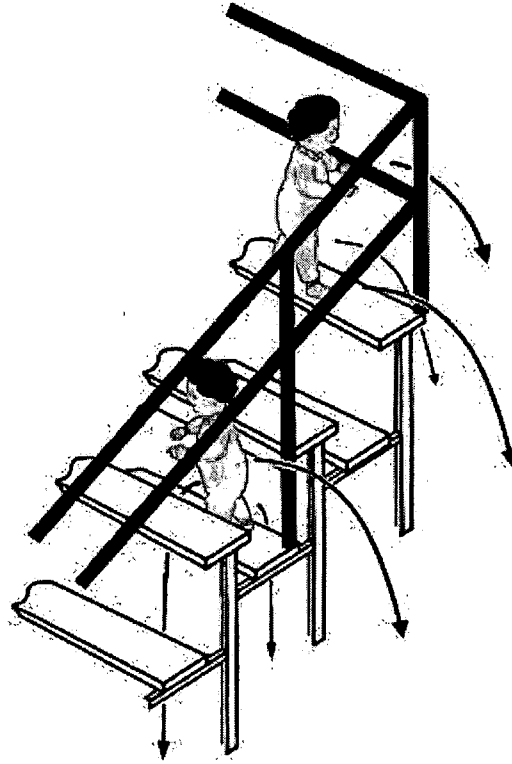
Figure 4: Inadequate guardrails and openings that permit falls from bleachers

Falls from bleachers can occur when guardrails are missing from the backs or open sides of the bleachers. Falls from bleachers can also occur when there are openings between components in the seating and guardrails that are big enough to permit a person to pass through them. These openings can exist in the following areas (and are shown in Figure 4): (1) between components of the guardrail, (2) between components of the seating, such as between the footboard and seatboard, and (3) between the bottom rail of the guardrail and the footboard or seatboard. These guidelines provide recommendations to prevent these falls.

Figures 6 and 7 depict the bleachers shown in Figure 4 after being retrofitted in order to satisfy the recommendations made for guardrails and openings. Figure 6 shows the preferable method of guardrail construction, which has only vertical components between the top and bottom rails. The vertical rails are spaced to prevent passage of a 4-inch sphere. Figure 7 shows guardrails that have been retrofitted with chain link fencing attached to the existing railings. If chain link fencing is used on guardrails, CPSC recommends only using chain link fencing which has a mesh size of 1.25-inch square or less, shown in Figure 8, so that the widest measurement of the openings measures 1.75 inches or less. This will discourage climbing by young children.

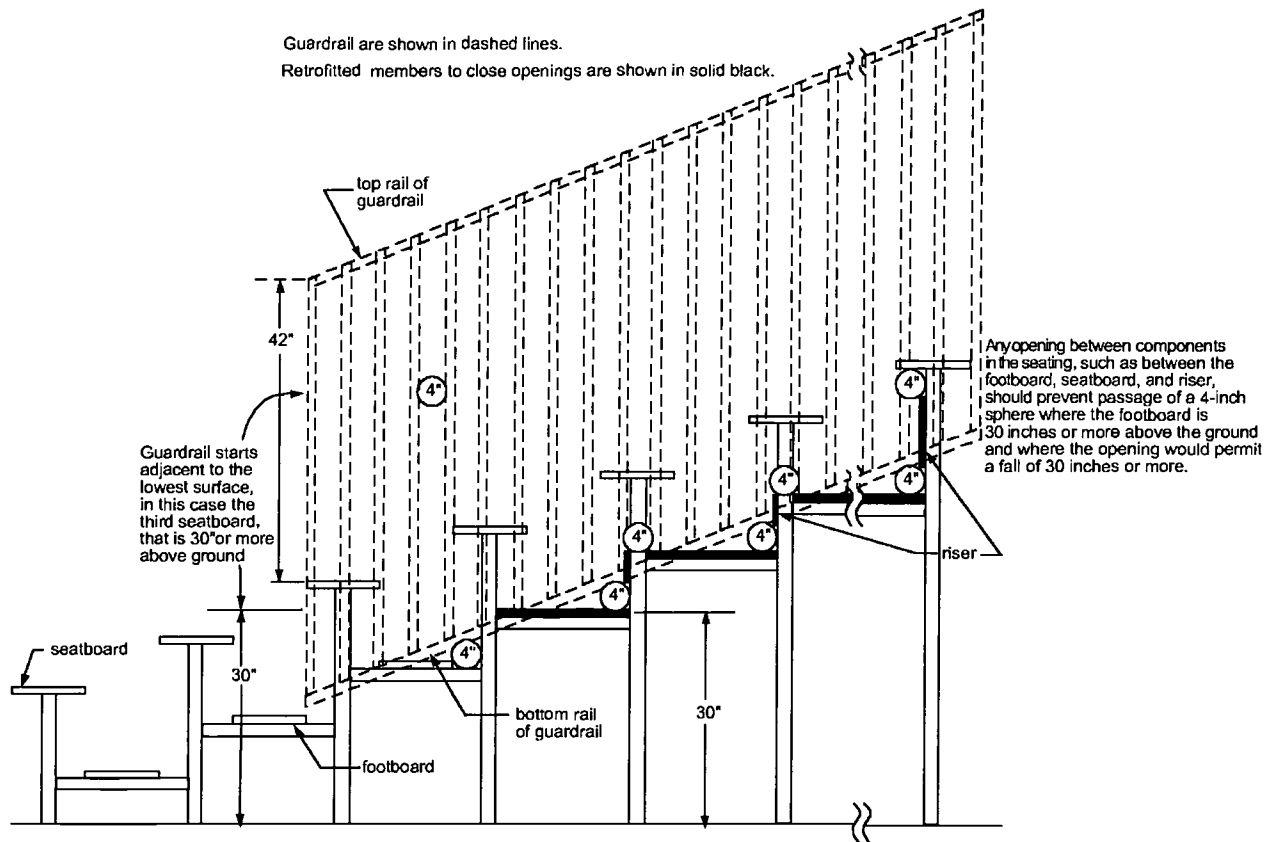
Figure 5: Recommendations for retrofitting guardrails and rigid components on bleachers where the top row exceeds a nominal 30-inch height above the ground.

- Guardrails should be present on the backs and portions of the open ends of bleachers where the footboard, seatboard, or aisle is 30 inches or more above the floor or ground below. See Figure 5. Bleachers with the top row nominally 30 inches above the ground may be exempt from this recommendation.

In addition to limiting the size of openings in and under the guardrails as described above, CPSC also recommends (also see Figure 5):

- Any opening between the components in the seating, such as between the footboard, seatboard, and riser, should prevent passage of a 4-inch sphere where the footboard is 30 inches or more above the ground and where the opening would permit a fall of 30 inches or more.

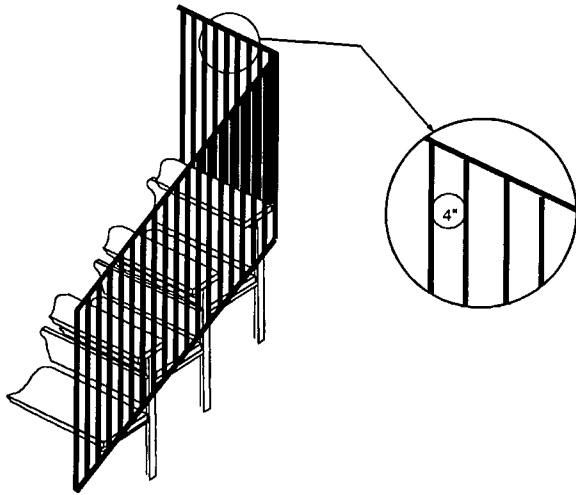
Figure 6: Vertical guardrail members spaced to prevent passage of a 4-inch sphere

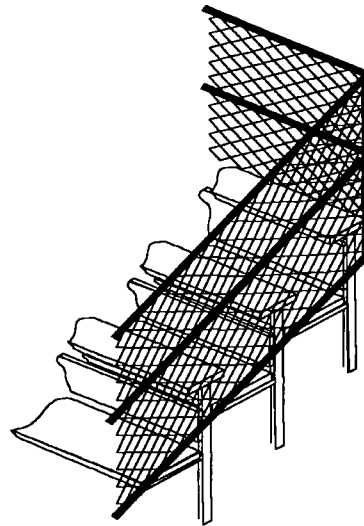
Figure 7: Guardrails with chain link fencing attached to the existing railings

CPSC recommends use of rigid materials, such as aluminum extrusions or grating material, to close the openings between the seating components. CPSC does not recommend the use of chain link or other fencing material to close openings under the seatboards and footboards for a number of reasons. Depending on how the fencing is attached, it can introduce potential trip hazards, it can allow combustible and unsanitary debris to collect under the seats that is not easy to remove, it can be difficult to inspect for any break in integrity, and it can encourage children to play on it and hang from it.

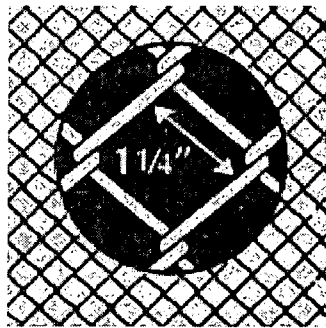
Figure 8: Chain link fence with 1.25" mesh to discourage climbing by young children

- The preferable guardrail design uses only vertical members as in-fill between the top and bottom rails. If there are openings in the in-fill that could provide a foothold for climbing, the widest measurement of the opening where the foot could rest should be limited to a maximum of 1.75 inches. Opening patterns that provide a ladder effect should be avoided. If chain link fencing is used on guardrails, it should have a mesh size of 1.25-inch square or less.
